# **Ayr Station Hotel Structural Condition Factual Report**

Interim Report

19 August 2019

**Document reference:** 399316ZZ-MMD-00-00-RP-S-002

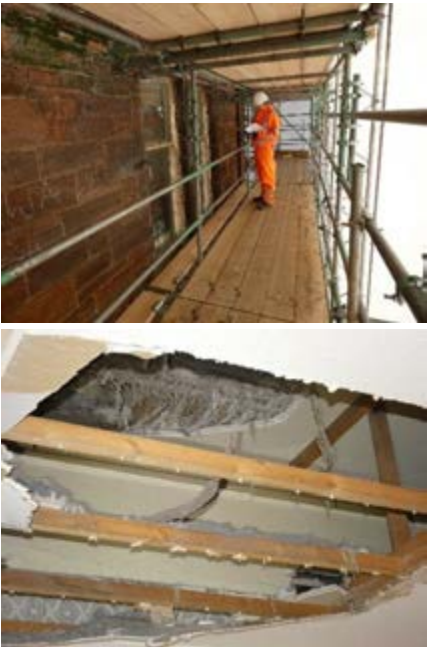
Defect ID	Photo Source	Defect Description	Defect Location	Crack Orientation	Crack Width (mm)	Crack Length (mm)	Comments	Photo	Severity Category
WE2.1	P1010 226-243	Collapsed ceiling plaster, Staining	Bedroom 204	n/a	n/a	n/a	Localised collapse of false ceiling and original ceiling above it, approx. defect area 3x4m (25% of ceiling) located adjacent en suite (226, 238) Peeling and bubbling of wallpaper in upper (lighter) areas of walls (241) Possible mould and signs of dampness on lower (red) sections of walls (243)

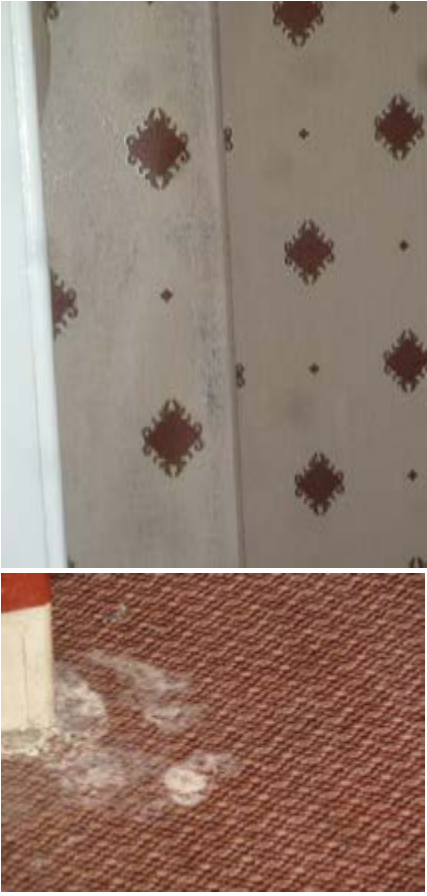
Defect ID	Photo Source	Defect Description	Defect Location	Crack Orientation	Crack Width (mm)	Crack Length (mm)	Comments	Photo	Severity Category
WE2.4	P1010 177-201	Evidence of vermin, Staining, Other	Bedroom 208	n/a	n/a	n/a	Uneven ceiling with slight bulging noted (200, 201) Evidence of possible vermin (193) Minor staining to wallpaper (190)	 	TBC

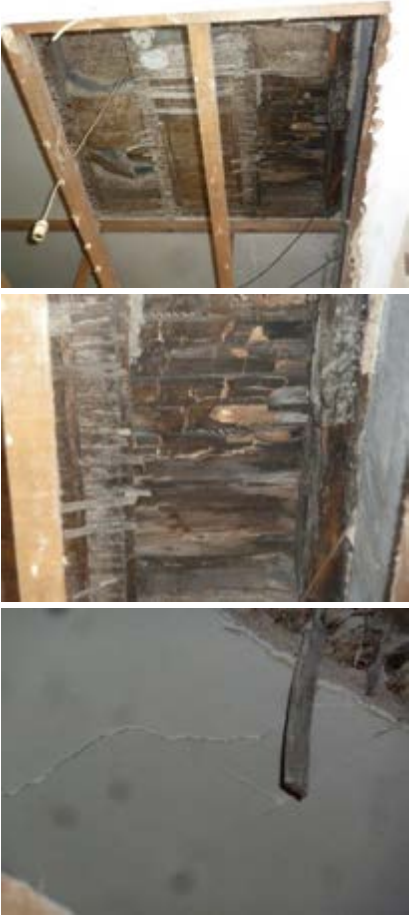
Defect ID	Photo Source	Defect Description	Defect Location	Crack Orientation	Crack Width (mm)	Crack Length (mm)	Comments	Photo	Severity Category
WE2.5	P1200 787-802	Collapsed ceiling plaster, Timber degradation, Dampness/water ingress, Plaster crack, Evidence of vermin	Bedroom 210	n/a	n/a	n/a	Plaster collapse to suspended ceiling and main ceiling above, approx. 25% area (791, 792) Evidence of timber degradation of suspended floor joists above (793-795) Evidence of timber degradation of suspended floorboards above (796-797) Dampness/water ingress (798) Plaster crack (799) Peeling wallpaper. Possible evidence of dampness behind (800, 801) Evidence of vermin (802)

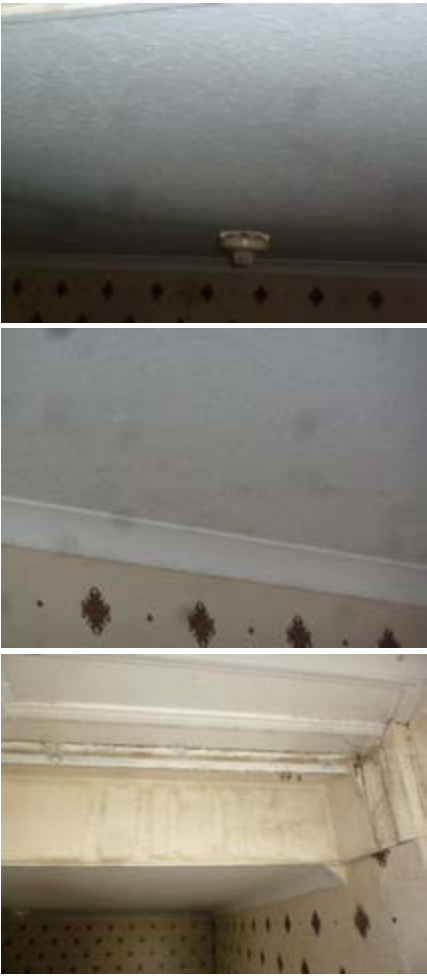
Defect ID	Photo Source	Defect Description	Defect Location	Crack Orientation	Crack Width (mm)	Crack Length (mm)	Comments	Photo	Severity Category
WE2.6	P1200 775-786	Collapsed ceiling plaster, Dampness/water ingress, Collapsed wall plaster, Dampness/water ingress, Evidence of vermin	Bedroom 212	n/a	n/a	n/a	Bulge to plasterboard ceiling. Possible indication of future collapse (782) Dampness/water ingress (783) Collapsed plaster to wall to right hand side of window (784) Dampness/water ingress (785) Evidence of vermin (786)

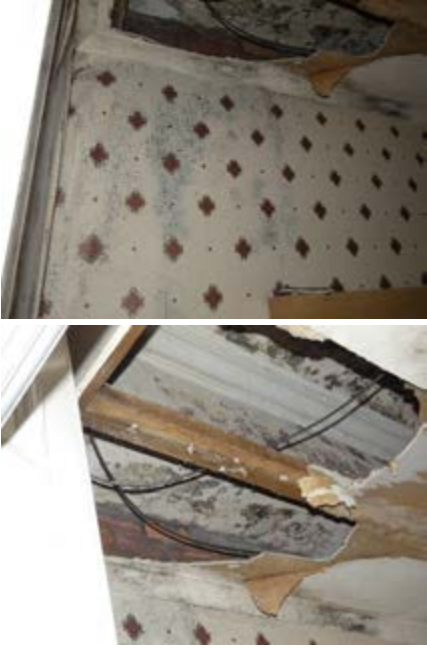
WE2.8	P1200 768-774	Dampness/water ingress	En suite (adj. Bedroom 216)	n/a	n/a	n/a	Dampness/water ingress (773, 774)

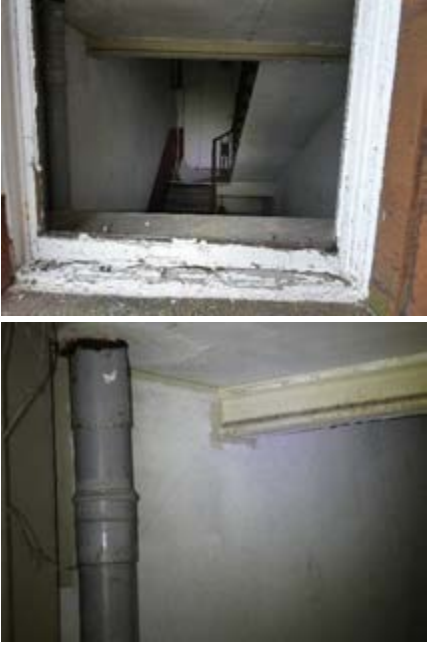
Defect ID	Photo Source	Defect Description	Defect Location	Crack Orientation	Crack Width (mm)	Crack Length (mm)	Comments	Photo	Severity Category
WS2.1	P1000 974-993	Crack, Other	Stair well (adj. Bedroom 203)	Diagonal	1	400	Crack (974/979) Spalling to paint finish (988/993) Damage to plaster wall and skirting separating (985) Mild corrosion to metal support beam (981)

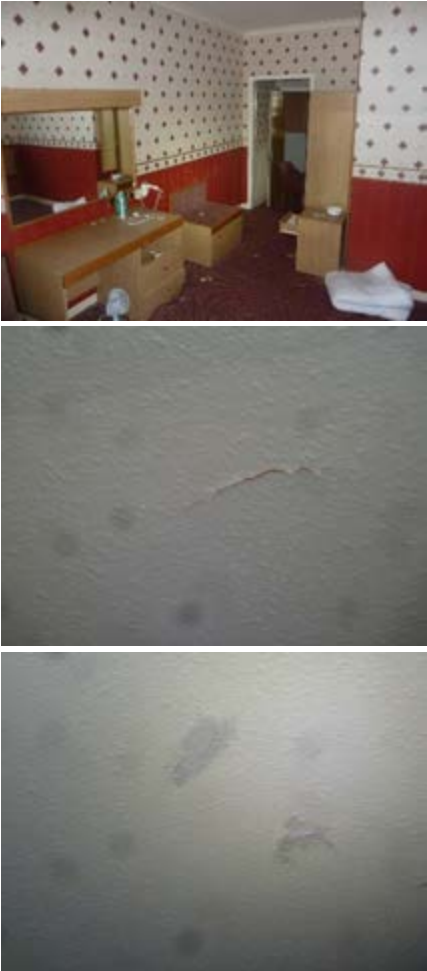
Defect ID	Photo Source	Defect Description	Defect Location	Crack Orientation	Crack Width (mm)	Crack Length (mm)	Comments	Photo	Severity Category
WS2.2	P1200 685-693	Plaster crack, Dampness/ water ingress	Bedroom 203	Horizontal	>1	10	Plaster crack (691) Dampness/water ingress (692, 693)

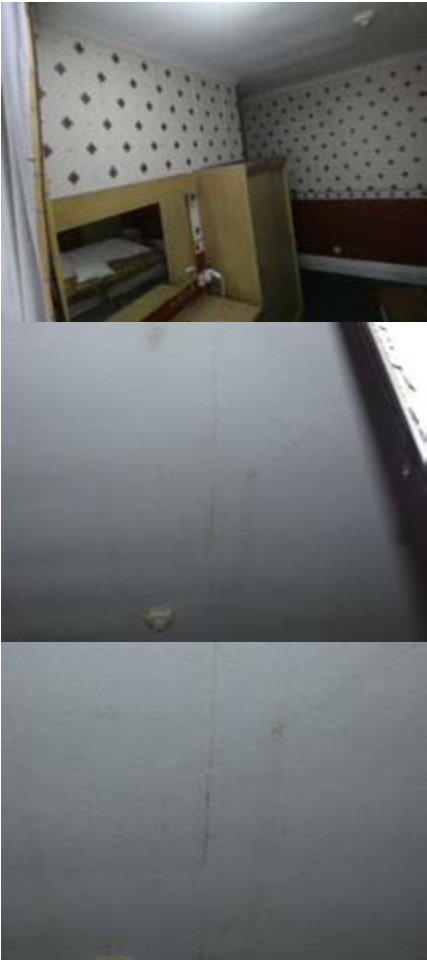
Defect ID	Photo Source	Defect Description	Defect Location	Crack Orientation	Crack Width (mm)	Crack Length (mm)	Comments	Photo	Severity Category
WW2.1	P1000 994-999 P1010 001-012	Staining, Crack, Evidence of vermin	Bedroom 205	Horizontal	1	3000	Peeling wallpaper and staining on the wall (999, 002) Crack on ceiling/possibly plaster ceiling joint line (011/012) Evidence of vermin (006)

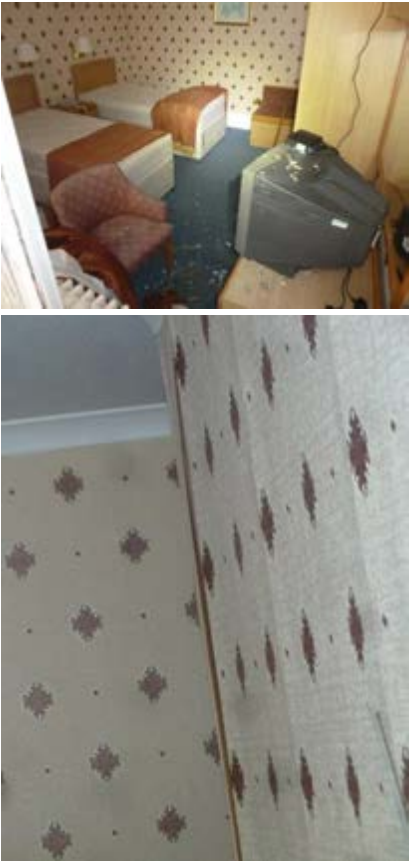
Defect ID	Photo Source	Defect Description	Defect Location	Crack Orientation	Crack Width (mm)	Crack Length (mm)	Comments	Photo	Severity Category
WW2.2	P1200 694-699	Evidence of vermin, Dampness/ water ingress	Bedroom 207	n/a	n/a	n/a	Evidence of vermin (698) Peeling wallpaper. Possible evidence of dampness behind (699)

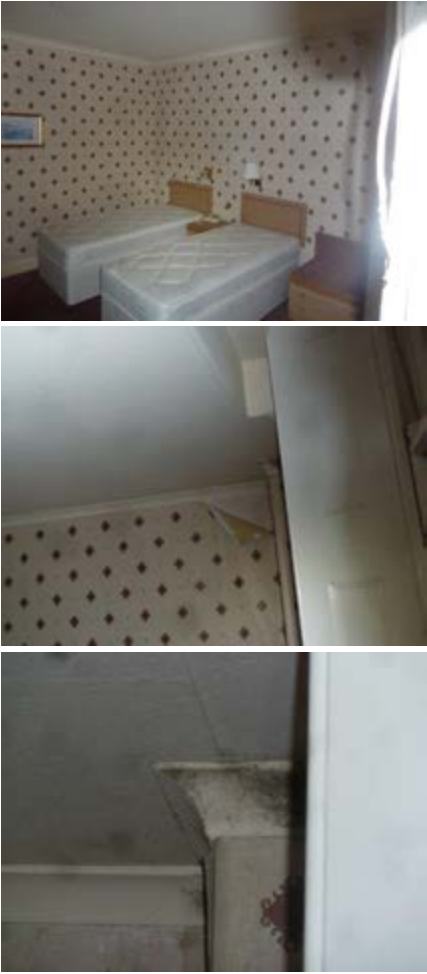
Defect ID	Photo Source	Defect Description	Defect Location	Crack Orientation	Crack Width (mm)	Crack Length (mm)	Comments	Photo	Severity Category
WW2.3	P1200 700-707	Dampness/ water ingress	Bedroom 209	n/a	n/a	n/a	Peeling wallpaper. Possible evidence of dampness behind (704) Dampness/water ingress (705, 706) Peeling wallpaper. Possible evidence of dampness behind (707)

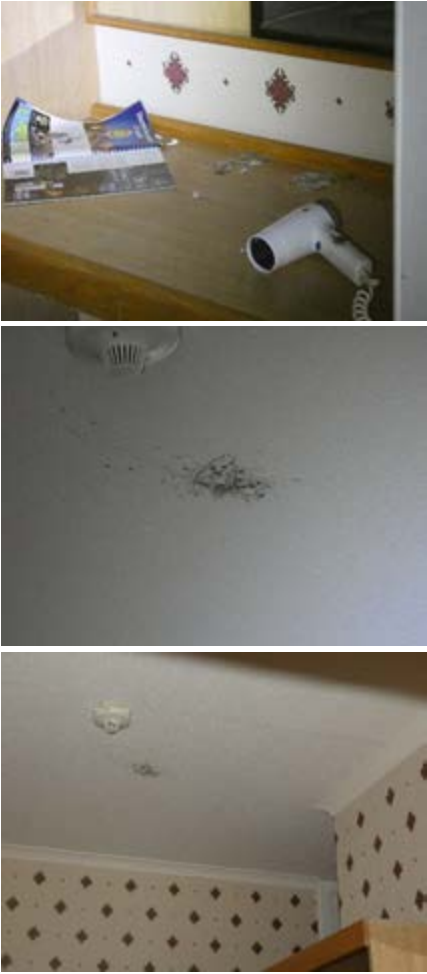
Defect ID	Photo Source	Defect Description	Defect Location	Crack Orientation	Crack Width (mm)	Crack Length (mm)	Comments	Photo	Severity Category
WW2.4	P1010 013-033	Evidence of vermin, Staining, Other, Crack	Bedroom 211	Horizontal	<1	1500	Evidence of vermin, Staining (019) Black localised staining on ceiling, possibly mould (020) Crack on ceiling/possibly plaster ceiling joint line (028/033)

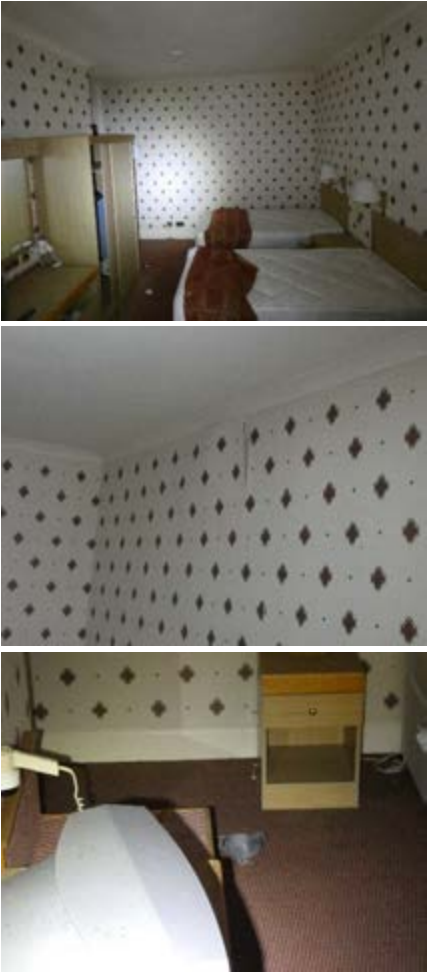
Defect ID	Photo Source	Defect Description	Defect Location	Crack Orientation	Crack Width (mm)	Crack Length (mm)	Comments	Photo	Severity Category
WW2.5	P1010 034-050	Evidence of vermin, Other	Bedroom 215	n/a	n/a	n/a	Peeling wallpaper and slight bulge behind wallpaper noted (034/048) Evidence of vermin (050)

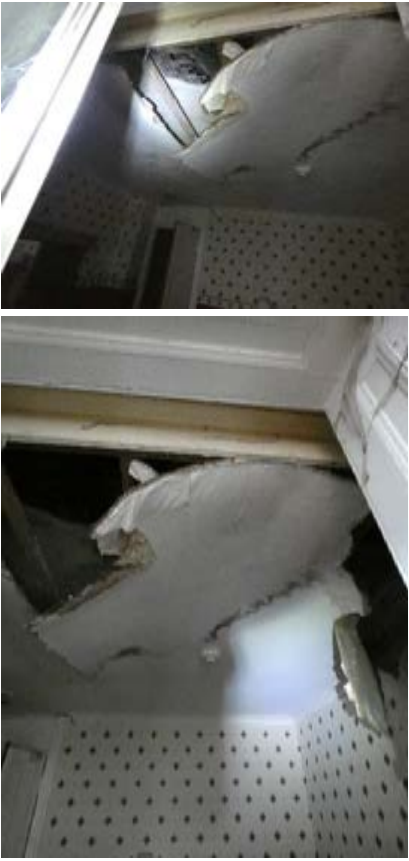
Defect ID	Photo Source	Defect Description	Defect Location	Crack Orientation	Crack Width (mm)	Crack Length (mm)	Comments	Photo	Severity Category
WE3.7	P1000 587-600	Collapsed ceiling plaster, Evidence of vermin, Staining	Bedroom 314	n/a	n/a	n/a	Significant collapse of false ceiling and original ceiling above it (589, 595) Staining to ceiling (598) White staining to wall (600) Evidence of vermin (597)

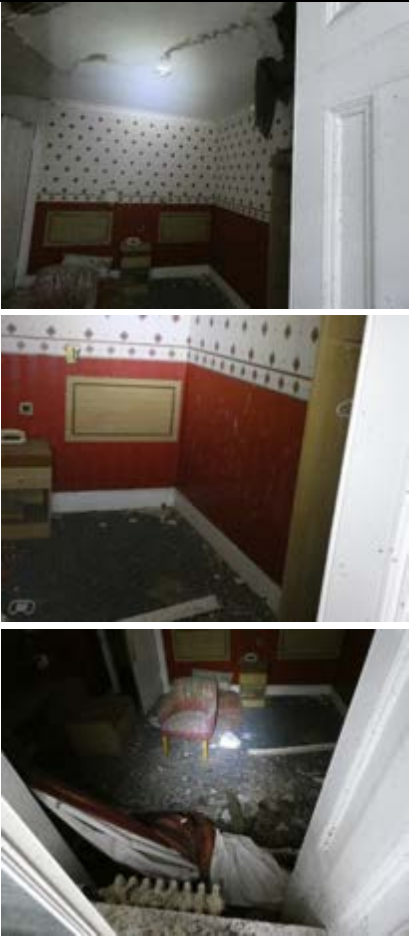
Defect ID	Photo Source	Defect Description	Defect Location	Crack Orientation	Crack Width (mm)	Crack Length (mm)	Comments	Photo	Severity Category
WE3.8	P1200 631-640	Collapsed ceiling plaster, Dampness/water ingress, Evidence of vermin	Bedroom 312	n/a	n/a	n/a	Plaster collapse to suspended ceiling and main ceiling above (635) Dampness/water ingress (639) Evidence of vermin (640)	 	TBC

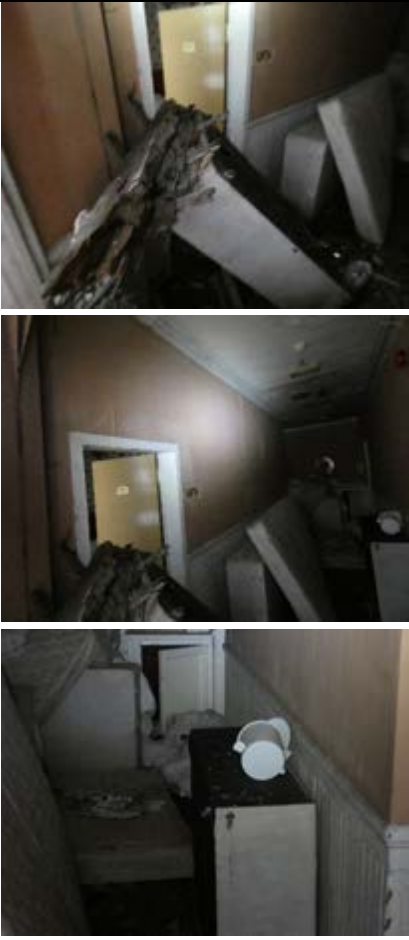
Defect ID	Photo Source	Defect Description	Defect Location	Crack Orientation	Crack Width (mm)	Crack Length (mm)	Comments	Photo	Severity Category
WN3.4	P1200 671-676	Ceiling plaster crack, Dampness/water ingress, Evidence of vermin	Hallway/Store	Horizontal	1	200	Ceiling plaster crack (675) Dampness/water ingress (674) Evidence of vermin (676)	 	TBC

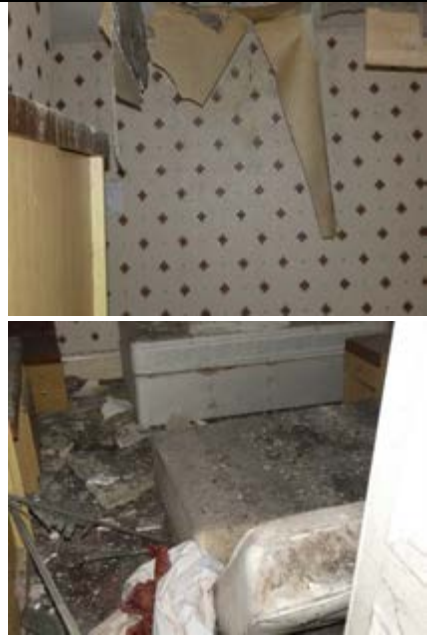
WW3.2	P1000 732-759	Collapsed ceiling plaster, Evidence of vermin, Staining	Bedroom 319	n/a	n/a	n/a	Significant collapse of ceiling (761) 2x Staining on ceiling (744, 746) 2x Staining on wall (748, 751) Evidence of vermin (754)

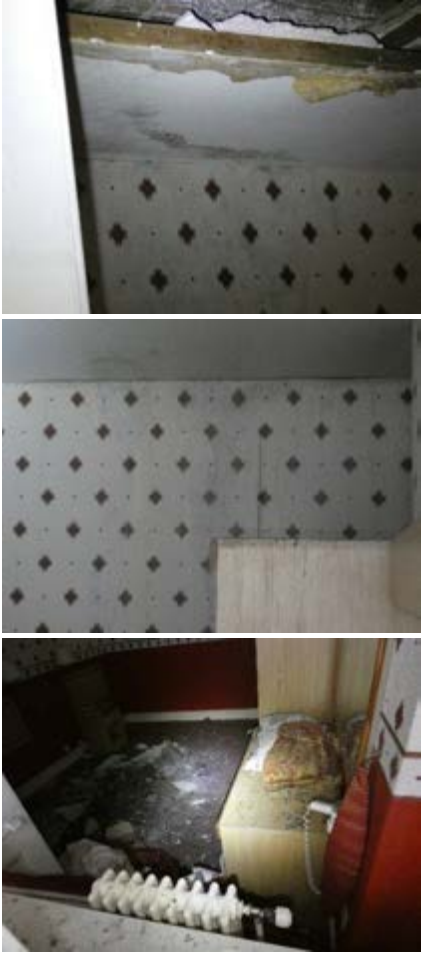
Defect ID	Photo Source	Defect Description	Defect Location	Crack Orientation	Crack Width (mm)	Crack Length (mm)	Comments	Photo	Severity Category
WW3.3	P1000 896-940	Collapsed wall plaster, Evidence of vermin, Other	Stairs (adj. Bedroom 319)	n/a	n/a	n/a	Wallpaper on wall to LHS of door (939, 940) Window cill broken with hole (900) 2x Crack to wall of window cill (902) Mould staining on ceiling, wallpaper detached from ceiling (910, 921, 922) Walls appear re-plastered (-) Black stain to wall above light (925, 926) Crack/tear in wall finish to wall at RHS of window (913) Evidence of vermin (928)	 	TBC

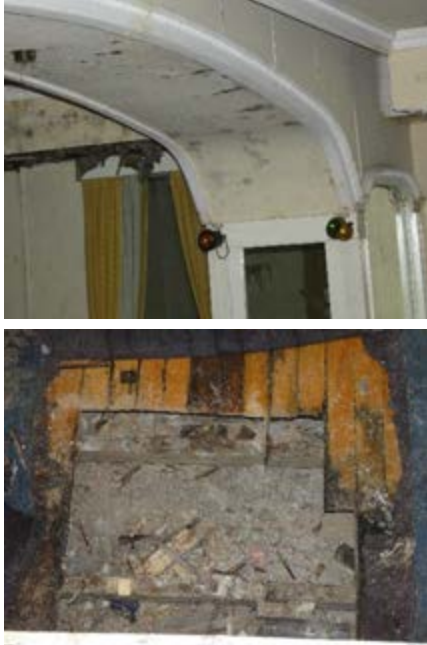
FO02	P1020 731-741	Dampness/water ingress, Other	South block, Ground level, Reception area	n/a	n/a	n/a	<p>Reception area in very good state. Ceiling all intact.</p> <p>Walls also intact – one area of damp (732, 734)</p> <p>Carpet still down on most floor area.</p> <p>Floor opened up, timber boards in good condition. Boards on timber joists on hard floor – possibly concrete (735-739).</p>
