# **Ayr Station Hotel Structural Condition Factual Report**

Interim Report

19 August 2019

**Document reference:** 399316ZZ-MMD-00-00-RP-S-002

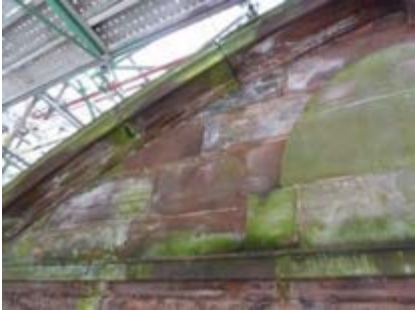
Defect ID	Photo Source	Defect Description	Defect Location	Crack Orientation	Crack Width (mm)	Crack Length (mm)	Comments	Photo	Severity Category
N1.4	P1200203, 204	Water staining efflorescence	North Elevation N1, Wall	n/a	n/a	n/a	General water staining and vegetation growth/staining noted on wall face

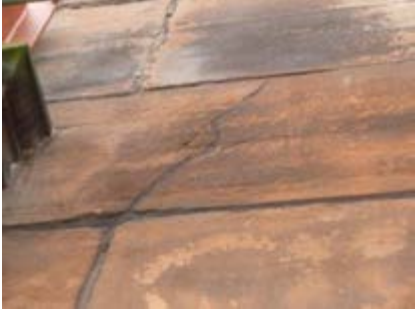
TBC
N1.5	P1200206	Cracking to sandstone	North Elevation N1, Wall	Diagonal	3	300	Crack on sandstone block, appears to have been repaired/infilled

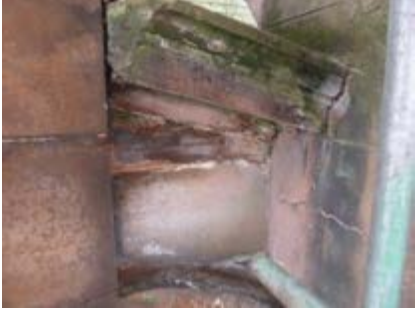
TBC
N1.6	P1200207, 208	Spalled/damaged sandstone	North Elevation N1, Wall	n/a	n/a	n/a	Spalled/cracked/broken sandstone below coping

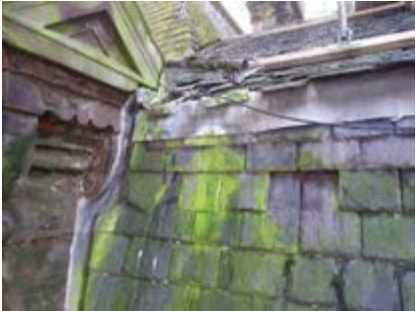
Defect ID	Photo Source	Defect Description	Defect Location	Crack Orientation	Crack Width (mm)	Crack Length (mm)	Comments	Photo	Severity Category
N1.12	P1200221	Missing/damaged tiles/roof	North Elevation N1, Wall	n/a	n/a	n/a	Missing/dislodged roof tiles

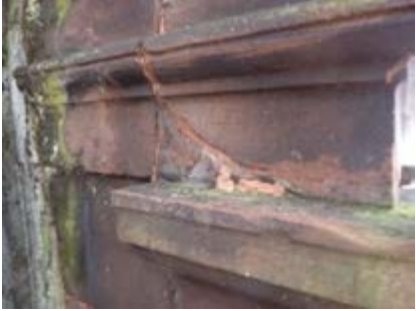
TBC
N1.13	P1200222, 0223	Spalled/damaged sandstone, Cracking to sandstone	North Elevation N1, Wall	Diagonal	1	150	Crack on sandstone block, appears to have been repaired/infilled

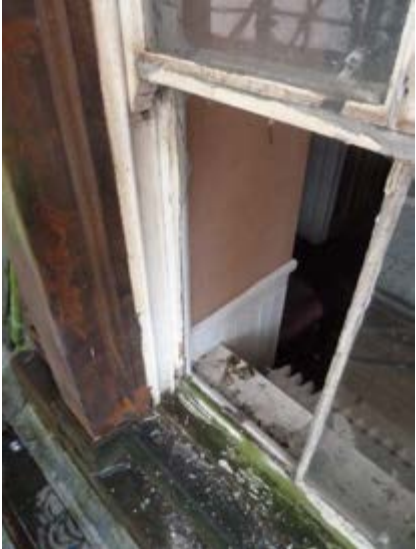
Defect ID	Photo Source	Defect Description	Defect Location	Crack Orientation	Crack Width (mm)	Crack Length (mm)	Comments	Photo	Severity Category
N1.14	P1200224	Other	North Elevation N1, Wall	n/a	n/a	n/a	Missing window pane

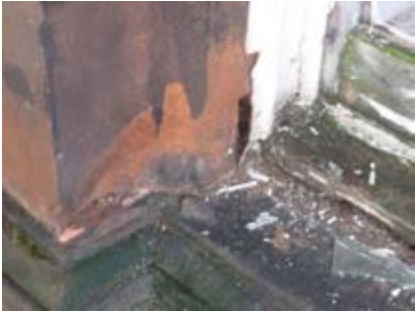
TBC
N1.15	P1200225	Spalled/damaged sandstone	North Elevation N1, Wall	n/a	n/a	n/a	Deterioration of sandstone pilaster at side of window

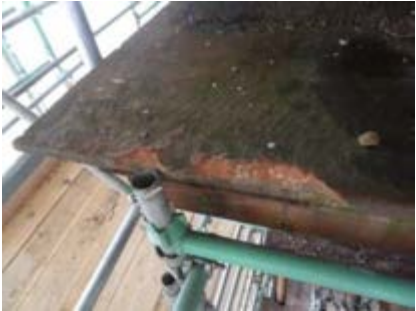
Defect ID	Photo Source	Defect Description	Defect Location	Crack Orientation	Crack Width (mm)	Crack Length (mm)	Comments	Photo	Severity Category
N1.16	P1200226, 227, 231, 232	Spalled/damaged sandstone ledge	North Elevation N1, Wall	n/a	n/a	n/a	Spalled/cracked/broken off sandstone to ledge feature at 5 locations

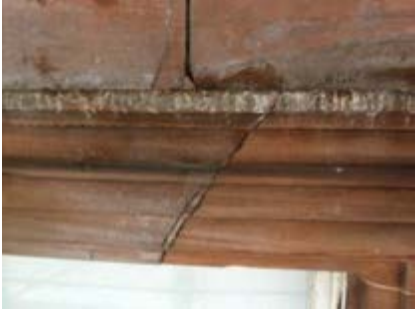
TBC
N1.17	P1200228	Cracking to sandstone	North Elevation N1, Wall	Diagonal	2	100	Crack on sandstone block of window lintel

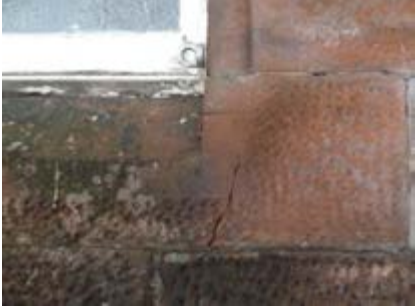
TBC
N1.18	P1200229	Cracking to sandstone	North Elevation N1, Wall	Vertical	2	150	Crack on sandstone block adjacent to window cill

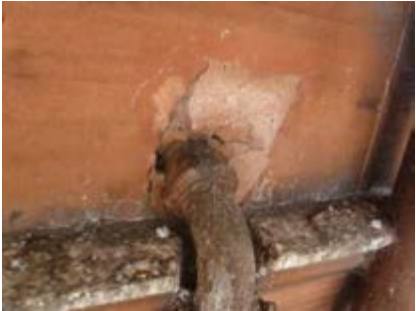
Defect ID	Photo Source	Defect Description	Defect Location	Crack Orientation	Crack Width (mm)	Crack Length (mm)	Comments	Photo	Severity Category
N1.19	P1200230	Spalled/damaged sandstone	North Elevation N1, Wall	n/a	n/a	n/a	Deterioration to sandstone block at pipe penetration

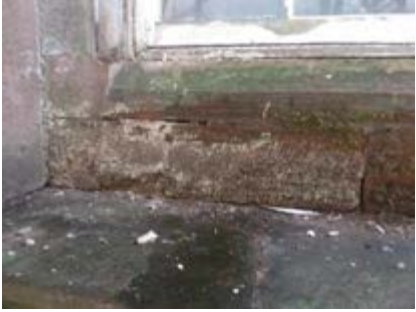
TBC
N1.20	P1200233, 234	Missing/damaged pointing	North Elevation N1, Wall	n/a	n/a	n/a	Deterioration and loss of mortar joints below window

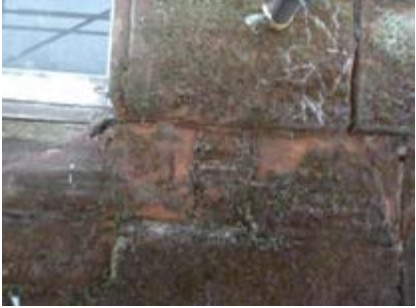
TBC
N1.21	P1200235	Spalled/damaged sandstone	North Elevation N1, Wall	n/a	n/a	n/a	Deterioration to sandstone block, appears to be weathered

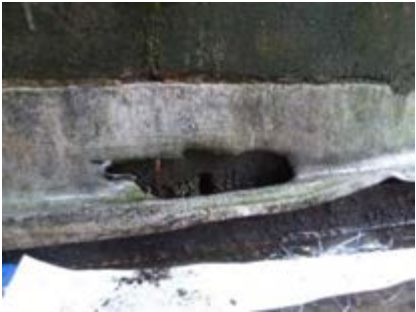
Defect ID	Photo Source	Defect Description	Defect Location	Crack Orientation	Crack Width (mm)	Crack Length (mm)	Comments	Photo	Severity Category
N1.22	P1200236	Other	North Elevation N1, Wall	n/a	n/a	n/a	Damaged flashing below window

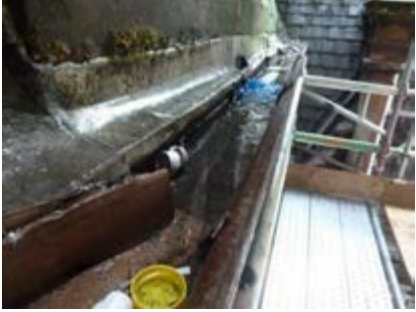
TBC
N1.23	P1200237, 238, 239	Damaged/defective gutter/drainage	North Elevation N1, Wall	n/a	n/a	n/a	Gutter appears to be defective and not draining

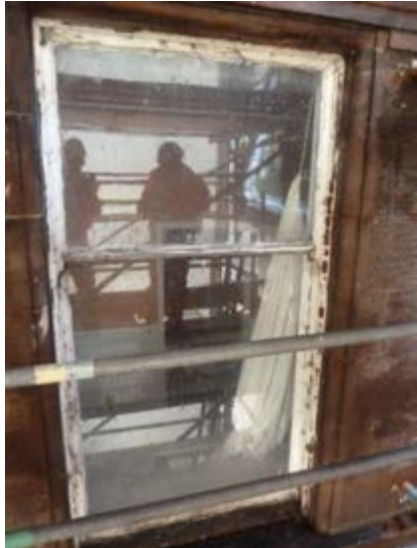
Defect ID	Photo Source	Defect Description	Defect Location	Crack Orientation	Crack Width (mm)	Crack Length (mm)	Comments	Photo	Severity Category
N1.24	P1200313, 315	Other	North Elevation N1, Wall	n/a	n/a	n/a	Deterioration of timber framing to windows

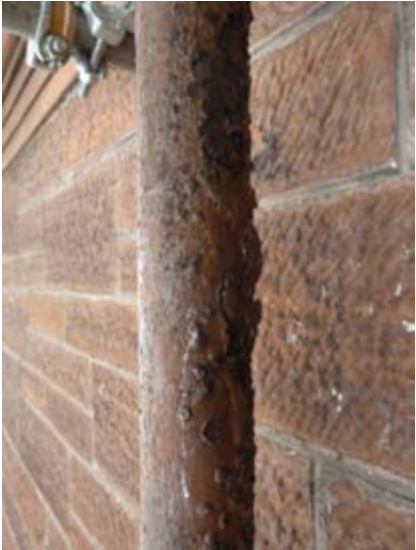
Defect ID	Photo Source	Defect Description	Defect Location	Crack Orientation	Crack Width (mm)	Crack Length (mm)	Comments	Photo	Severity Category
N1.26	P1200316	Damaged/d efective gutter/drain age	North Elevation N1, Wall	n/a	n/a	n/a	Surface corrosion to downpipe, appears quite extensive

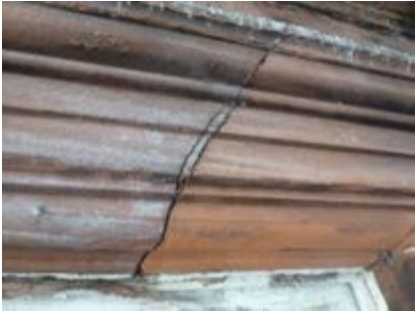
TBC
N1.27	P1200317, 318	Cracking to sandstone	North Elevation N1, Wall	Diagonal	4	300	Cracked window lintel, 2no. separate cracks on lintel observed

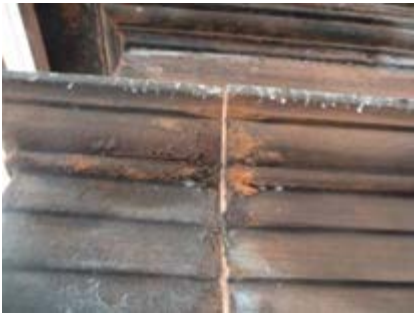
Defect ID	Photo Source	Defect Description	Defect Location	Crack Orientation	Crack Width (mm)	Crack Length (mm)	Comments	Photo	Severity Category
N1.28	P1200319	Spalled/damaged sandstone	North Elevation N1, Wall	n/a	n/a	n/a	Spalling/delamination of sandstone blocks on and adjacent ledge feature

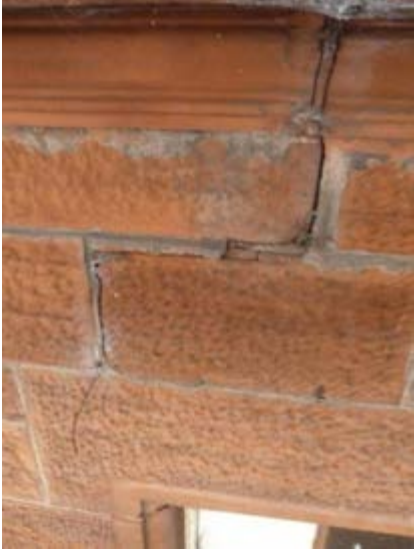
TBC
N1.29	P1200428, 430	Missing/damaged pointing, Cracking to sandstone	North Elevation N1, Wall	Stepped / Diagonal	3	2000	Crack between upper and lower windows. Crack travels mostly along mortar joint and extends on a sandstone block

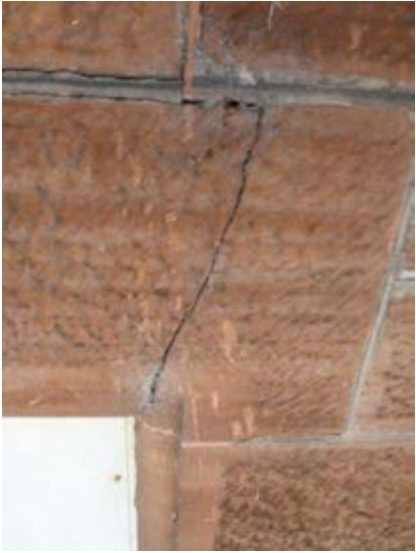
Defect ID	Photo Source	Defect Description	Defect Location	Crack Orientation	Crack Width (mm)	Crack Length (mm)	Comments	Photo	Severity Category
N1.30	P1200429	Cracking to sandstone	North Elevation N1, Wall	Diagonal	1	300	Crack on lintel

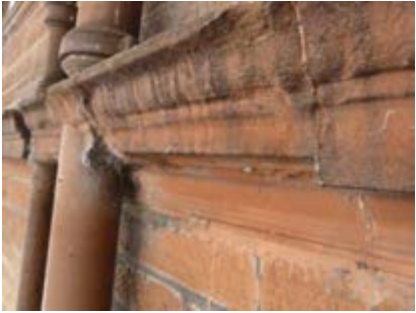
TBC
N1.31	P1200431, 432	Spalled/damaged sandstone	North Elevation N1, Wall	n/a	n/a	n/a	Sandstone ledge feature appears to exhibit delamination/erosion with loss of section observed

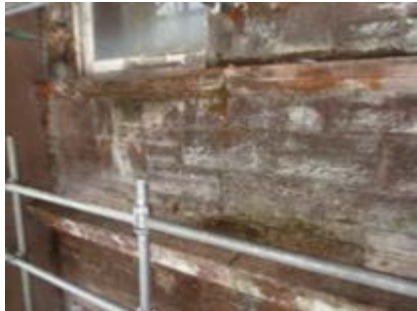
Defect ID	Photo Source	Defect Description	Defect Location	Crack Orientation	Crack Width (mm)	Crack Length (mm)	Comments	Photo	Severity Category
N1.32	P1200433	Water staining efflorescence	North Elevation N1, Wall	n/a	n/a	n/a	-

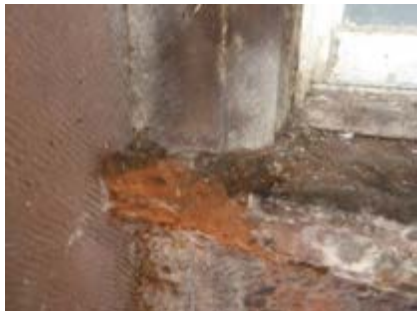
TBC
N1.33	P1200434	spalled/damaged sandstone	North Elevation N1, Wall	n/a	n/a	n/a	Deterioration to sandstone block at window cill

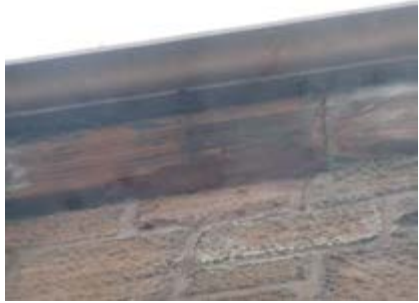
Defect ID	Photo Source	Defect Description	Defect Location	Crack Orientation	Crack Width (mm)	Crack Length (mm)	Comments	Photo	Severity Category
N3.1	P1190481	Spalled/damaged sandstone	Underside gutter support	n/a	n/a	n/a	Sandstone ledge feature appears to exhibit delamination/erosion

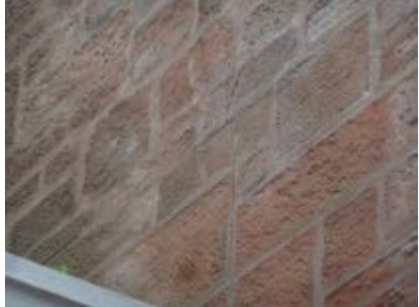
TBC
N3.2	P1190482	Cracking to sandstone	Wall	Vertical	1	750	-

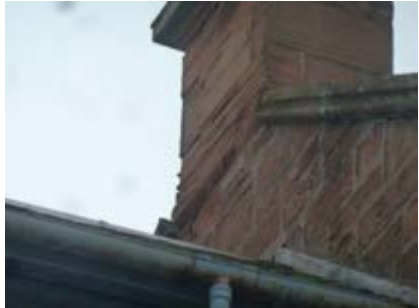
TBC
N3.3	P1190483	Spalled/damaged sandstone	Underside chimney	n/a	n/a	n/a	Sandstone blocks appears to exhibit delamination/erosion

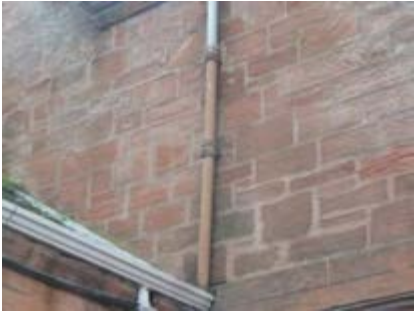
Defect ID	Photo Source	Defect Description	Defect Location	Crack Orientation	Crack Width (mm)	Crack Length (mm)	Comments	Photo	Severity Category
N3.4	P1190484	Spalled/damaged sandstone	Elevation N3, Wall	n/a	n/a	n/a	Sandstone blocks appears to exhibit weathering/erosion

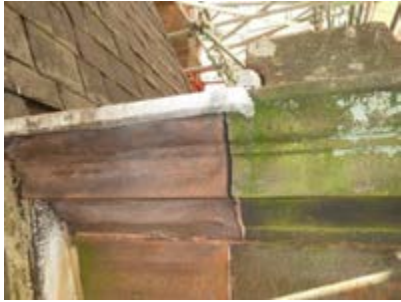
Defect ID	Photo Source	Defect Description	Defect Location	Crack Orientation	Crack Width (mm)	Crack Length (mm)	Comments	Photo	Severity Category
E1.7	P1200112	Other	Coping above window	n/a	n/a	n/a	Missing mortar between stonework, possibly loose block

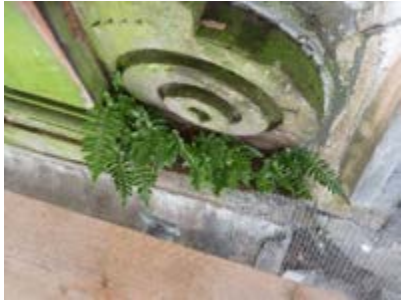
Defect ID	Photo Source	Defect Description	Defect Location	Crack Orientation	Crack Width (mm)	Crack Length (mm)	Comments	Photo	Severity Category
E1.15	P1200125	Vegetation growth	Roof and wall	n/a	n/a	n/a	General vegetation growth observed on elevation E1 building face

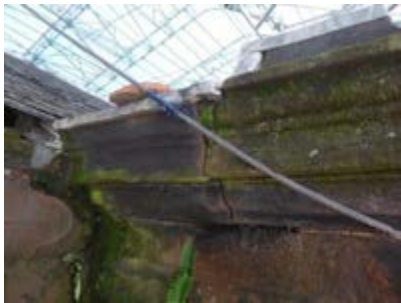
Defect ID	Photo Source	Defect Description	Defect Location	Crack Orientation	Crack Width (mm)	Crack Length (mm)	Comments	Photo	Severity Category
E1.18	P1200133	Other	Mansard roof	n/a	n/a	n/a	Missing tiles exposed and damaged/rotted timber. Roof void exposed. Broken cast iron feature	 	TBC
E1.19	P1200136	Spalled/damaged sandstone	Above roof	n/a	n/a	n/a	Cracked/broken off sandstone. Missing mortar, possibly loose block

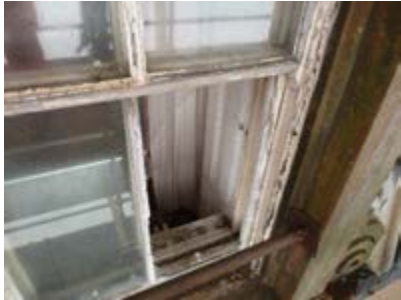
Defect ID	Photo Source	Defect Description	Defect Location	Crack Orientation	Crack Width (mm)	Crack Length (mm)	Comments	Photo	Severity Category
E1.26	P1200146	Other	Window	n/a	n/a	n/a	Smashed window pane

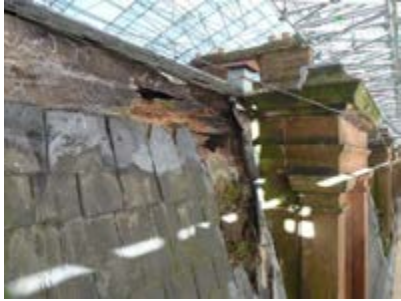
TBC
E1.27	P1200147-152	Other	Mansard roof	n/a	n/a	n/a	Missing tiles exposed and damaged/rotted timber. Roof void exposed. Damaged flashing

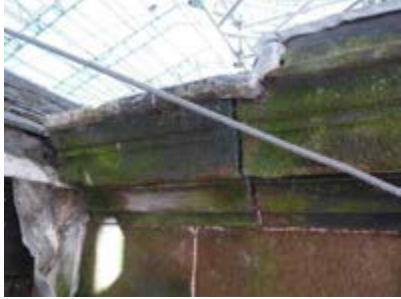
TBC
E1.28	P1200153	Spalled/damaged sandstone	Above window	n/a	n/a	n/a	Cracked/broken off sandstone. Missing mortar, possibly loose block

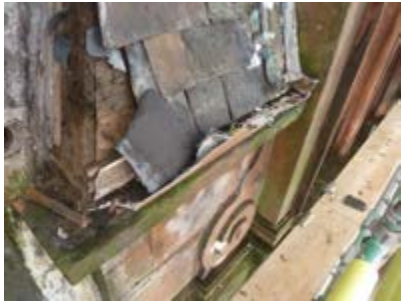
Defect ID	Photo Source	Defect Description	Defect Location	Crack Orientation	Crack Width (mm)	Crack Length (mm)	Comments	Photo	Severity Category
E1.41	P1200182	Damaged/defective gutter/drainage Displaced tiles/slates	Mansard roof	n/a	n/a	n/a	Damaged gutter

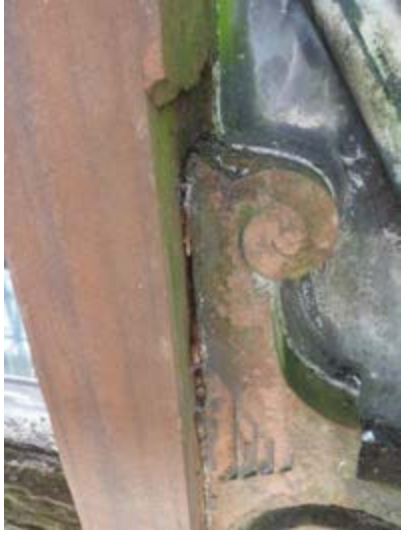
TBC
E1.42	P1200183	Spalled/damaged sandstone	Mansard roof	n/a	n/a	n/a	Delamination/erosion of sandstone to feature stonework

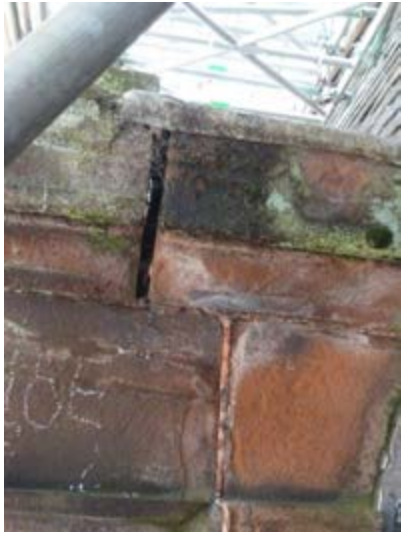
Defect ID	Photo Source	Defect Description	Defect Location	Crack Orientation	Crack Width (mm)	Crack Length (mm)	Comments	Photo	Severity Category
E1.46	P1200190194	Spalled/damaged sandstone	Above roof	n/a	n/a	n/a	Delamination/erosion of sandstone. Missing mortar, possibly loose block

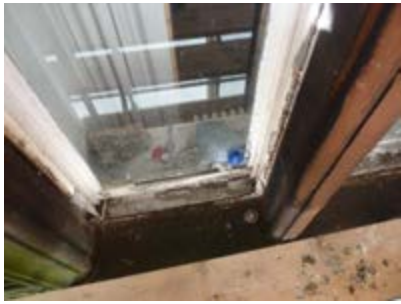
TBC
E1.47	P1200191	Other	Window	n/a	n/a	n/a	Broken window pane

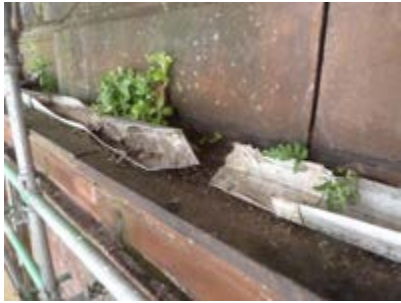
Defect ID	Photo Source	Defect Description	Defect Location	Crack Orientation	Crack Width (mm)	Crack Length (mm)	Comments	Photo	Severity Category
E1.51	P1200243	Other	Gutter	n/a	n/a	n/a	Damage to temporary gutters

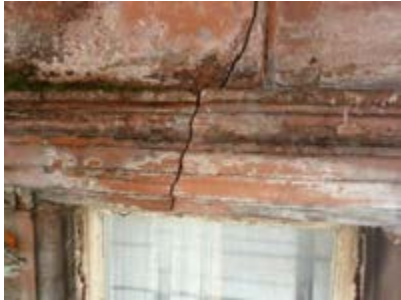
TBC
E1.52	P1200244-245	Cracking to sandstone	Wall	Diagonal	6	700	Substantial crack to lintel which extends into sandstone wall

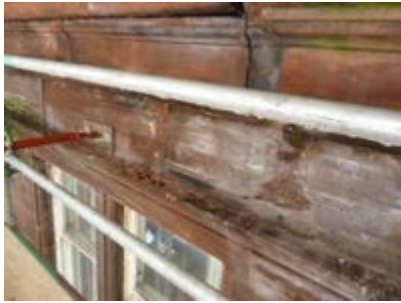
Defect ID	Photo Source	Defect Description	Defect Location	Crack Orientation	Crack Width (mm)	Crack Length (mm)	Comments	Photo	Severity Category
E1.55	P1200248-250	Water staining efflorescence	Wall	n/a	n/a	n/a	General defect - water staining to building face

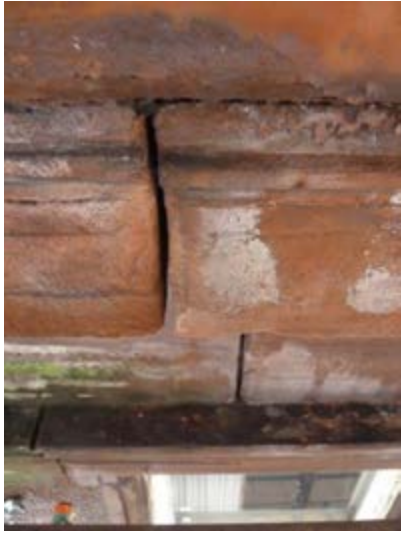
TBC
E1.56	P1200251-252	Spalled/damaged sandstone	Wall	n/a	n/a	n/a	Missing mortar, possibly loose block

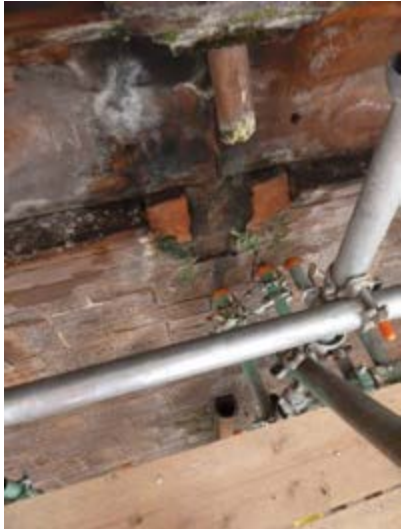
Defect ID	Photo Source	Defect Description	Defect Location	Crack Orientation	Crack Width (mm)	Crack Length (mm)	Comments	Photo	Severity Category
E1.59	P1200257	Spalled/damaged sandstone	Wall	n/a	n/a	n/a	Cracked/broken off sandstone due to broken rainwater pipe

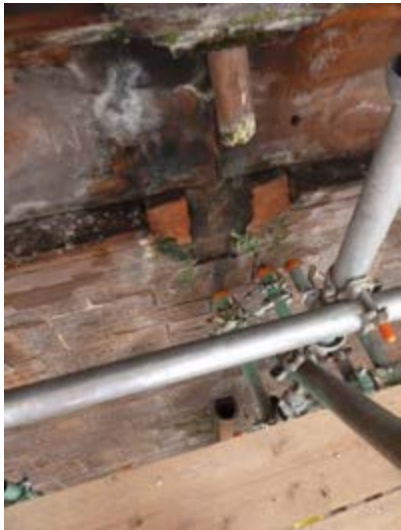
TBC
E1.60	P1200257	Damaged/defective gutter/drainage	Downpipe	n/a	n/a	n/a	Missing section of downpipe

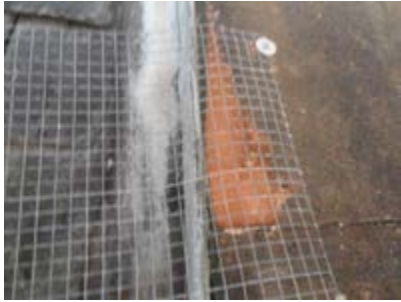
Defect ID	Photo Source	Defect Description	Defect Location	Crack Orientation	Crack Width (mm)	Crack Length (mm)	Comments	Photo	Severity Category
E1.66	P1200267	Spalled/damaged sandstone	Wall	n/a	n/a	n/a	Cracked/broken off sandstone

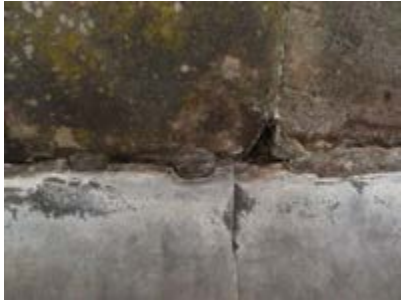
TBC
E1.67	P1200269	Spalled/damaged sandstone	Wall	n/a	n/a	n/a	Cracked/broken off sandstone

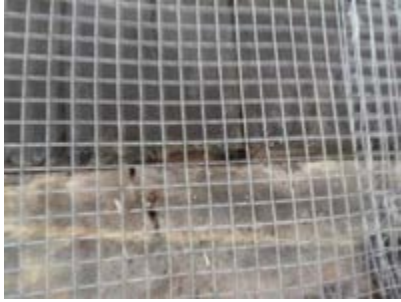
TBC
E1.68	P1200270	Other	Flashing	n/a	n/a	n/a	Defective flashing

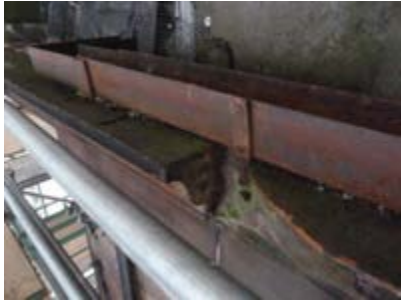
Defect ID	Photo Source	Defect Description	Defect Location	Crack Orientation	Crack Width (mm)	Crack Length (mm)	Comments	Photo	Severity Category
E1.93	P1200312	Spalled/damaged sandstone	Sandstone ledge feature	n/a	n/a	n/a	Cracked/broken off sandstone to sandstone ledge feature

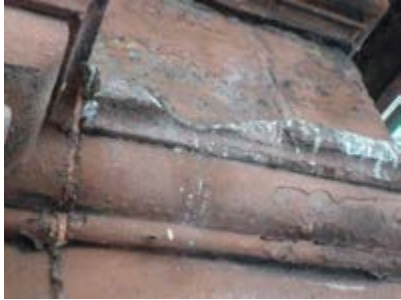
TBC
E1.94	Not used	Not used	Not used	Not used	Not used	Not used	Not used	Not used	Not used
E1.95	P1200322	Spalled/damaged sandstone	Sandstone ledge feature	n/a	n/a	n/a	Cracked/broken off sandstone to sandstone ledge feature

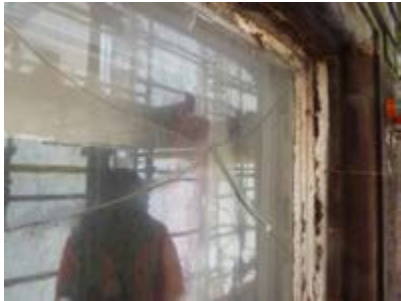
Defect ID	Photo Source	Defect Description	Defect Location	Crack Orientation	Crack Width (mm)	Crack Length (mm)	Comments	Photo	Severity Category
E1.101	P1200328	Other	Window	n/a	n/a	n/a	Crack to window pane

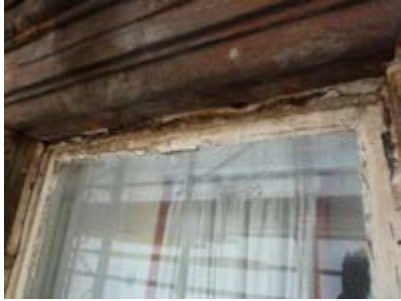
TBC
E1.102	P1200329	Other	Window	n/a	n/a	n/a	Deterioration of timber framing to windows - Common defect visible in majority of windows

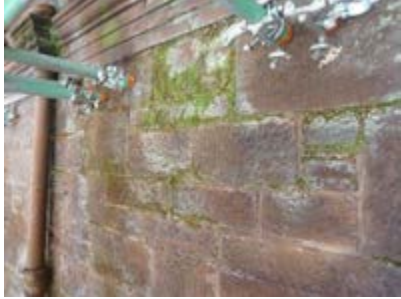
Defect ID	Photo Source	Defect Description	Defect Location	Crack Orientation	Crack Width (mm)	Crack Length (mm)	Comments	Photo	Severity Category
E1.107	P1200334	Cracking to sandstone	Lintel	Diagonal	6	100	Crack to window lintel	 	TBC
E1.108	P1200335	Other	Window	n/a	n/a	n/a	Deterioration of timber framing to windows - Common defect visible in majority of windows	 	TBC
E1.109	P1200336	Water staining efflorescence	Wall	n/a	n/a	n/a	Water staining to building face

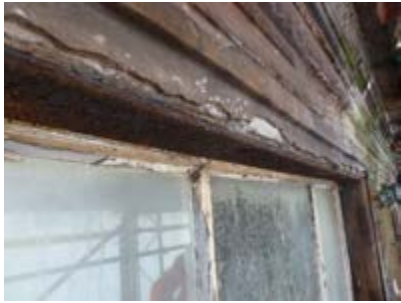
Defect ID	Photo Source	Defect Description	Defect Location	Crack Orientation	Crack Width (mm)	Crack Length (mm)	Comments	Photo	Severity Category
E1.113	P1200341, 342	Other	Lintel	n/a	n/a	n/a	Corroded steel lintel

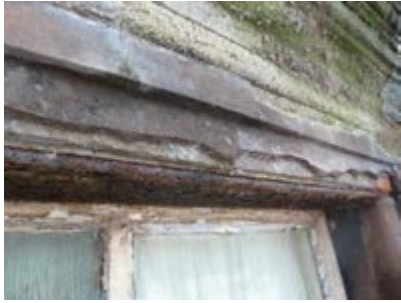
TBC
E1.114	P1200343	Spalled/damaged sandstone	Lintel	n/a	n/a	n/a	Sections of sandstone appear to have cracked/broken off the window lintel

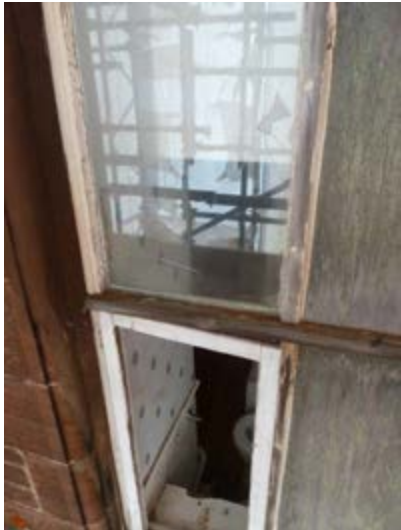
Defect ID	Photo Source	Defect Description	Defect Location	Crack Orientation	Crack Width (mm)	Crack Length (mm)	Comments	Photo	Severity Category
E1.115	P1200344	Other	Window	n/a	n/a	n/a	Crack to window pane

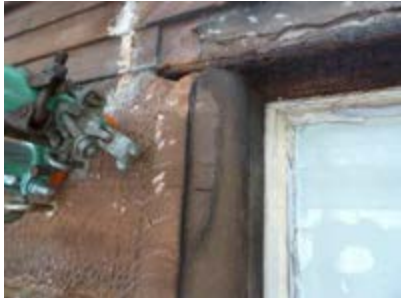
TBC
E1.116	P1200345	Spalled/damaged sandstone	Window	n/a	n/a	n/a	Cracked/broken off sandstone

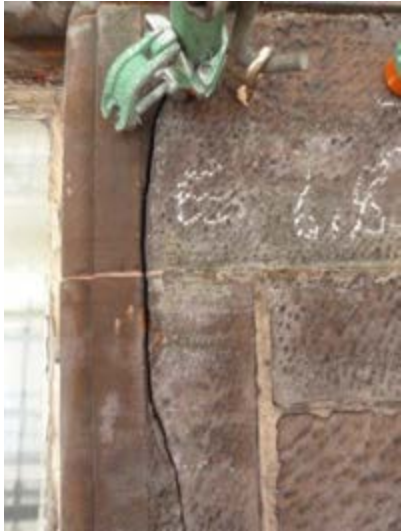
Defect ID	Photo Source	Defect Description	Defect Location	Crack Orientation	Crack Width (mm)	Crack Length (mm)	Comments	Photo	Severity Category
E1.120	P1200350	Cracking to sandstone	Window	Vertical	8	500	Crack to sandstone blocks at vertical window surround

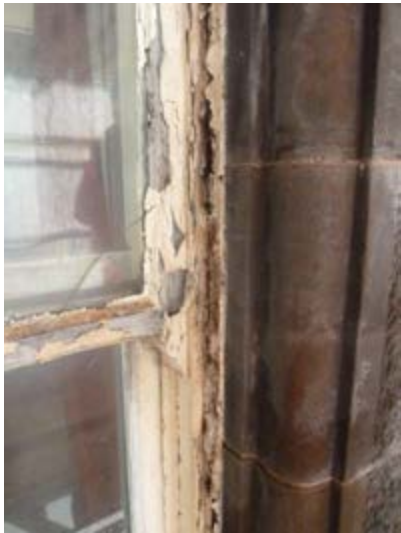
TBC
E1.121	P1200351	Other	Window	n/a	n/a	n/a	Deterioration of timber framing to windows - Common defect visible in majority of window frames

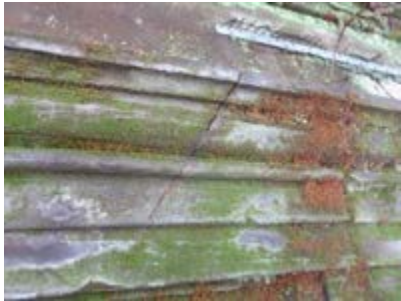
Defect ID	Photo Source	Defect Description	Defect Location	Crack Orientation	Crack Width (mm)	Crack Length (mm)	Comments	Photo	Severity Category
E1.124	P1200354	Cracking to sandstone	Lintel	Diagonal	2	200	Crack to lintel, likely due to lost lintel support (see below E1.125)

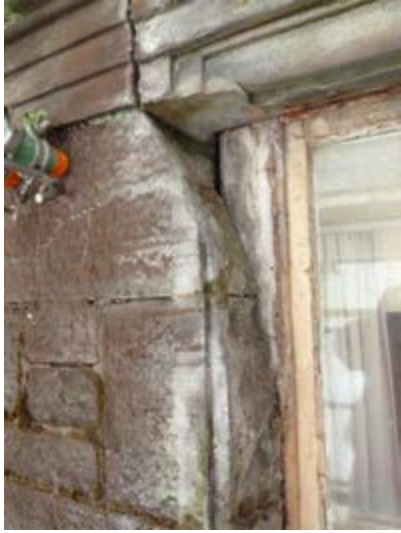
TBC
E1.125	P1200355-357	Spalled/damaged sandstone	Wall	n/a	n/a	n/a	Cracked/broken off sandstone to vertical window framing/support to lintel. Evidence of lintel movement. Danger of lintel failure if left untreated

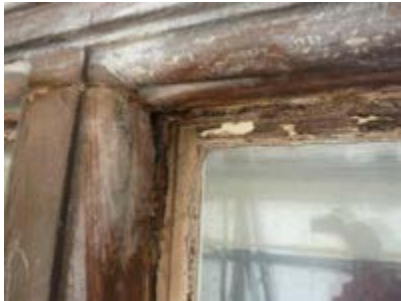
Defect ID	Photo Source	Defect Description	Defect Location	Crack Orientation	Crack Width (mm)	Crack Length (mm)	Comments	Photo	Severity Category
E1.128	P1200361	Other	Window	n/a	n/a	n/a	Deterioration of timber framing to windows - Common defect visible in majority of windows

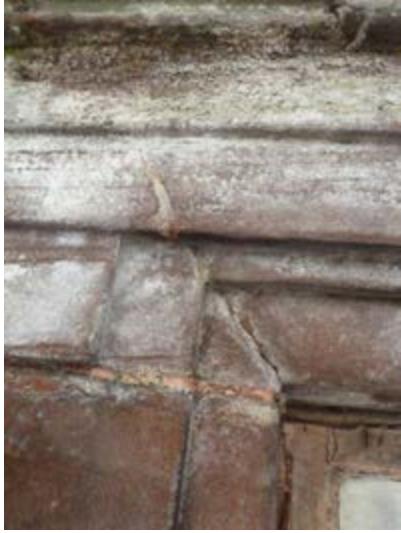
TBC
E1.129	P1200362	Cracking to sandstone	Wall	Diagonal	1	100	Crack in sandstone to window frame

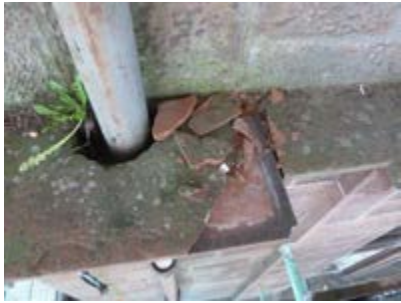
Defect ID	Photo Source	Defect Description	Defect Location	Crack Orientation	Crack Width (mm)	Crack Length (mm)	Comments	Photo	Severity Category
E1.133	P1200366	Spalled/damaged sandstone	Wall	n/a	n/a	n/a	Cracked/broken off sandstone to ledge feature

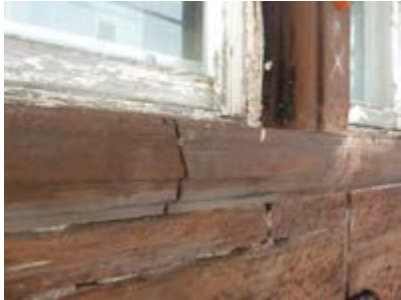
TBC
E1.134	P1200367	Cracking to sandstone	Wall	Diagonal	3	200	Cracked sandstone to cill

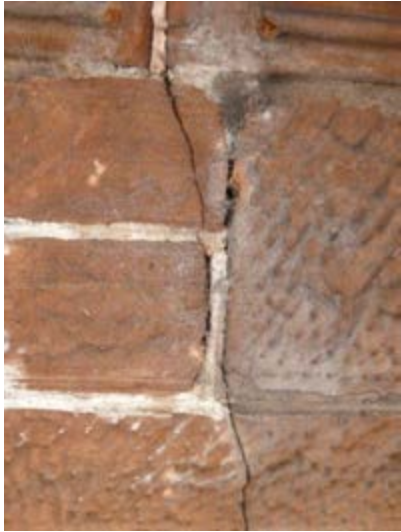
Defect ID	Photo Source	Defect Description	Defect Location	Crack Orientation	Crack Width (mm)	Crack Length (mm)	Comments	Photo	Severity Category
E1.137	P1200372	Cracking to sandstone	Wall	Vertical	1	1000	Crack to sandstone block adjacent to window

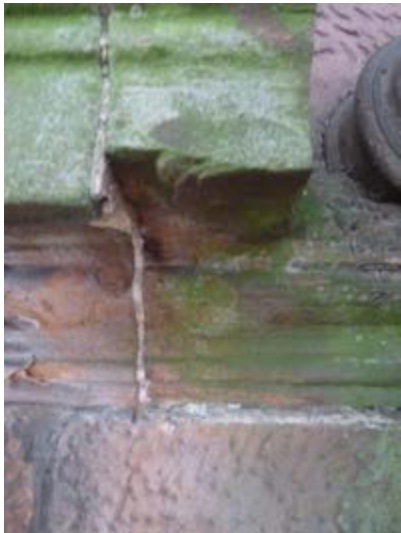
TBC
E1.138	P1200373	Spalled/damaged sandstone	Wall	n/a	n/a	n/a	Cracked/broken off sandstone to underside of ledge feature

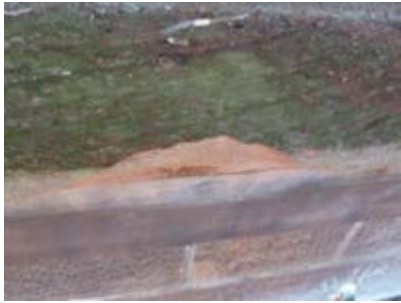
Defect ID	Photo Source	Defect Description	Defect Location	Crack Orientation	Crack Width (mm)	Crack Length (mm)	Comments	Photo	Severity Category
E1.139	P1200375	Spalled/damaged sandstone	Wall	n/a	n/a	n/a	Cracked/broken off sandstone to top of sandstone ledge feature

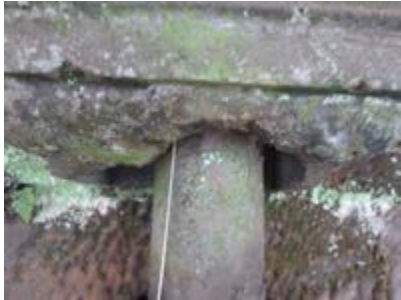
TBC
E1.140	P1200376	Spalled/damaged sandstone	Wall	n/a	n/a	n/a	Delamination/erosion of sandstone to gutter framing – Common defect throughout

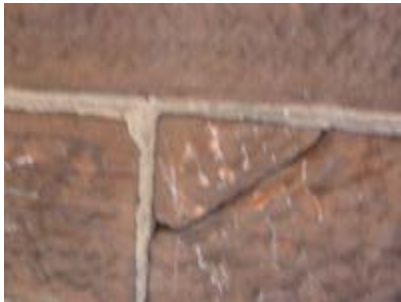
Defect ID	Photo Source	Defect Description	Defect Location	Crack Orientation	Crack Width (mm)	Crack Length (mm)	Comments	Photo	Severity Category
E1.147	P1200389	Cracking to sandstone	Wall	Diagonal	1	100	Crack to corner of sandstone block

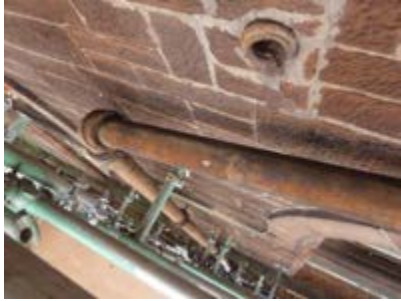
TBC
E1.148	P1200390	Other	Wall	n/a	n/a	n/a	Corroded downpipe

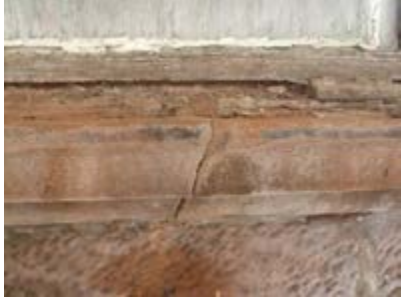
TBC
E1.149	P1200391	Cracking to sandstone	Wall	Vertical	5	100	Crack to sandstone cill. Cill stonework also exhibiting delamination/erosion with stonework section cracked/broken off

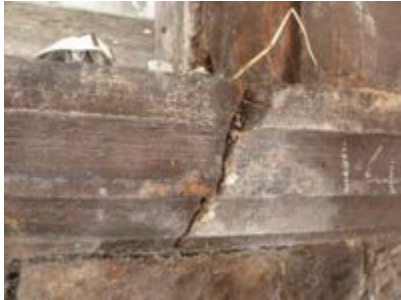
Defect ID	Photo Source	Defect Description	Defect Location	Crack Orientation	Crack Width (mm)	Crack Length (mm)	Comments	Photo	Severity Category
E1.152	P1200394	Cracking to sandstone	Wall	Vertical	5	100	Crack to sandstone cill

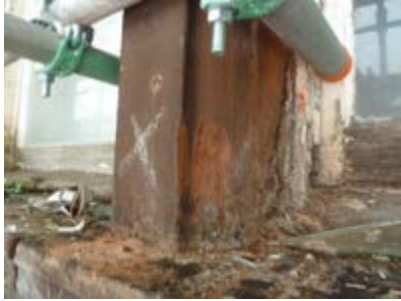
TBC
E1.153	P1200395	Spalled/damaged sandstone	Window mullion	n/a	n/a	n/a	Delamination/erosion of sandstone to mullion

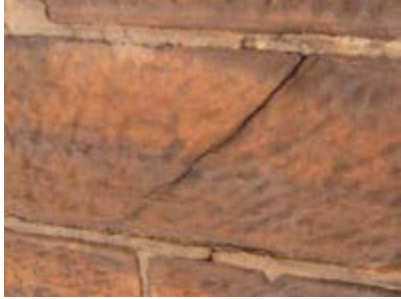
TBC
E1.154	P1200396	Cracking to sandstone	Wall	Diagonal	1	100	Crack to sandstone block

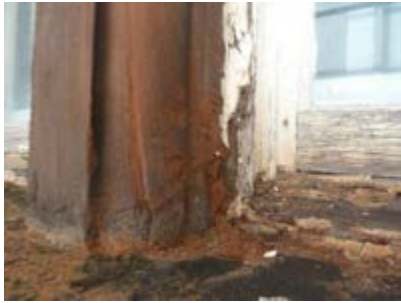
Defect ID	Photo Source	Defect Description	Defect Location	Crack Orientation	Crack Width (mm)	Crack Length (mm)	Comments	Photo	Severity Category
E1.155	P1200397	Spalled/damaged sandstone	Window mullion	n/a	n/a	n/a	Delamination/erosion of sandstone to mullion

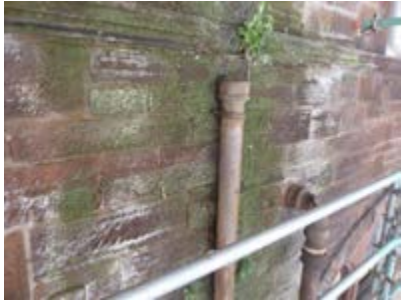
TBC
E1.156	P1200398	Water staining efflorescence	Wall	n/a	n/a	n/a	Water staining to building face

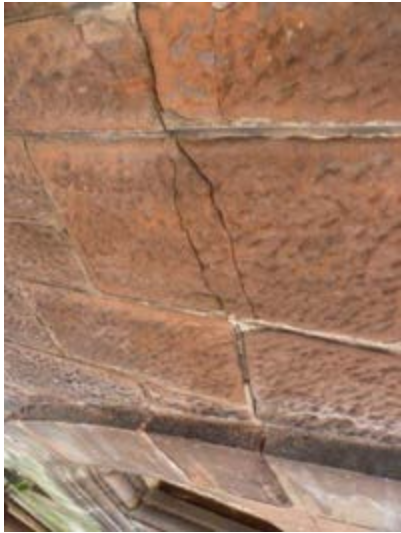
Defect ID	Photo Source	Defect Description	Defect Location	Crack Orientation	Crack Width (mm)	Crack Length (mm)	Comments	Photo	Severity Category
E1.157	P1200399-404	Cracking to sandstone	Wall	Vertical	10	3000	Large crack running vertically between window frames

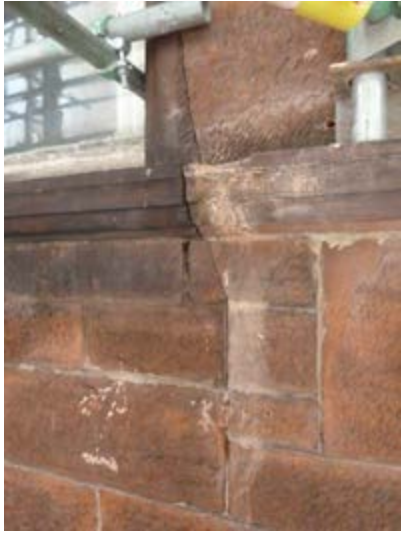
Defect ID	Photo Source	Defect Description	Defect Location	Crack Orientation	Crack Width (mm)	Crack Length (mm)	Comments	Photo	Severity Category
E1.162	P1200409-411	Cracking to sandstone	Window	Vertical	2	500	Crack to sandstone to side of window framing, crack extends below cill level

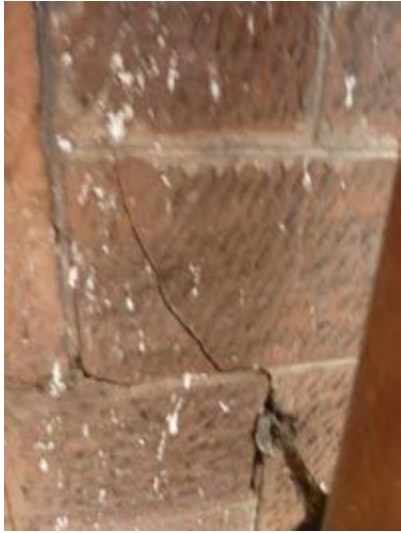
TBC
E1.163	P1200412-413	Cracking to sandstone	Wall	Vertical	1	1000	Crack to sandstone block. Crack appears to emanate from metal/anchor insert

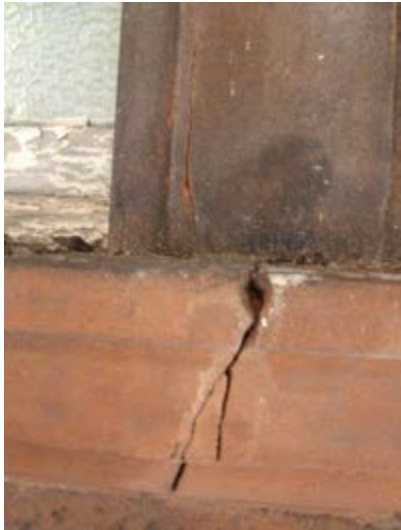
Defect ID	Photo Source	Defect Description	Defect Location	Crack Orientation	Crack Width (mm)	Crack Length (mm)	Comments	Photo	Severity Category
E1.164	P1200416	Cracking to sandstone	Sandstone	Diagonal	5	100	Crack to sandstone block at cill

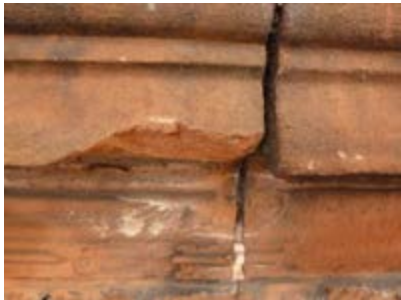
TBC
E1.165	P1200417	Spalled/damaged sandstone	Sandstone ledge feature	n/a	n/a	n/a	Cracked/broken off sandstone to underside of ledge feature

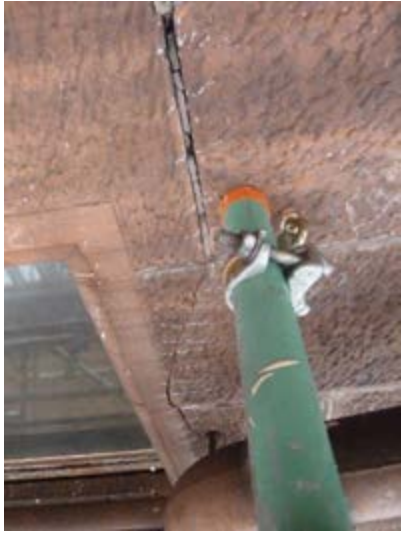
Defect ID	Photo Source	Defect Description	Defect Location	Crack Orientation	Crack Width (mm)	Crack Length (mm)	Comments	Photo	Severity Category
E1.166	P1200418-419	Cracking to sandstone	Sandstone	Vertical	1-3	1000	Crack spans vertically from sandstone ledge feature above to side of window framing. Crack travels through mortar joint and blocks. Deterioration of mortar joint noted

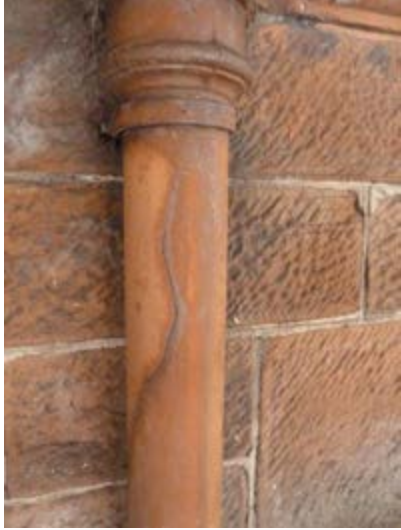
TBC
E1.167	P1200422	Other	Downpipe	n/a	n/a	n/a	Crack to downpipe

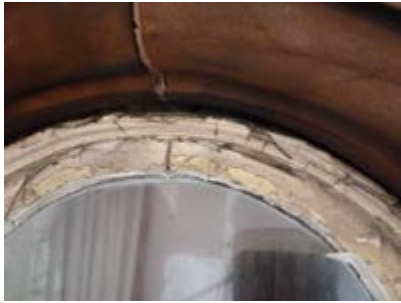
Defect ID	Photo Source	Defect Description	Defect Location	Crack Orientation	Crack Width (mm)	Crack Length (mm)	Comments	Photo	Severity Category
E1.175	P1200443	Other	Window	n/a	n/a	n/a	Timber window frame debonding from sandstone surround and showing signs of deterioration

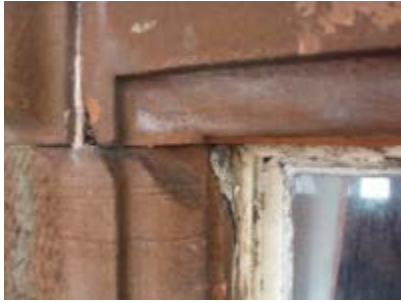
TBC
E1.176	P1200445	Spalled/damaged sandstone	Window	n/a	n/a	n/a	Delamination/erosion of sandstone to vertical window frame

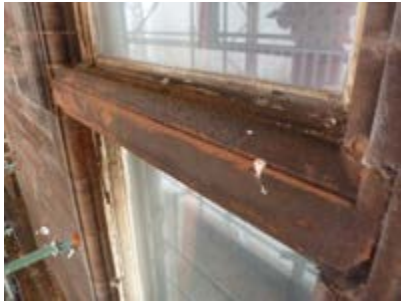
Defect ID	Photo Source	Defect Description	Defect Location	Crack Orientation	Crack Width (mm)	Crack Length (mm)	Comments	Photo	Severity Category
E1.181	P1200449-451	Spalled/damaged sandstone	Window	n/a	n/a	n/a	Delamination/erosion of sandstone to window transom

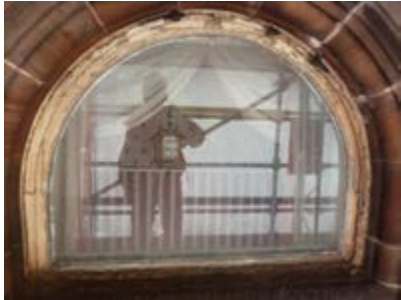
TBC
E1.182	P1200452	Other	Window	n/a	n/a	n/a	Deterioration of timber framing to arch window

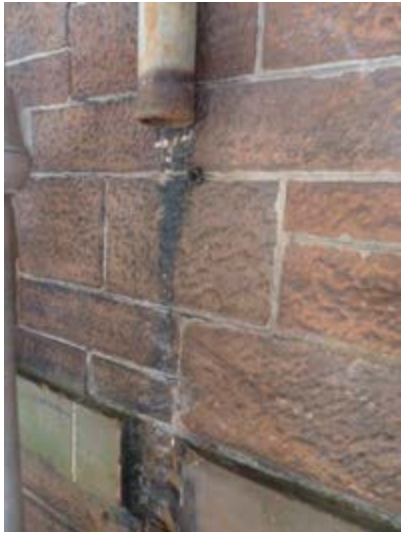
Defect ID	Photo Source	Defect Description	Defect Location	Crack Orientation	Crack Width (mm)	Crack Length (mm)	Comments	Photo	Severity Category
E1.183	P1200454-455	Damaged/defective gutter/drainage	Downpipe	n/a	n/a	n/a	Missing downpipe

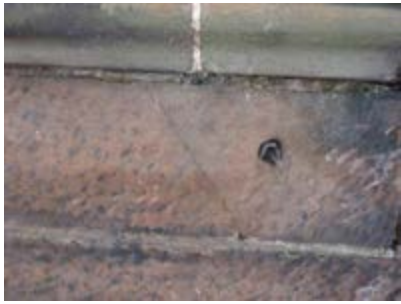
TBC
E1.184	P1200456	Cracking to sandstone	Wall	Diagonal	1	300	Crack to sandstone block

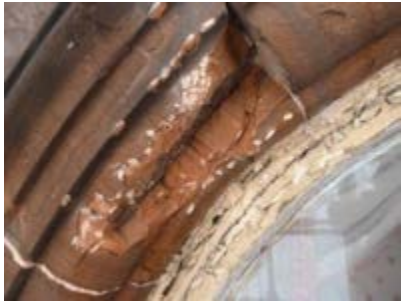
Defect ID	Photo Source	Defect Description	Defect Location	Crack Orientation	Crack Width (mm)	Crack Length (mm)	Comments	Photo	Severity Category
E1.185	P1200457-458	Spalled/damaged sandstone	Arch lintel	n/a	n/a	n/a	Cracked/broken off sandstone to arch lintel

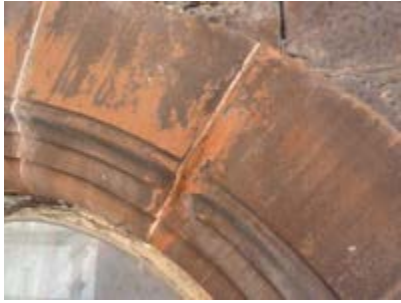
TBC
E1.186	P1200459-460	Spalled/damaged sandstone	Arch lintel	n/a	n/a	n/a	Delamination/erosion of/cracked/broken off sandstone to arch lintel

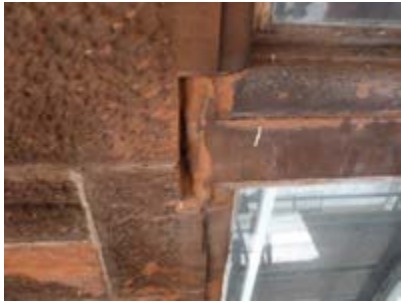
Defect ID	Photo Source	Defect Description	Defect Location	Crack Orientation	Crack Width (mm)	Crack Length (mm)	Comments	Photo	Severity Category
E1.189	P1200468	Spalled/damaged sandstone	Window	n/a	n/a	n/a	Delamination/erosion of/cracked/broken off sandstone to window transom. Visible gap/loss of mortar between transom and vertical frame, risk of movement to transom

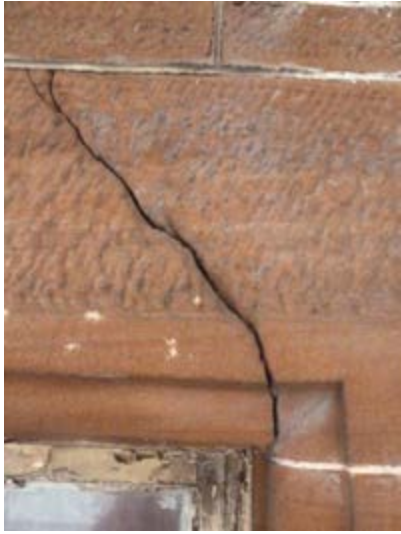
TBC
E1.190	P1200469	Cracking to sandstone	Window	Diagonal	5	200	Crack to sandstone window lintel

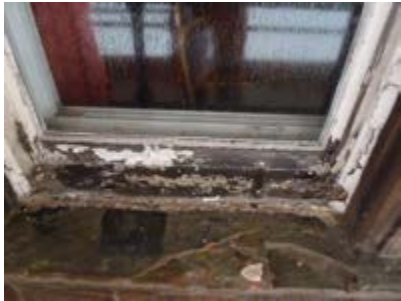
Defect ID	Photo Source	Defect Description	Defect Location	Crack Orientation	Crack Width (mm)	Crack Length (mm)	Comments	Photo	Severity Category
E1.194	P1200478	Other	Window	n/a	n/a	n/a	Deterioration of timber framing to windows - Common defect visible in majority of window frames

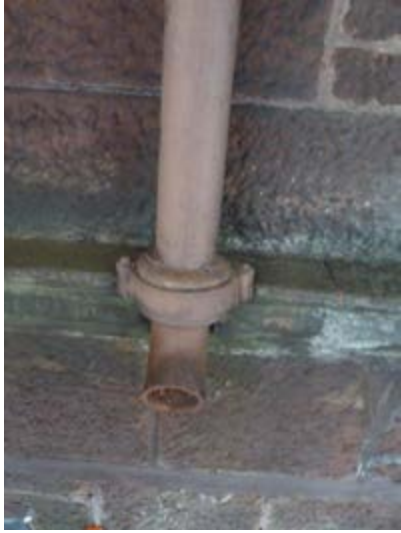
TBC
E1.195	P1200479-480	Damaged/defective gutter/drainage	Downpipe	n/a	n/a	n/a	Missing downpipe section

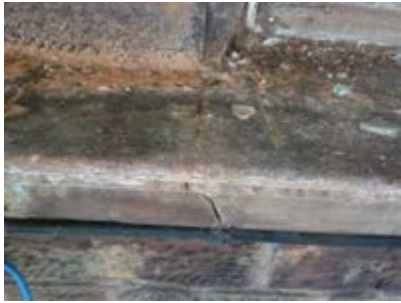
Defect ID	Photo Source	Defect Description	Defect Location	Crack Orientation	Crack Width (mm)	Crack Length (mm)	Comments	Photo	Severity Category
E1.207	P1200498	Cracking to sandstone	Window	Vertical	2	100	Crack to sandstone at window cill ledge

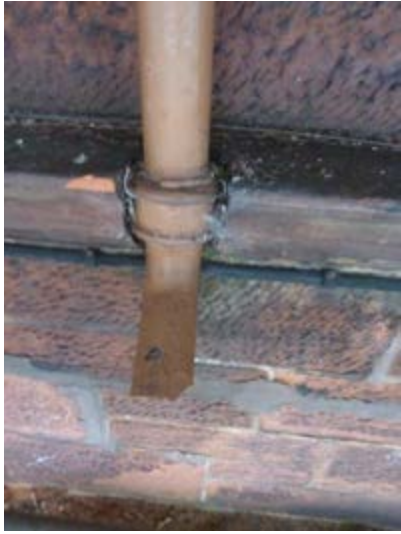
TBC
E1.208	P1200499	Damaged/defective gutter/drainage	Downpipe	n/a	n/a	n/a	Missing downpipe section

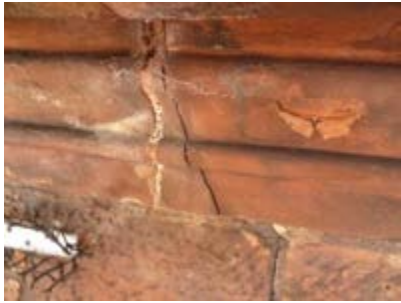
Defect ID	Photo Source	Defect Description	Defect Location	Crack Orientation	Crack Width (mm)	Crack Length (mm)	Comments	Photo	Severity Category
E1.224	P1200519	Cracking to sandstone	Sandstone ledge feature	Vertical	1	150	Crack to sandstone ledge feature. Delamination of sandstone also noted

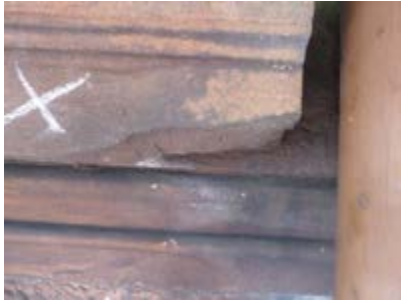
TBC
E1.225	P1200520	Spalled/damaged sandstone	Sandstone ledge feature	n/a	n/a	n/a	Cracked/broken off sandstone to underside of ledge feature adjacent to downpipe

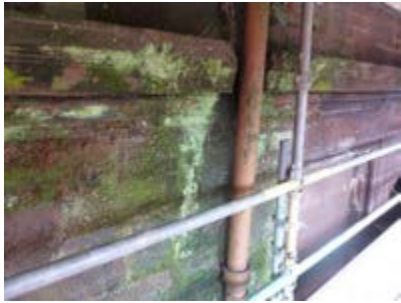
Defect ID	Photo Source	Defect Description	Defect Location	Crack Orientation	Crack Width (mm)	Crack Length (mm)	Comments	Photo	Severity Category
E1.228	P1200524	Water staining efflorescence	Wall	n/a	n/a	n/a	Water staining and vegetation growth/staining to building face

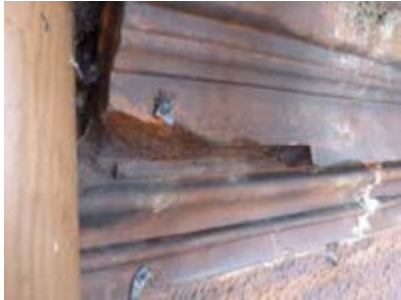
TBC
E1.229	P1200525	Spalled/damaged sandstone	Downpipe	n/a	n/a	n/a	Cracked/broken off sandstone to underside of sandstone ledge feature adjacent downpipe

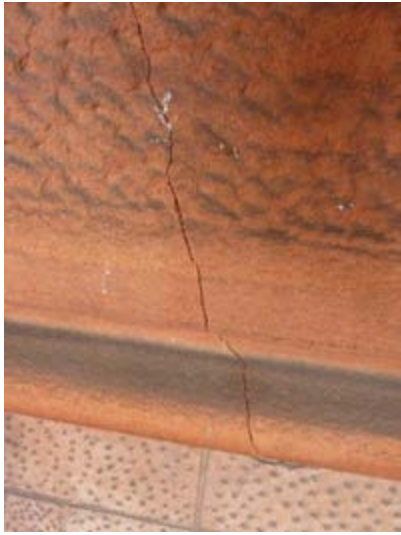
Defect ID	Photo Source	Defect Description	Defect Location	Crack Orientation	Crack Width (mm)	Crack Length (mm)	Comments	Photo	Severity Category
E1.234	P1200531	Cracking to sandstone	Lintel	Vertical	1	300	Crack to sandstone at window lintel

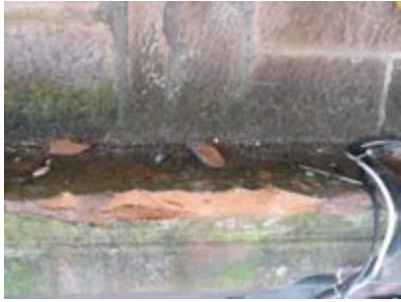
TBC
E1.235	P1200532	Spalled/damaged sandstone	Sandstone ledge feature	n/a	n/a	n/a	Cracked/broken off sandstone to sandstone ledge feature

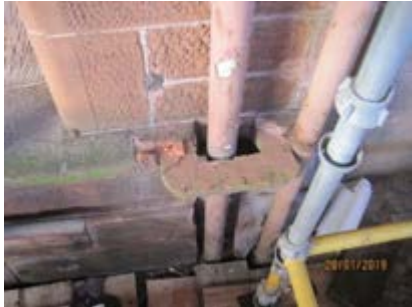
Defect ID	Photo Source	Defect Description	Defect Location	Crack Orientation	Crack Width (mm)	Crack Length (mm)	Comments	Photo	Severity Category
E1.251	P1200899	Spalled/damaged sandstone	Downpipe	n/a	n/a	n/a	Delamination/erosion of/cracked/broken off sandstone at downpipe

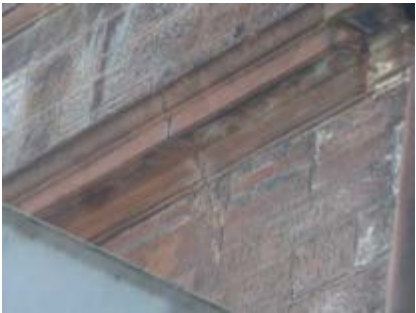
Defect ID	Photo Source	Defect Description	Defect Location	Crack Orientation	Crack Width (mm)	Crack Length (mm)	Comments	Photo	Severity Category
E2.7	P1190448	Cracking to sandstone	Elevation E2, Wall	Vertical	2	300	-

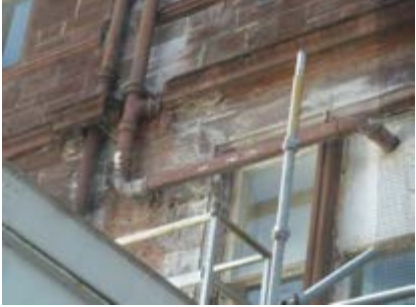
TBC
E2.8	P1190447	Spalled/damaged sandstone	Elevation E2, Wall	n/a	n/a	n/a	Cracked/broken off sandstone to sandstone ledge feature section face	 	TBC
E2.9	P1190446	Spalled/damaged sandstone	Elevation E2, Wall	n/a	n/a	n/a	Cracked/broken off sandstone to sandstone ledge feature section edge

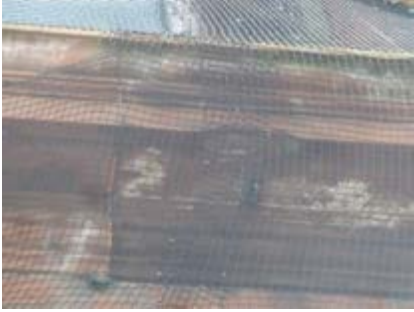
Defect ID	Photo Source	Defect Description	Defect Location	Crack Orientation	Crack Width (mm)	Crack Length (mm)	Comments	Photo	Severity Category
E2.10	P1190450	Missing/damaged tiles/roof	Elevation E2, Wall	n/a	n/a	n/a	Displaced slates to tower roof, sides & vertical face	 	TBC
E2.11	P1190444	Spalled/damaged sandstone	Elevation E2, Wall	n/a	n/a	n/a	Cracked/broken off sandstone to underside of Sandstone ledge feature

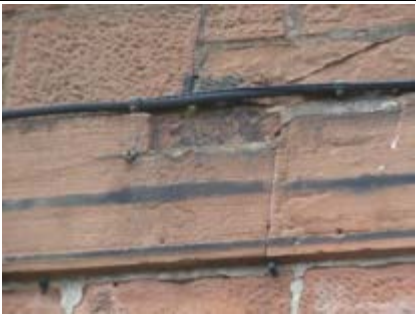
Defect ID	Photo Source	Defect Description	Defect Location	Crack Orientation	Crack Width (mm)	Crack Length (mm)	Comments	Photo	Severity Category
E2.16	P1190460	Spalled/damaged sandstone	Elevation E2, Wall	n/a	n/a	n/a	Cracked sandstone & vertical through render

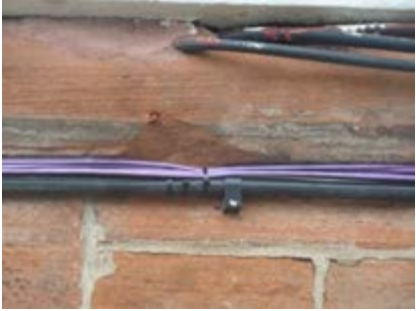
TBC
E2.17	P1190461	Spalled/damaged sandstone	Elevation E2, Wall	n/a	n/a	n/a	-

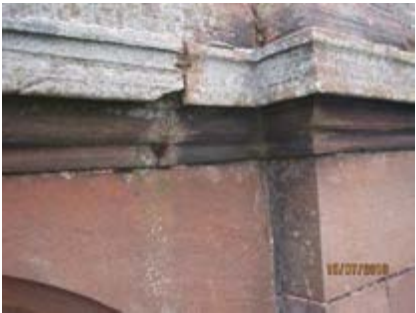
Defect ID	Photo Source	Defect Description	Defect Location	Crack Orientation	Crack Width (mm)	Crack Length (mm)	Comments	Photo	Severity Category
S1.7	IMG_9573	Fractured, detached sandstone element of block	Above featured arched aperture, at Chimney Top.	n/a	n/a	n/a	-

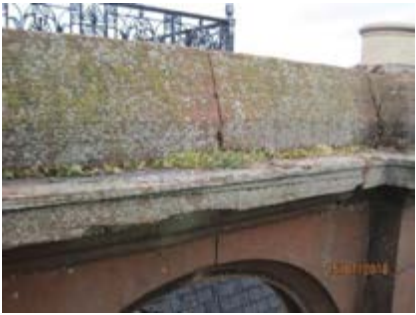
TBC
S1.8	IMG_9574, IMG_9575	Vegetation growth	On top of promontory stone, at Chimney Top.	n/a	n/a	n/a	Vegetation growth all over promontory stone at U/S of chimney pots.
