# **Ayr Station Hotel Structural Condition Factual Report**

Interim Report

19 August 2019

**Document reference:** 399316ZZ-MMD-00-00-RP-S-002

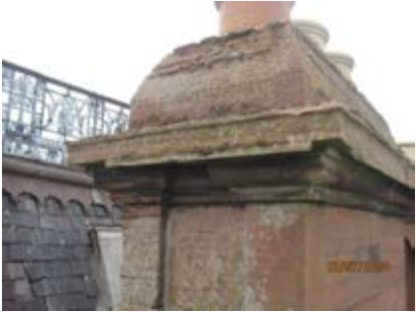
TBC
S1.9	IMG_9576-IMG_9578	Fractured, detached element of sandstone block.	Drip check feature to U/S of capping stone, at Chimney Top.	n/a	n/a	n/a	-

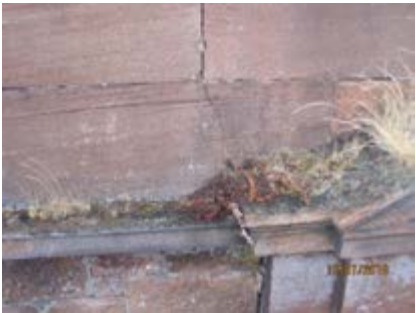
Defect ID	Photo Source	Defect Description	Defect Location	Crack Orientation	Crack Width (mm)	Crack Length (mm)	Comments	Photo	Severity Category
S1.16	IMG_9585	Crack though sandstone block	Chimney stack, above Upper Eaves Level.	Diagonal	1-2	200	-

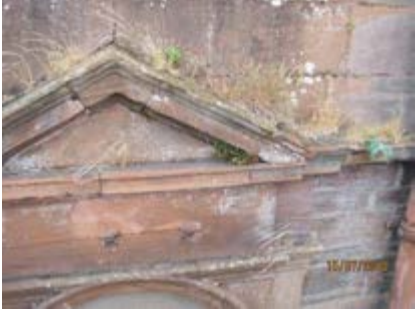
TBC
S1.17	IMG_9588- IMG_9590	Deterioration of the pediment stone.	Triangular feature panel, above Upper Eaves Level.	n/a	n/a	n/a	-

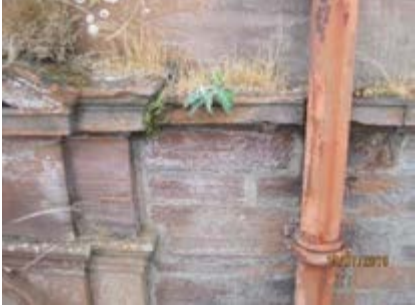
TBC
S1.18	IMG_9591	Crack through Sandstone ledge feature stone	RHS of triangular feature panel, at Upper Eaves Level.	Vertical	1	100	-

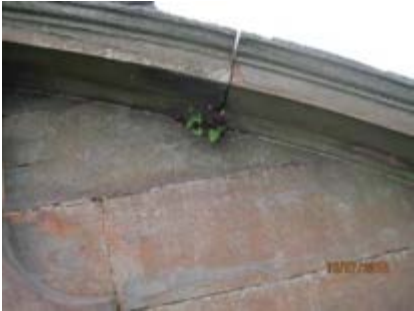
Defect ID	Photo Source	Defect Description	Defect Location	Crack Orientation	Crack Width (mm)	Crack Length (mm)	Comments	Photo	Severity Category
S1.22	IMG_9596	Fractured, detached element of sandstone block.	Soffit of RHS arched capping stone, above Upper Eaves Level.	n/a	n/a	n/a	-

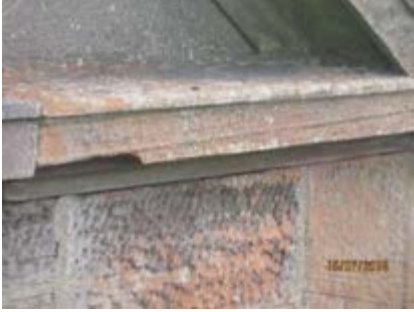
TBC
S1.23	IMG_9597	Fractured and broken sandstone block.	Sandstone ledge feature below RHS arched capping stone, at Upper Eaves Level.	n/a	n/a	n/a	-

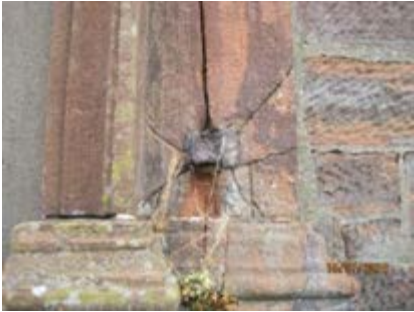
TBC
S1.24	IMG_9598- IMG_9600	7no. Cracks	RHS of feature panel, at Eaves Level.	Radial	1-8	1400 (longest)	Crack propagating from cast/wrought iron insert. Friable, exposed and loose sandstone

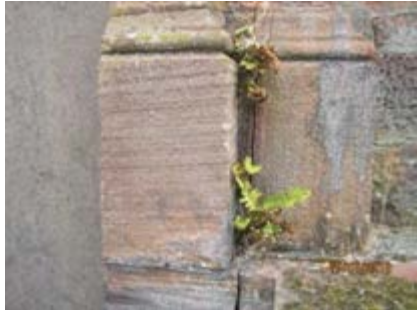
Defect ID	Photo Source	Defect Description	Defect Location	Crack Orientation	Crack Width (mm)	Crack Length (mm)	Comments	Photo	Severity Category
S1.25	IMG_9602- IMG_9603	Crack	RHS of feature panel, mullion support stone at Eaves Level.	Vertical	1-5	500	-

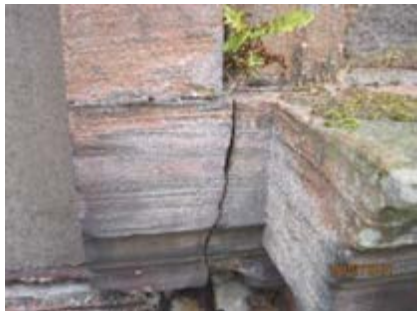
TBC
S1.26	IMG_9604	Crack	Sandstone ledge feature at RHS of feature panel, at Eaves Level.	Vertical	5-10	400	-

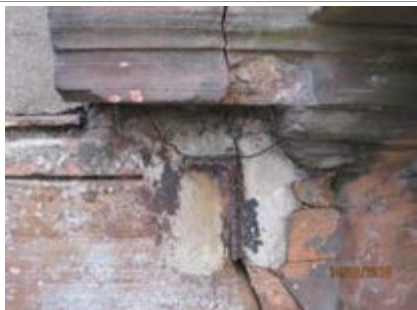
TBC
S1.27	IMG_9606	10no. Cracks	RHS of feature panel, at Eaves Level.	Radial	6-15	100 to 150	Cracks propagating from wrought iron insert. Friable, exposed and loose sandstone

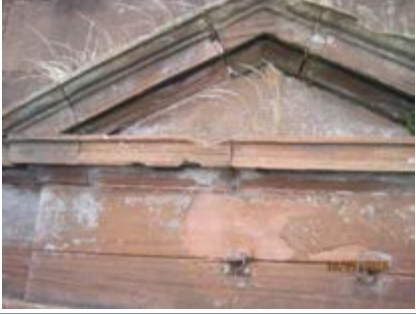
Defect ID	Photo Source	Defect Description	Defect Location	Crack Orientation	Crack Width (mm)	Crack Length (mm)	Comments	Photo	Severity Category
S1.28	IMG_9641	Crack	Top RHS corner of feature panel, below Eaves Level.	Vertical	<1	150	-	 	TBC
S1.29	Not used	Not used	Not used	Not used	Not used	Not used	Not used	Not used	Not used
S1.30	IMG_9608	Fractured, detached element of sandstone block.	Sandstone ledge feature below triangular feature panel, at Upper Eaves Level.	n/a	n/a	n/a	-

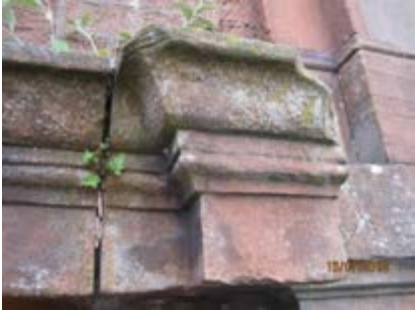
Defect ID	Photo Source	Defect Description	Defect Location	Crack Orientation	Crack Width (mm)	Crack Length (mm)	Comments	Photo	Severity Category
S1.38	IMG_9627	Detached element of sandstone block	LHS mullion at feature panel, at Eaves Level.	n/a	n/a	n/a	-

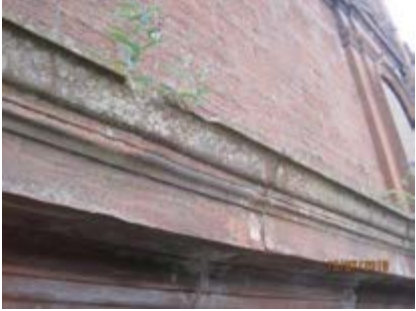
TBC
S1.39	IMG_9628- IMG_9629	Fractured, detached and broken sandstone block.	Edge to Sandstone ledge feature, at LHS of feature panel, at Eaves Level.	n/a	n/a	n/a	-

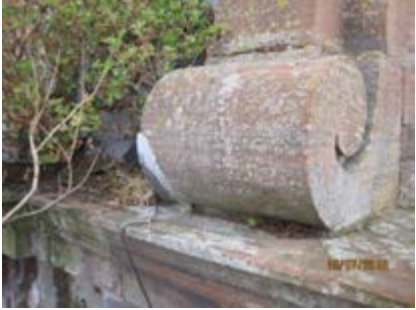
TBC
S1.40	IMG_9630- IMG_9632	Repair to curled stone feature.	LHS of gable, at Eaves Level.	n/a	n/a	n/a	-

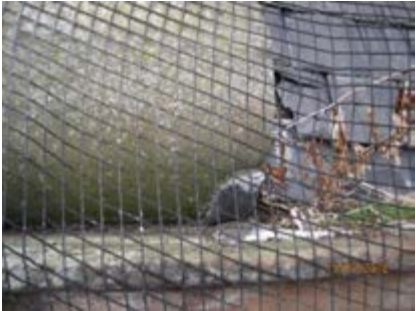
Defect ID	Photo Source	Defect Description	Defect Location	Crack Orientation	Crack Width (mm)	Crack Length (mm)	Comments	Photo	Severity Category
S1.41	IMG_9633- IMG_9634	Repair to curled stone feature.	RHS of gable, at Eaves Level.	n/a	n/a	n/a	-

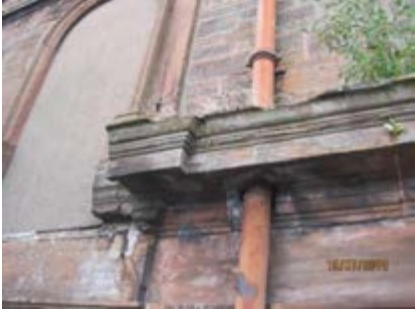
TBC
S1.42	IMG_9635	Fractured and detached element of sandstone.	Edge to Sandstone ledge feature, at RHS of feature panel, at Eaves Level.	n/a	n/a	n/a	-

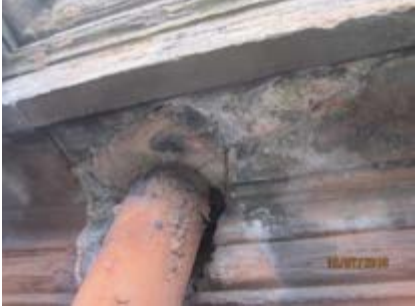
TBC
S1.43	IMG_9636- IMG_9638	2no. Cracks	Soffit of Sandstone ledge feature at RWP, at RHS of feature panel, at Eaves Level.	Radial	<1-2	400	-

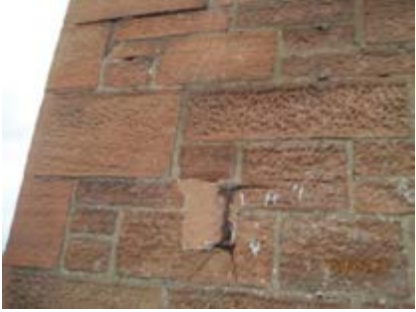
Defect ID	Photo Source	Defect Description	Defect Location	Crack Orientation	Crack Width (mm)	Crack Length (mm)	Comments	Photo	Severity Category
S1.44	IMG_9642	Crack	LHS of feature panel, below Eaves Level.	n/a	<1-2	150	-	 	TBC
S1.45	IMG_9643	5no. Cracks	LHS of feature panel, below Upper Eaves Level.	Radial	<1-3	550	Cracks propagating from wrought iron insert

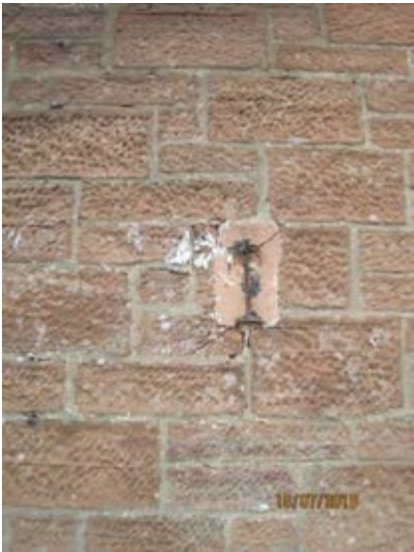
Defect ID	Photo Source	Defect Description	Defect Location	Crack Orientation	Crack Width (mm)	Crack Length (mm)	Comments	Photo	Severity Category
S1.46	IMG_9644- IMG_9645	5no. Cracks	LHS of feature panel, below Upper Eaves Level.	Radial	<1-3	700	Cracks propagating from wrought iron insert

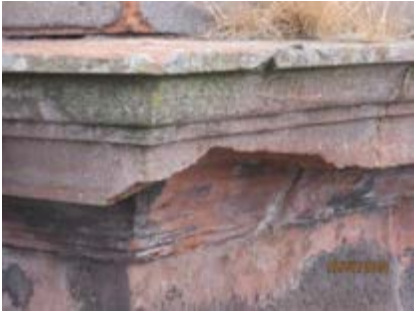
TBC
S1.47	IMG_9646, IMG_9649	Fractured, detached and broken sandstone block.	Side of gable next to RWP, at 2nd Floor Level.	n/a	n/a	n/a	-

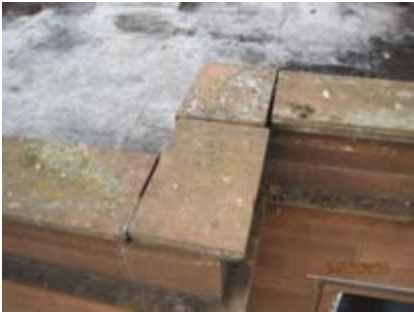
Defect ID	Photo Source	Defect Description	Defect Location	Crack Orientation	Crack Width (mm)	Crack Length (mm)	Comments	Photo	Severity Category
S1.48	IMG_9647- IMG_9648	Dislodged capping stones.	Roof of 2 storey extension building at LHS of gable.	n/a	n/a	n/a	3no. Capping stones dislodged at 2no. Locations.

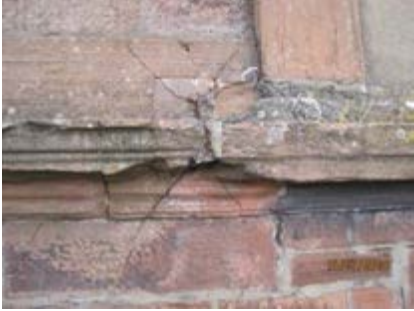
TBC
S1.49	IMG_9651	5no. Cracks & Damage to Sandstone ledge feature	LHS of rectangular panel, at 2nd Floor Level.	Radial	<1-4	900 (longest)	Cracks propagating from wrought iron insert. Damage to U/S of Sandstone ledge feature - fractured and broken with elements detached

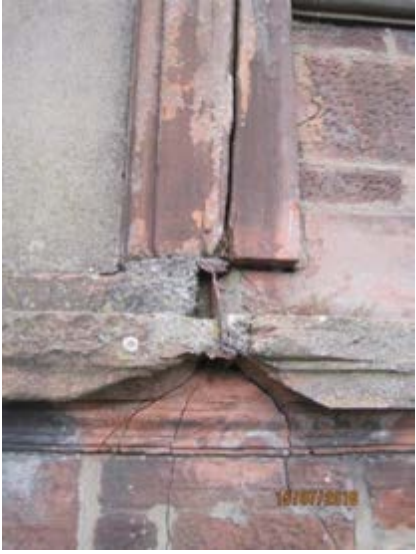
Defect ID	Photo Source	Defect Description	Defect Location	Crack Orientation	Crack Width (mm)	Crack Length (mm)	Comments	Photo	Severity Category
S1.50	IMG_9652- IMG_9659, IMG_9671	Multiple cracks	RHS corner of rectangular panel, at 2nd Floor Level.	Vertical and diagonal	<1-10	1000 (longest)	Cracks propagating from wrought iron insert

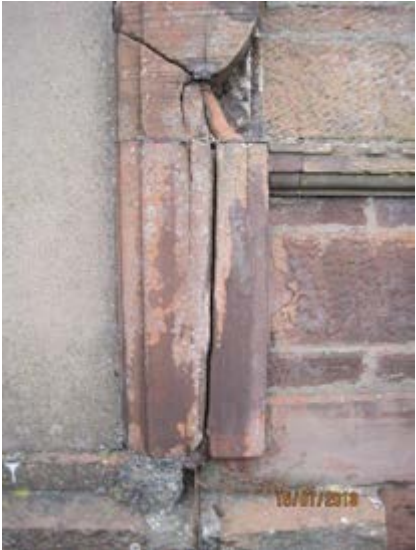
Defect ID	Photo Source	Defect Description	Defect Location	Crack Orientation	Crack Width (mm)	Crack Length (mm)	Comments	Photo	Severity Category
S1.51	IMG_9660- IMG_9667, IMG_9671	4no. Cracks & loss of section	RHS of rectangular panel, above 2nd Floor Level.	Radial and vertical	10-20	1300 (vertical)	Cracks propagating from wrought iron insert. Loss of section - fractured, broken and loose

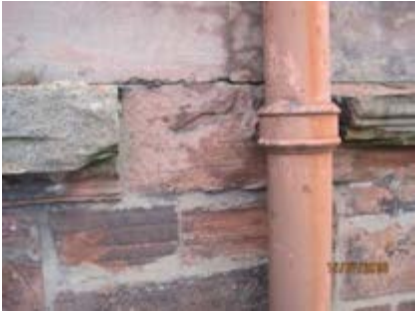
TBC
S1.52	IMG_9668- IMG_9669, IMG_9671	Fractured, detached and broken sandstone block.	Adjacent RWP, at 2nd Floor Level.	n/a	n/a	n/a	Approx. 300mm section of sandstone missing on LHS of RWP.

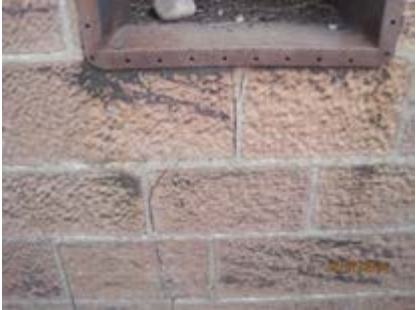
Defect ID	Photo Source	Defect Description	Defect Location	Crack Orientation	Crack Width (mm)	Crack Length (mm)	Comments	Photo	Severity Category
S1.53	IMG_9672- IMG_9677	5no. Cracks	Around RHS opening, below 2nd Floor Level.	Vertical and diagonal	<1-3	700 (longest)	-

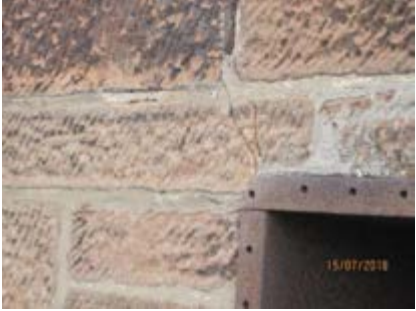
TBC
S1.54	IMG_9681- IMG_9684	7no. Cracks	Around LHS opening, below 2nd Floor Level.	Vertical	<1-1	125-950	-

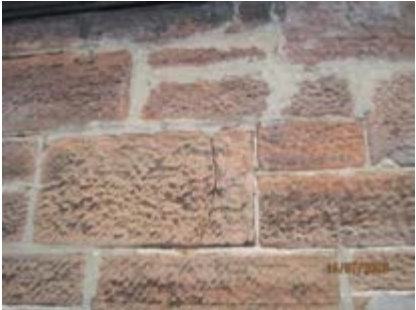
TBC
S1.55	IMG_9678	Crack	Between LHS and RHS openings, below 2nd Floor Level.	Vertical	1	250	-

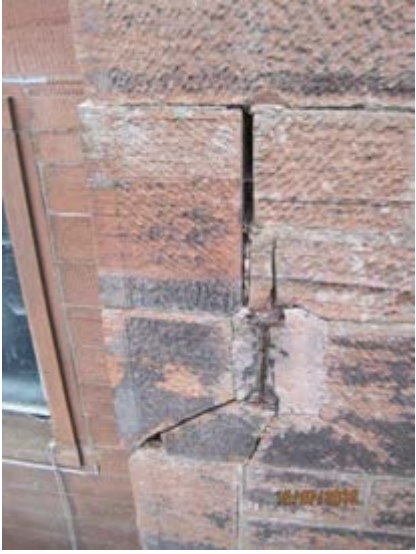
Defect ID	Photo Source	Defect Description	Defect Location	Crack Orientation	Crack Width (mm)	Crack Length (mm)	Comments	Photo	Severity Category
S1.56	IMG_9685- IMG_9687	4no. Cracks	LHS of gable, below First Floor Level.	Radial	<1-12	125-300	Cracks propagating from wrought iron insert

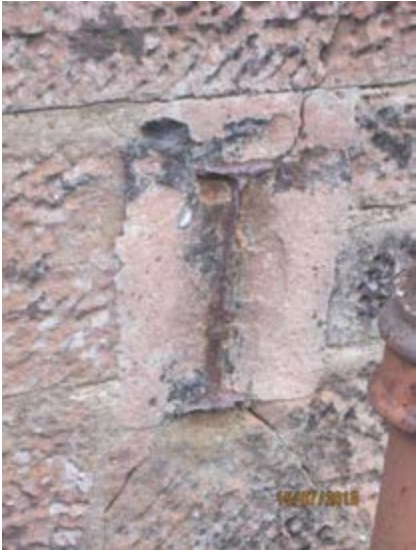
Defect ID	Photo Source	Defect Description	Defect Location	Crack Orientation	Crack Width (mm)	Crack Length (mm)	Comments	Photo	Severity Category
S1.57	IMG_9688- IMG_9689	3no. Cracks	LHS of 2no. openings, below First Floor Level.	Radial	<1-2	200	Cracks propagating from wrought iron insert

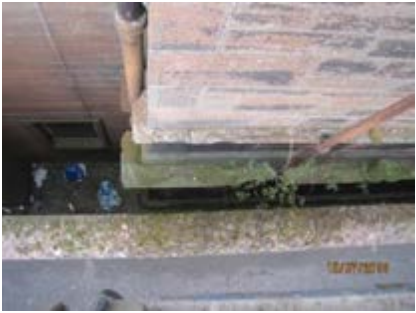
TBC
S1.58	IMG_9690- IMG_9691	Multiple broken and detached elements of sandstone.	Along the edges of the 2no. Sandstone ledge feature lines, below First Floor Level.	n/a	n/a	n/a	Multiple points of erosion and likely damage from debris falling from above.

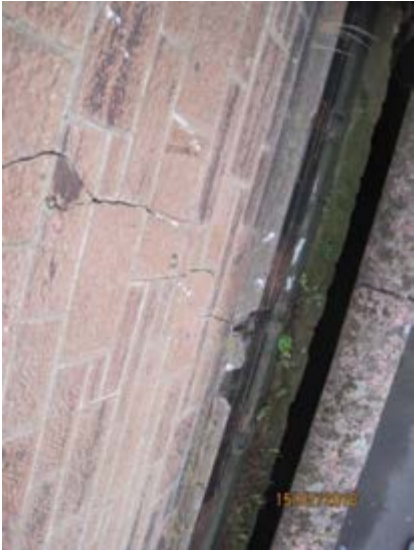
Defect ID	Photo Source	Defect Description	Defect Location	Crack Orientation	Crack Width (mm)	Crack Length (mm)	Comments	Photo	Severity Category
S1.59	IMG_9679- IMG_9680	2no. Cracks	Between Ground Level and First Floor Level.	Vertical	1-10	4000	Visibility limited by the bridge parapet wall. However, cracks appear to propagate from foundation level.

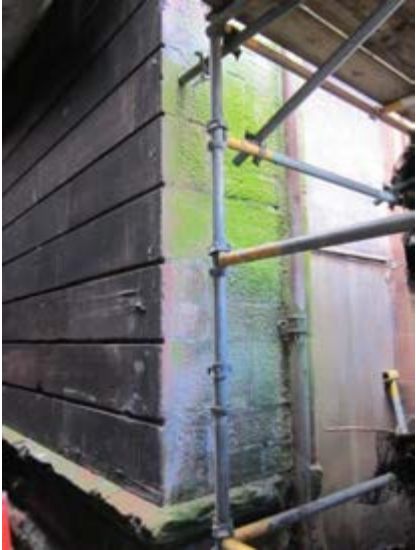
Defect ID	Photo Source	Defect Description	Defect Location	Crack Orientation	Crack Width (mm)	Crack Length (mm)	Comments	Photo	Severity Category
S1.60	IMG_2040	Vegetation staining	Elevation S1, Wall	n/a	n/a	n/a	Near corner on wall facing tracks

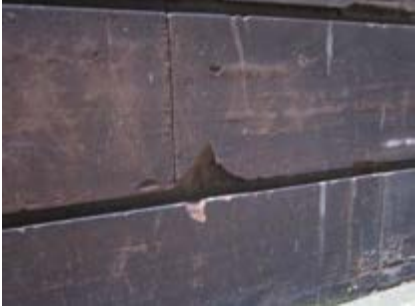
TBC
S1.61	IMG_2027	Spalled/damaged sandstone	Elevation S1, Wall	n/a	n/a	n/a	Cracked/broken off sandstone block, four blocks up from base

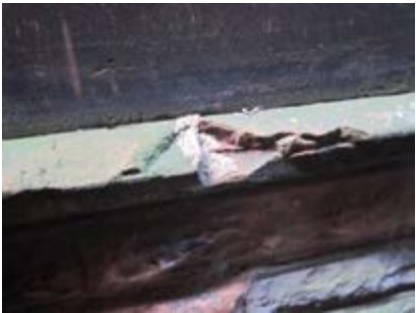
Defect ID	Photo Source	Defect Description	Defect Location	Crack Orientation	Crack Width (mm)	Crack Length (mm)	Comments	Photo	Severity Category
S1.62	IMG_2028	Spalled/damaged sandstone	Elevation S1, Wall	n/a	n/a	n/a	Delamination/erosion of/cracked/broken off sandstone to ledge feature

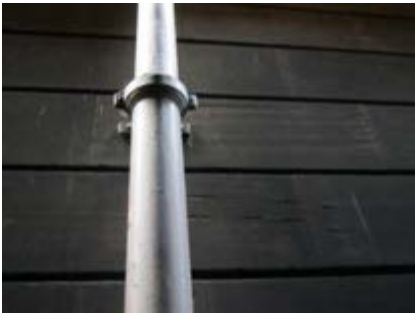
TBC
S1.63	IMG_2023	Crack	Elevation S1, Wall	Horizontal	1-5	800	Behind down pipe near tracks

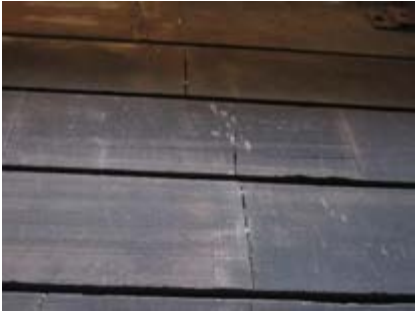
TBC
S1.64	IMG_2017	Crack	Elevation S1, Wall	Vertical	1-3	600	Ten blocks up from wall base

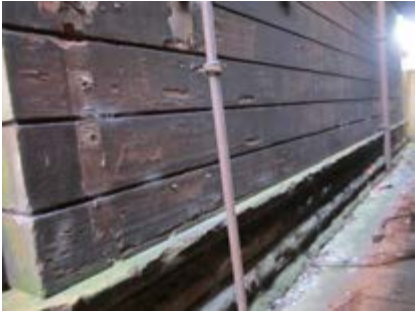
Defect ID	Photo Source	Defect Description	Defect Location	Crack Orientation	Crack Width (mm)	Crack Length (mm)	Comments	Photo	Severity Category
S1.65	IMG_2011	Staining	Elevation S1, Wall	n/a	n/a	n/a	-	 	TBC
S1.66	IMG_2010	Crack	Elevation S1, Wall	Diagonal	1-3	200	Crack through block	 	TBC
S1.67	IMG_2000	Spalled/damaged sandstone	Elevation S1, Wall	n/a	n/a	n/a	Delamination/erosion of and minor spalling occurring at multiple locations

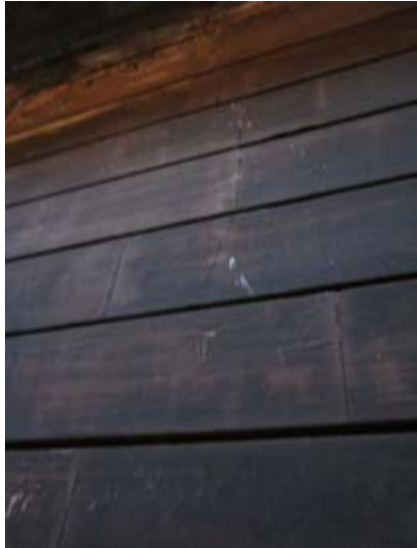
Defect ID	Photo Source	Defect Description	Defect Location	Crack Orientation	Crack Width (mm)	Crack Length (mm)	Comments	Photo	Severity Category
S1.68	IMG_1998	Crack	Elevation S1, Wall	Vertical	3-5	1500	From block 8 to ledge projection. It is likely that the crack extends upwards above bridge parapet

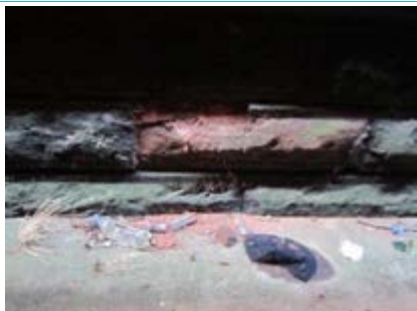
TBC
S1.69	IMG_1994	Spalled/damaged sandstone	Elevation S1, Wall	n/a	n/a	n/a	Deterioration of sandstone blocks with delamination/erosion of/cracked/broken off sandstone noted. Surface of blocks crumble on light contact

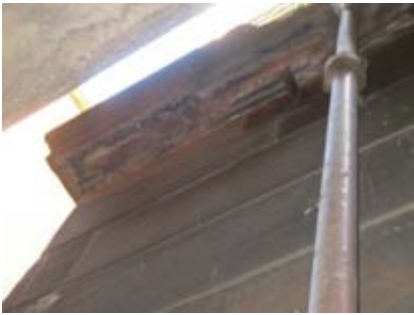
Defect ID	Photo Source	Defect Description	Defect Location	Crack Orientation	Crack Width (mm)	Crack Length (mm)	Comments	Photo	Severity Category
S1.70	IMG_1992	Spalled/damaged sandstone	Elevation S1, Wall	n/a	n/a	n/a	Delamination/erosion of/cracked/broken off sandstone to underside of ledge feature at road level	 	TBC
S1.71	IMG_1988	Crack	Elevation S1, Wall	Vertical	-	-	Possible crack near down pipe

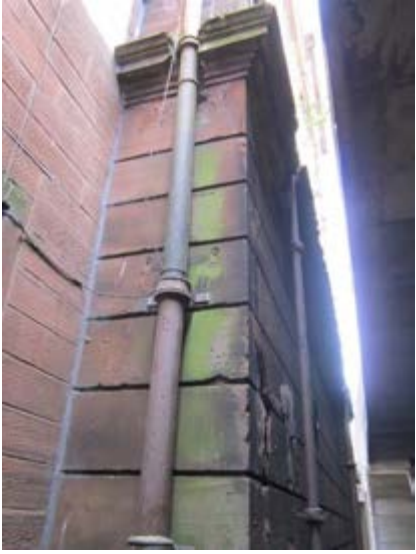
Defect ID	Photo Source	Defect Description	Defect Location	Crack Orientation	Crack Width (mm)	Crack Length (mm)	Comments	Photo	Severity Category
S1.75	IMG_1972	Spalled/damaged sandstone	Elevation S1, Wall	n/a	n/a	n/a	Delamination/spalling to sandstone near down pipe and corners

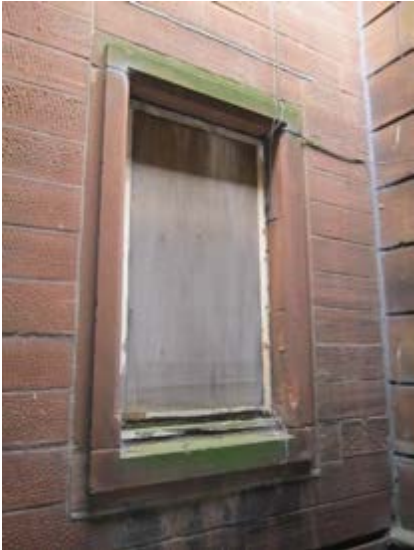
Defect ID	Photo Source	Defect Description	Defect Location	Crack Orientation	Crack Width (mm)	Crack Length (mm)	Comments	Photo	Severity Category
S1.78	IMG_1962	Deteriorating timber frame	Elevation S1, Wall	n/a	n/a	n/a	-

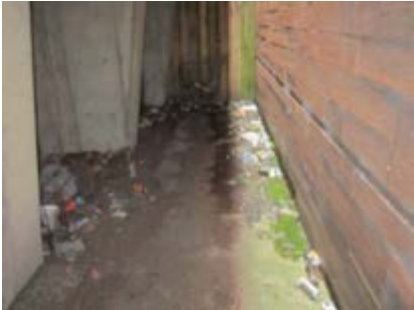
TBC
S1.79	IMG_1950	Vegetation growth	Elevation S1, Wall	n/a	n/a	n/a	-

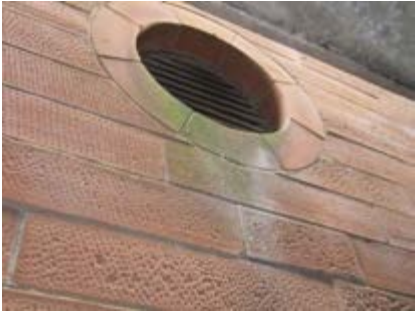
Defect ID	Photo Source	Defect Description	Defect Location	Crack Orientation	Crack Width (mm)	Crack Length (mm)	Comments	Photo	Severity Category
S1.80	IMG_1949	Vegetation staining	Elevation S1, Wall	n/a	n/a	n/a	-

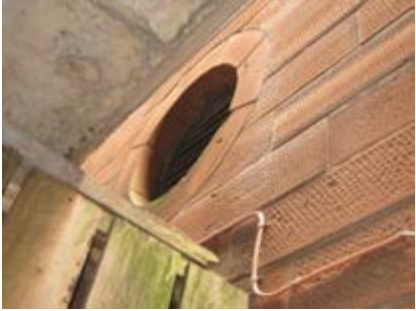
TBC
S1.81	IMG_1947	Loss of section	Elevation S1, Wall	n/a	n/a	n/a	-

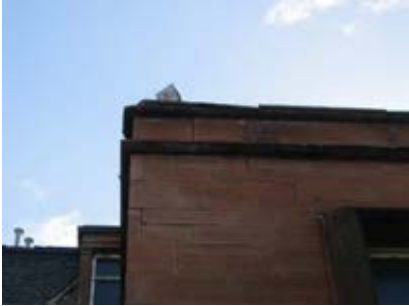
Defect ID	Photo Source	Defect Description	Defect Location	Crack Orientation	Crack Width (mm)	Crack Length (mm)	Comments	Photo	Severity Category
W2.4	IMG_1847	Loss of pointing	Elevation W2, Wall	n/a	n/a	n/a	-

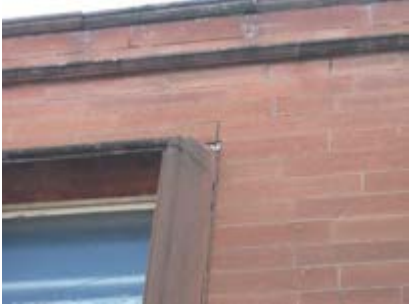
TBC
W2.5	IMG_1849	Cracking to sandstone	Elevation W2, Wall	Vertical	1.0-5.0	300	-

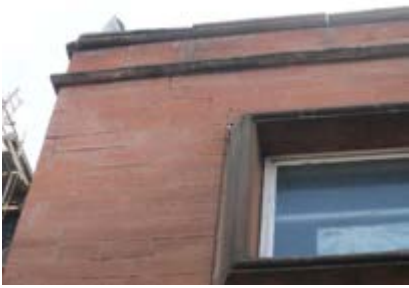
TBC
W2.6	IMG_1851	Cracking to sandstone	Elevation W2, Wall	Diagonal	1.0-5.0	800	Stepped crack

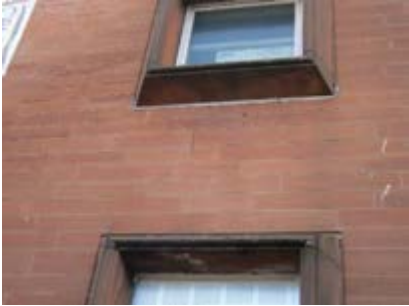
Defect ID	Photo Source	Defect Description	Defect Location	Crack Orientation	Crack Width (mm)	Crack Length (mm)	Comments	Photo	Severity Category
W2.7	IMG_1856	Cracking to sandstone	Elevation W2, Wall	Diagonal	1.0-3.0	1500	Stepped crack

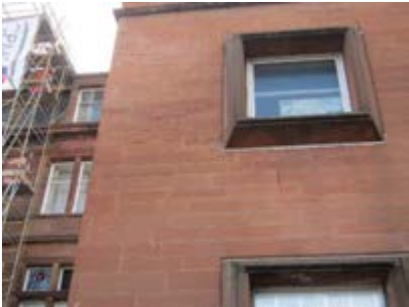
TBC
W2.8	IMG_1859	Loss of pointing	Elevation W2, Wall	n/a	n/a	n/a	-

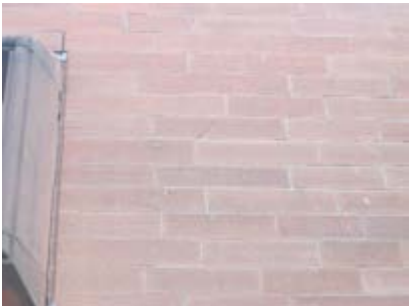
TBC
W2.9	IMG_1861	Cracking to sandstone	Elevation W2, Wall	Diagonal	1.0-3.0	300	-

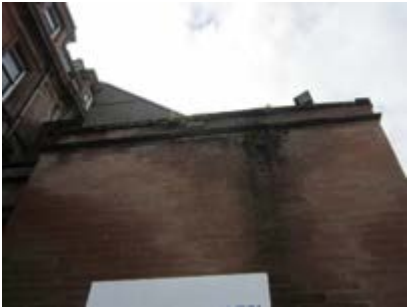
Defect ID	Photo Source	Defect Description	Defect Location	Crack Orientation	Crack Width (mm)	Crack Length (mm)	Comments	Photo	Severity Category
W3.1	IMG_1865	Vegetation growth/staining	Elevation W3, Wall	n/a	n/a	n/a	-

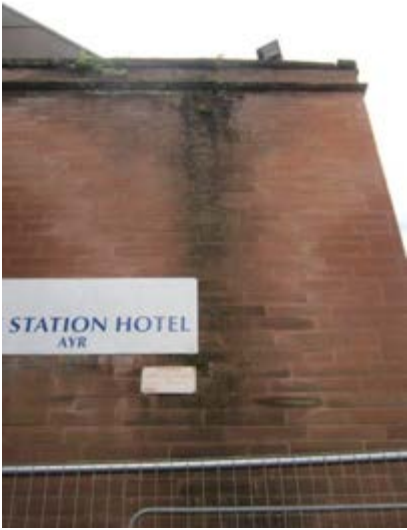
TBC
W3.2	IMG_1866	Vegetation growth/staining	Elevation W3, Wall	n/a	n/a	n/a	-

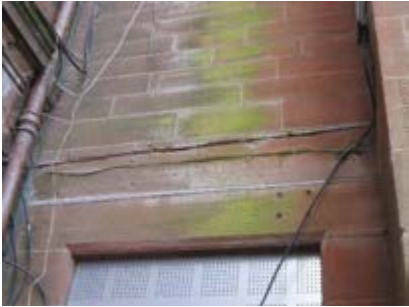
Defect ID	Photo Source	Defect Description	Defect Location	Crack Orientation	Crack Width (mm)	Crack Length (mm)	Comments	Photo	Severity Category
W3.5	IMG_1873	Cracking to sandstone	Elevation W3, Wall	Horizontal	20-30	1500-2000	-

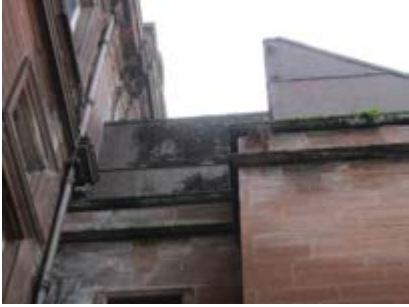
TBC
W3.6	IMG_1876	Vegetation growth/staining	Elevation W3, Wall	n/a	n/a	n/a	-

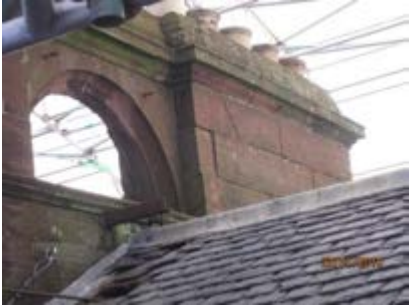
Defect ID	Photo Source	Defect Description	Defect Location	Crack Orientation	Crack Width (mm)	Crack Length (mm)	Comments	Photo	Severity Category
W4.16	IMG_0164	Cracking to sandstone	Elevation W4, Roof Cross wall	Diagonal	1-3	200-300	Chimney stack

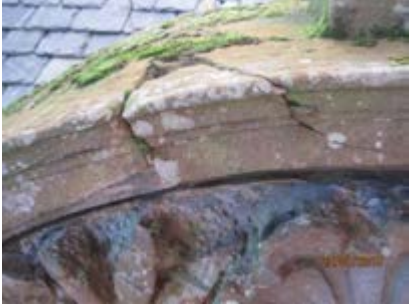
TBC
W4.17	IMG_0167	Cracking to sandstone	Elevation W4, Roof Arch feature	Vertical / Diagonal	1	-	Arch feature capping stone

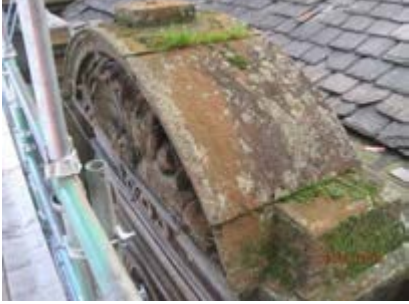
TBC
W4.18	IMG_0168, 0169	Vegetation growth, gap	Elevation W4, Roof Arch feature	n/a	n/a	n/a	Separation/gap between sandstone blocks to arch, vegetation growth

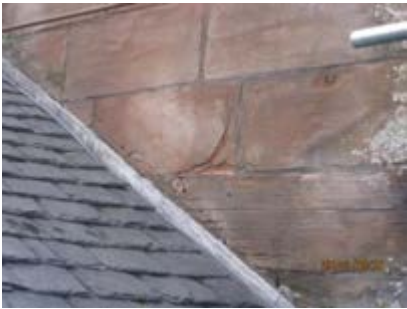
Defect ID	Photo Source	Defect Description	Defect Location	Crack Orientation	Crack Width (mm)	Crack Length (mm)	Comments	Photo	Severity Category
W4.19	IMG_0171	Spalled/damaged sandstone	Elevation W4, Roof	n/a	n/a	n/a	Chimney stack

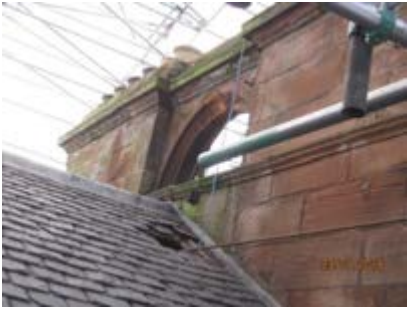
TBC
W4.20	IMG_0173	Vegetation growth	Elevation W4, Roof Cross wall	n/a	n/a	n/a	-

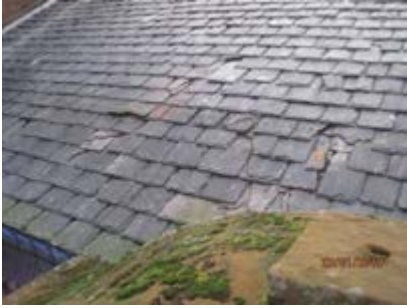
TBC
W4.21	IMG_0174-0176	Missing / Dislodged / damaged tiles	Elevation W4, Roof Arch feature	n/a	n/a	n/a	General dislodged / missing roof tiles

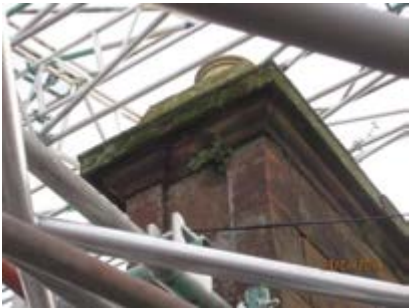
Defect ID	Photo Source	Defect Description	Defect Location	Crack Orientation	Crack Width (mm)	Crack Length (mm)	Comments	Photo	Severity Category
W4.22	IMG_0180	Cracking to sandstone	Elevation W4, Roof Cross wall	Diagonal	1-2	300	Chimney stack	 	TBC
W4.23	IMG_0182	Vegetation growth	Elevation W4, Roof Cross wall	n/a	n/a	n/a	Top of chimney stack

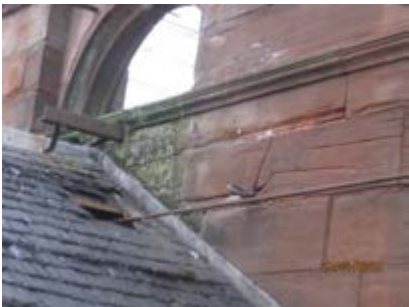
TBC
W4.24	IMG_0185	Cracking to sandstone	Elevation W4, Roof Cross wall	Horizontal	3-5	300-400	Chimney stack. Crack emanating from metal insert

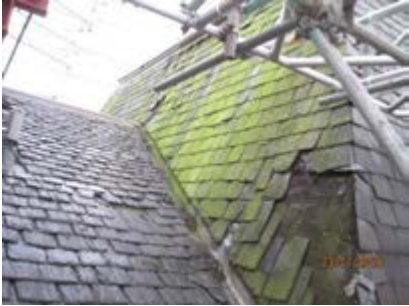
Defect ID	Photo Source	Defect Description	Defect Location	Crack Orientation	Crack Width (mm)	Crack Length (mm)	Comments	Photo	Severity Category
W4.28	IMG_0191, 0192	Vegetation growth	Elevation W4, Roof	n/a	n/a	n/a	-

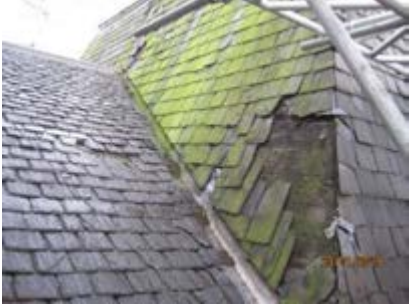
TBC
W4.29	IMG_0191, 0192	Missing / Dislodged / damaged tiles	Elevation W4, Roof	n/a	n/a	n/a	-

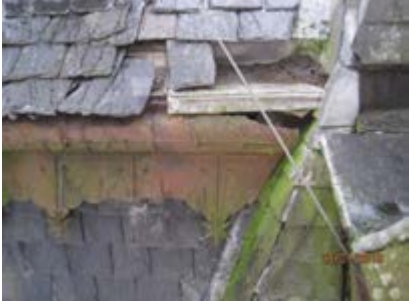
TBC
W4.30	IMG_0197	Damaged cast iron fittings	Elevation W4, Roof	n/a	n/a	n/a	Damage to cast iron/metal feature

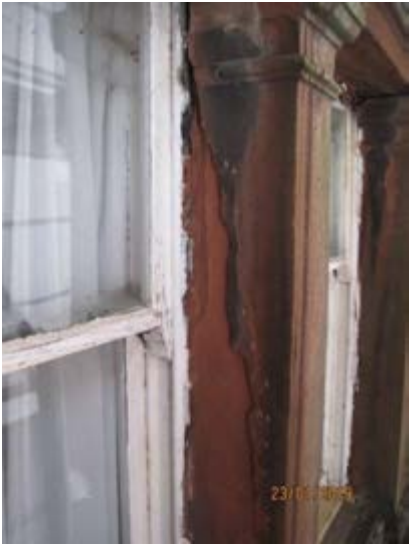
Defect ID	Photo Source	Defect Description	Defect Location	Crack Orientation	Crack Width (mm)	Crack Length (mm)	Comments	Photo	Severity Category
W4.40	IMG_0230-0232	Spalled/damaged sandstone	Elevation W4, Wall Dormer window	n/a	n/a	n/a	Surface of sandstone crumbles on light contact

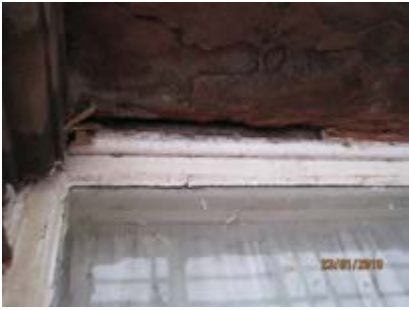
TBC
W4.41	IMG_0233	Other	Elevation W4, Wall Dormer window	n/a	n/a	n/a	Visible gap between window frame and stonework circa 10-20mm

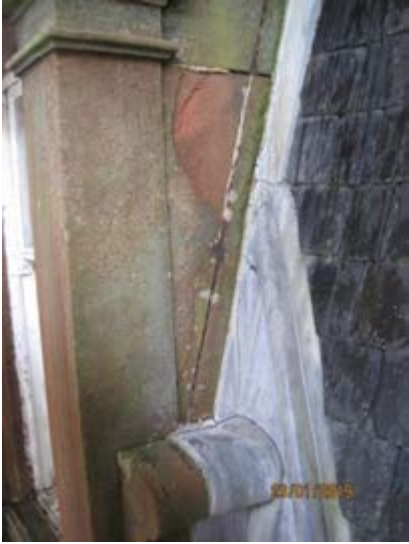
Defect ID	Photo Source	Defect Description	Defect Location	Crack Orientation	Crack Width (mm)	Crack Length (mm)	Comments	Photo	Severity Category
W4.49	IMG_0256-0257	Spalled/damaged sandstone	Elevation W4, Wall Dormer window	n/a	n/a	n/a	Sandstone appears to be delaminating

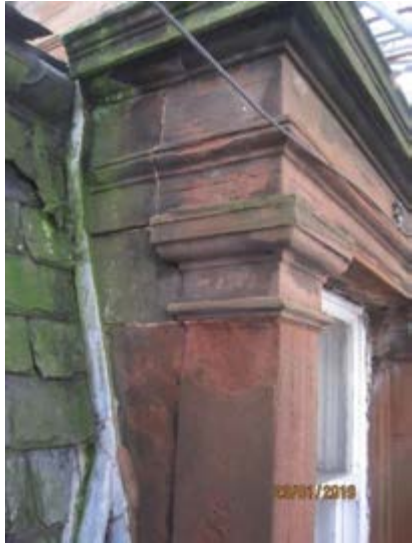
Defect ID	Photo Source	Defect Description	Defect Location	Crack Orientation	Crack Width (mm)	Crack Length (mm)	Comments	Photo	Severity Category
W4.58	IMG_0278-0279	Spalled/damaged sandstone	Elevation W4, Wall Dormer window	n/a	n/a	n/a	-

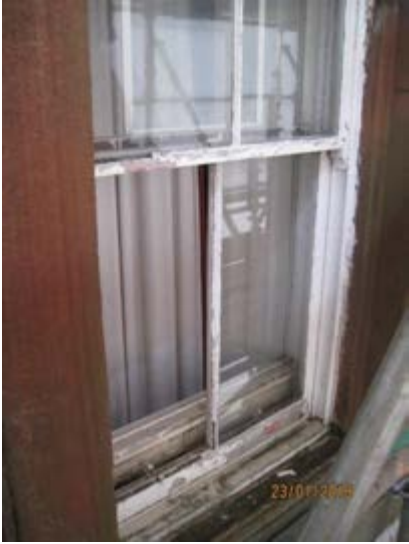
Defect ID	Photo Source	Defect Description	Defect Location	Crack Orientation	Crack Width (mm)	Crack Length (mm)	Comments	Photo	Severity Category
W4.59	IMG_0280-0281	Other	Elevation W4, Wall Dormer window	n/a	n/a	n/a	Timber window frame in poor condition. Missing window pane

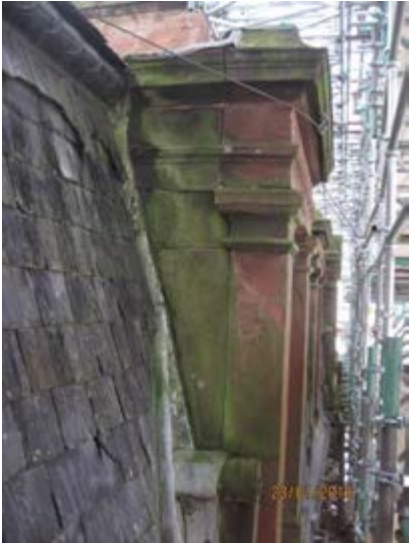
Defect ID	Photo Source	Defect Description	Defect Location	Crack Orientation	Crack Width (mm)	Crack Length (mm)	Comments	Photo	Severity Category
W4.60	IMG_0282-0284	Other	Elevation W4, Wall Dormer window	n/a	n/a	n/a	Vertical joint/gap between sandstone blocks, gap appears to be widening towards the top end

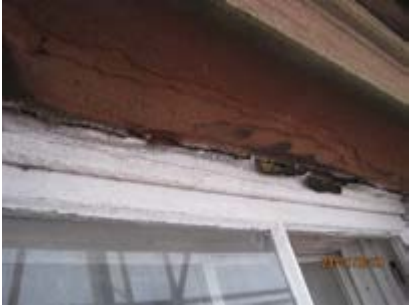
TBC
W4.61	IMG_0288-0289	Spalled/damaged sandstone	Elevation W4, Wall Dormer window	n/a	n/a	n/a	Soffit of sandstone window lintel appears to be delaminating

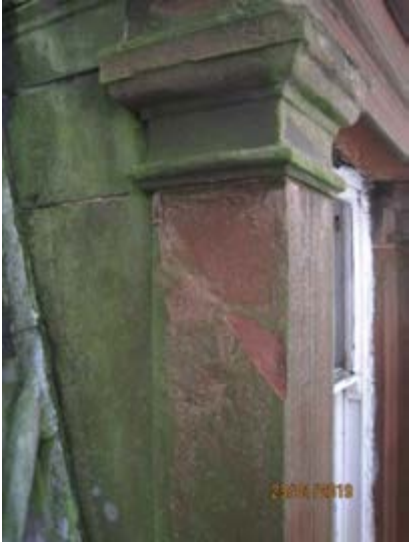
Defect ID	Photo Source	Defect Description	Defect Location	Crack Orientation	Crack Width (mm)	Crack Length (mm)	Comments	Photo	Severity Category
W4.62	IMG_0285-0286	Spalled/damaged sandstone	Elevation W4, Wall Dormer window	n/a	n/a	n/a	Sandstone pilaster appears to be delaminating

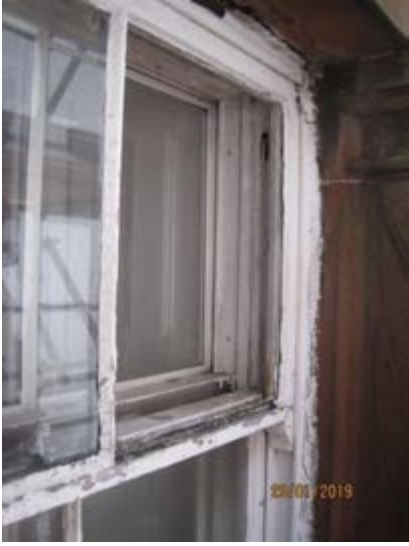
Defect ID	Photo Source	Defect Description	Defect Location	Crack Orientation	Crack Width (mm)	Crack Length (mm)	Comments	Photo	Severity Category
W4.63	IMG_0290	Other	Elevation W4, Wall Dormer window	n/a	n/a	n/a	Timber window frame in poor condition. Missing window pane

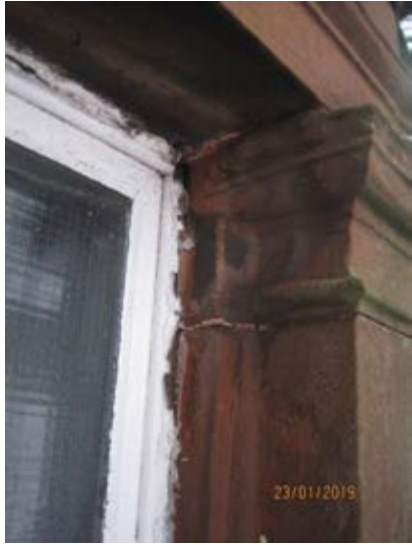
Defect ID	Photo Source	Defect Description	Defect Location	Crack Orientation	Crack Width (mm)	Crack Length (mm)	Comments	Photo	Severity Category
W4.66	IMG_0298-0299	Spalled/damaged sandstone	Elevation W4, Wall Dormer window	n/a	n/a	n/a	-

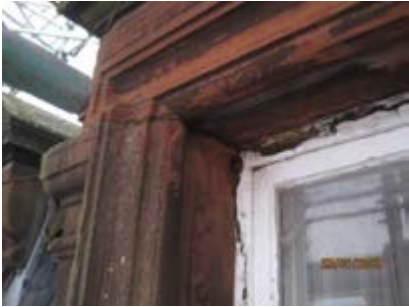
Defect ID	Photo Source	Defect Description	Defect Location	Crack Orientation	Crack Width (mm)	Crack Length (mm)	Comments	Photo	Severity Category
W4.69	IMG_0308-0310	Spalled/damaged sandstone	Elevation W4, Wall Dormer window	n/a	n/a	n/a	Sandstone pilaster at side of window appears to be delaminating. Surface layer of sandstone crumbles on light contact.

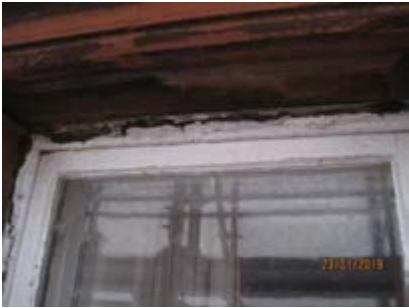
TBC
W4.70	IMG_0311-0314	Other	Elevation W4, Wall Dormer window	n/a	n/a	n/a	Timber window frame in poor condition. Peeling paintwork

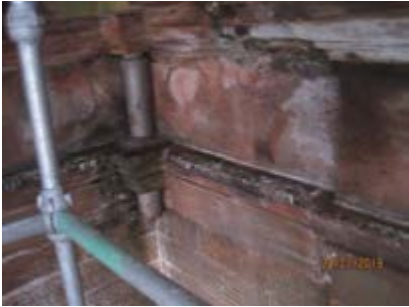
TBC
W4.71	IMG_0323	Water staining efflorescence	Elevation W4, Wall	n/a	n/a	n/a	Staining and dampness

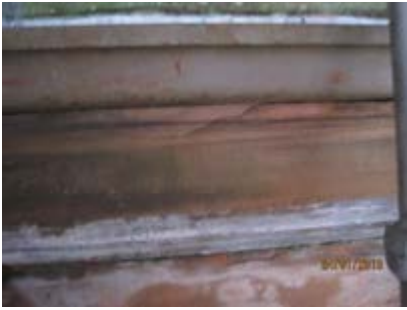
Defect ID	Photo Source	Defect Description	Defect Location	Crack Orientation	Crack Width (mm)	Crack Length (mm)	Comments	Photo	Severity Category
W4.72	IMG_0330	Spalled/damaged sandstone	Elevation W4, Wall	n/a	n/a	n/a	Minor delamination/spalling of sandstone	 	TBC
W4.73	IMG_0329	Cracking to sandstone	Elevation W4, Wall	Horizontal	1-2	200-300	-

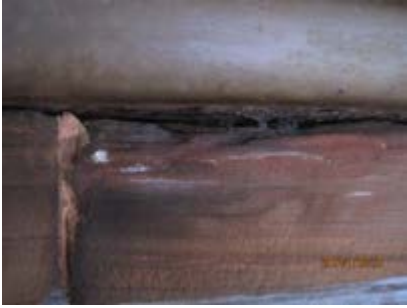
TBC
W4.74	IMG_0331-0333	Other	Elevation W4, Wall	n/a	n/a	n/a	Gap between sandstone ledge feature and gutter varies circa 5-25mm

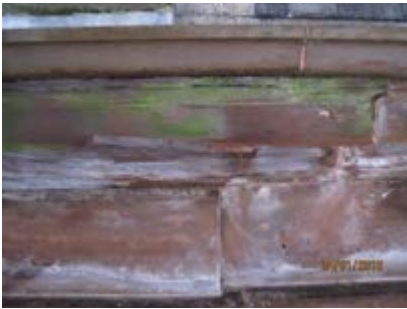
Defect ID	Photo Source	Defect Description	Defect Location	Crack Orientation	Crack Width (mm)	Crack Length (mm)	Comments	Photo	Severity Category
W4.75	IMG_0338-0339	Loss of section	Elevation W4, Wall	n/a	n/a	n/a	-

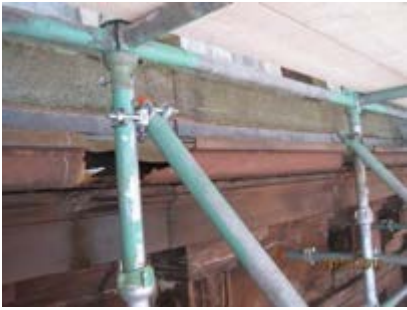
TBC
W4.76	IMG_0340-0341	Damaged/ defective gutter/drainage	Elevation W4, Wall	n/a	n/a	n/a	Section of gutter removed for installed scaffold

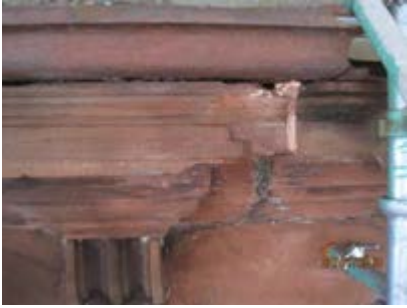
TBC
W4.77	IMG_0342-0343	Loss of section	Elevation W4, Wall	n/a	n/a	n/a	-

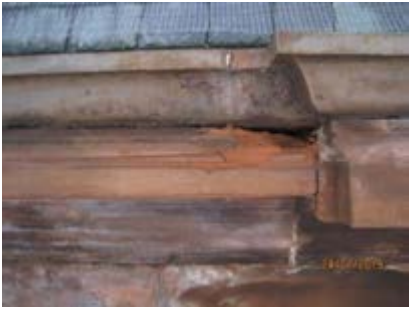
Defect ID	Photo Source	Defect Description	Defect Location	Crack Orientation	Crack Width (mm)	Crack Length (mm)	Comments	Photo	Severity Category
W4.78	IMG_0345-0346	Damaged/ defective gutter/drainage	Elevation W4, Wall	n/a	n/a	n/a	Downpipe with poor fitting narrower section attachment	 	TBC
W4.79	IMG_0347-0348	Spalled/ damaged sandstone	Elevation W4, Wall	n/a	n/a	n/a	Loss of section/broken off section to sandstone roof cornice feature

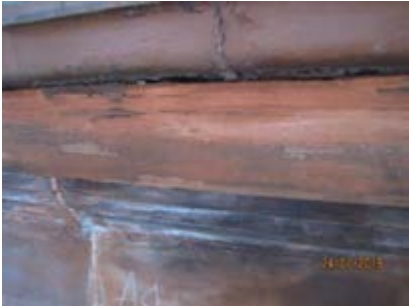
Defect ID	Photo Source	Defect Description	Defect Location	Crack Orientation	Crack Width (mm)	Crack Length (mm)	Comments	Photo	Severity Category
W4.86	IMG_0368, 0370	Spalled/damaged sandstone	Elevation W4, Wall	n/a	n/a	n/a	Delamination/erosion along sandstone ledge feature with loss of section/broken off sections noted

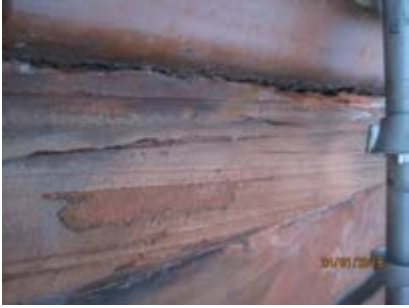
TBC
W4.87	IMG_0372, 0374	Spalled/damaged sandstone	Elevation W4, Wall	n/a	n/a	n/a	Delamination/erosion along sandstone ledge feature

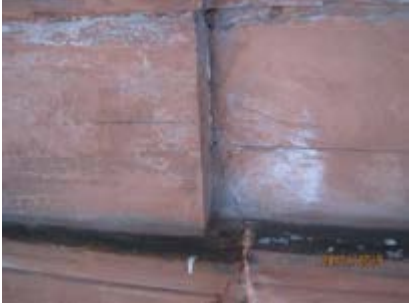
TBC
W4.88	IMG_0375, 0377	Cracking to sandstone	Elevation W4, Wall	Horizontal	1-2	400-500	-

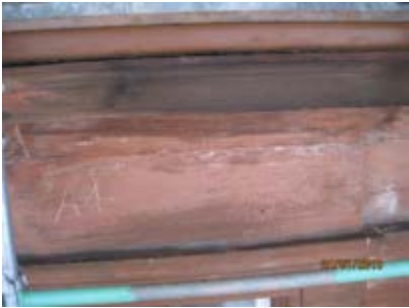
Defect ID	Photo Source	Defect Description	Defect Location	Crack Orientation	Crack Width (mm)	Crack Length (mm)	Comments	Photo	Severity Category
W4.89	IMG_0378, 0379	Water staining efflorescence	Elevation W4, Wall	n/a	n/a	n/a	Along sandstone ledge feature. Appears damp

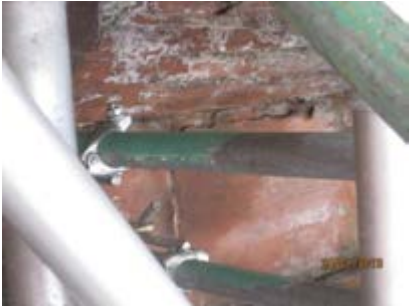
Defect ID	Photo Source	Defect Description	Defect Location	Crack Orientation	Crack Width (mm)	Crack Length (mm)	Comments	Photo	Severity Category
W4.91	IMG_0382, 0385	Spalled/damaged sandstone	Elevation W4, Wall	n/a	n/a	n/a	-

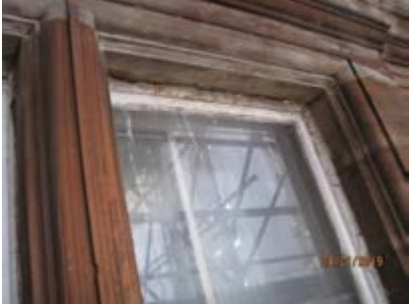
TBC
W4.92	IMG_0399, 0403	Other	Elevation W4, Wall	n/a	n/a	n/a	Timber window frame in poor condition. Peeling paintwork

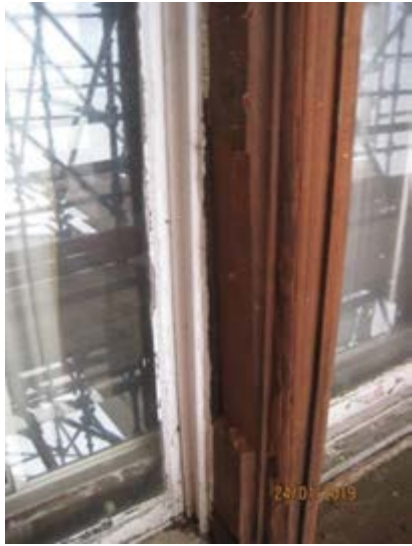
Defect ID	Photo Source	Defect Description	Defect Location	Crack Orientation	Crack Width (mm)	Crack Length (mm)	Comments	Photo	Severity Category
W4.93	IMG_0404, 0406	Loss of section	Elevation W4, Wall	n/a	n/a	n/a	-

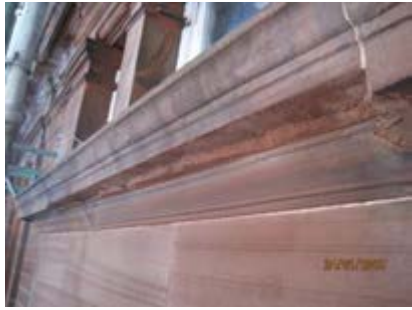
TBC
W4.94	IMG_0409, 0411	Loss of section	Elevation W4, Wall	n/a	n/a	n/a	-

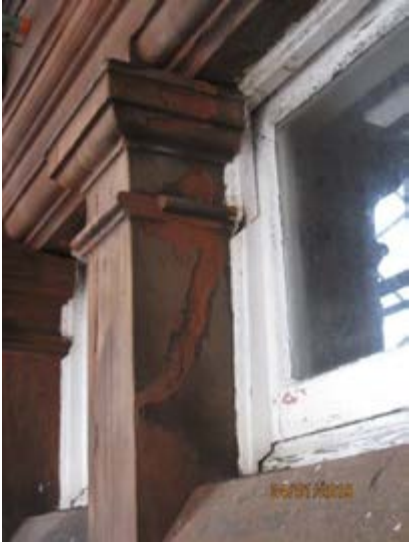
Defect ID	Photo Source	Defect Description	Defect Location	Crack Orientation	Crack Width (mm)	Crack Length (mm)	Comments	Photo	Severity Category
W4.95	IMG_0413, 0414	Spalled/damaged sandstone	Elevation W4, Wall	n/a	n/a	n/a	Sandstone mullion appears to be delaminating

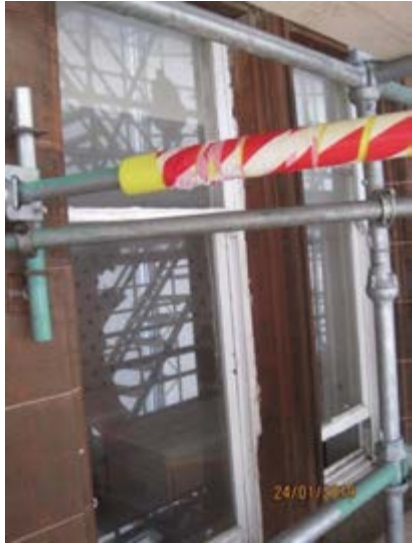
Defect ID	Photo Source	Defect Description	Defect Location	Crack Orientation	Crack Width (mm)	Crack Length (mm)	Comments	Photo	Severity Category
W4.98	IMG_0425, 0436	Other	Elevation W4, Wall	n/a	n/a	n/a	Timber window frame in poor condition. Gaps between sandstone blocks and timber window frame

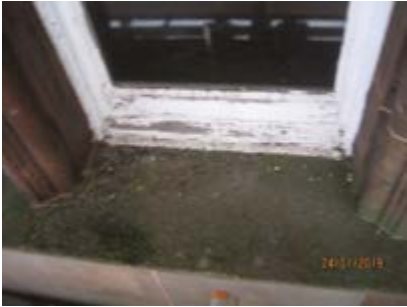
Defect ID	Photo Source	Defect Description	Defect Location	Crack Orientation	Crack Width (mm)	Crack Length (mm)	Comments	Photo	Severity Category
W4.106	IMG_0477-0483	Other	Elevation W4, Wall	n/a	n/a	n/a	Timber window frame in poor condition. Peeling paintwork. Appears damp

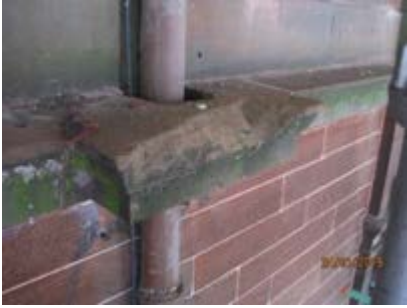
TBC
W4.107	IMG_0484-0485	Spalled/damaged sandstone	Elevation W4, Wall	n/a	n/a	n/a	Cracked/broken off Sandstone to ledge architectural feature

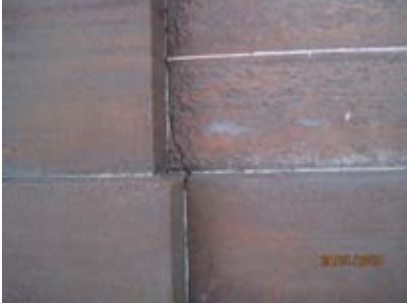
TBC
W4.108	IMG_0490-0491	Cracking to sandstone	Elevation W4, Wall	Diagonal	1	50	-

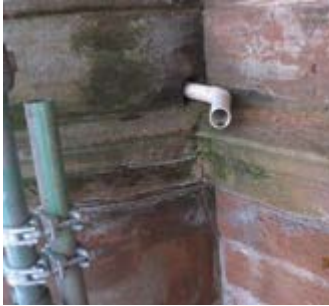
Defect ID	Photo Source	Defect Description	Defect Location	Crack Orientation	Crack Width (mm)	Crack Length (mm)	Comments	Photo	Severity Category
W4.112	IMG_0505	Damaged/ defective gutter/ drainage	Elevation W4, Wall	n/a	n/a	n/a	Possible defective drainage outlet

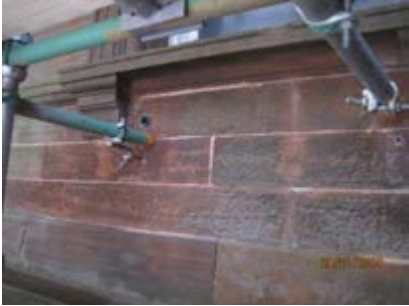
TBC
W4.113	IMG_0510-0511	Cracking to sandstone	Elevation W4, Wall	Diagonal	1	50	Crack emanating from metal insert/hole

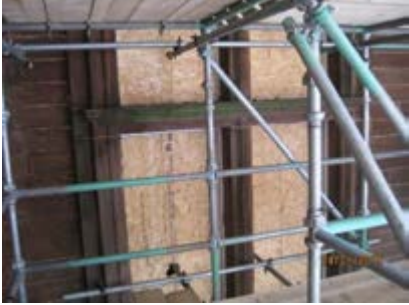
TBC
W4.114	IMG_0536	Other	Elevation W4, Wall	n/a	n/a	n/a	Windows boarded up

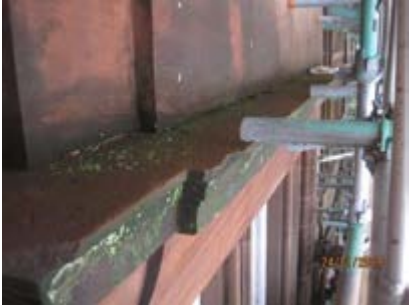
Defect ID	Photo Source	Defect Description	Defect Location	Crack Orientation	Crack Width (mm)	Crack Length (mm)	Comments	Photo	Severity Category
W4.115	IMG_0537, 0538	Water staining efflorescence. Vegetation growth	Elevation W4, Wall	n/a	n/a	n/a	Along the length of the ledge architectural feature

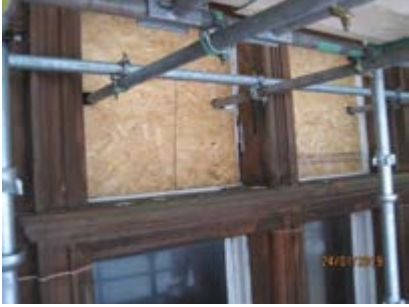
TBC
W4.116	IMG_0539	Other	Elevation W4, Wall	n/a	n/a	n/a	Windows partially boarded up

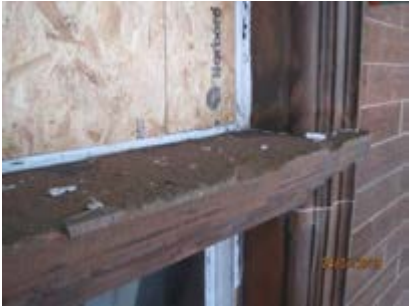
Defect ID	Photo Source	Defect Description	Defect Location	Crack Orientation	Crack Width (mm)	Crack Length (mm)	Comments	Photo	Severity Category
W4.118	IMG_0544	Spalled/damaged sandstone	Elevation W4, Wall	n/a	n/a	n/a	Delamination/cracked/broken off sandstone to window transom

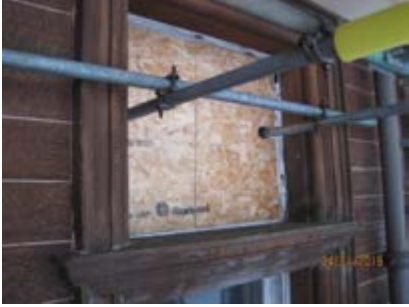
TBC
W4.119	IMG_0556	Other	Elevation W4, Wall	n/a	n/a	n/a	Windows partially boarded up

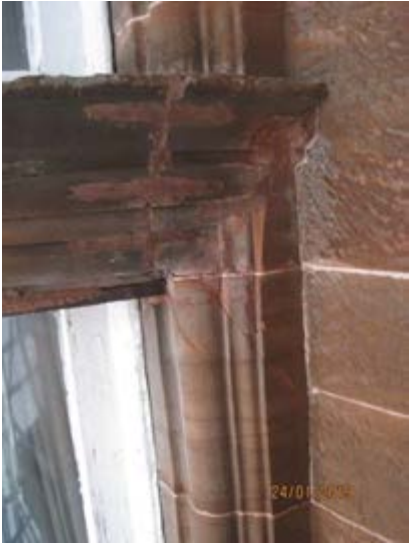
Defect ID	Photo Source	Defect Description	Defect Location	Crack Orientation	Crack Width (mm)	Crack Length (mm)	Comments	Photo	Severity Category
W4.120	IMG_0560, 0561	Cracking to sandstone	Elevation W4, Wall Circular bay window	Diagonal	0-1	200	-

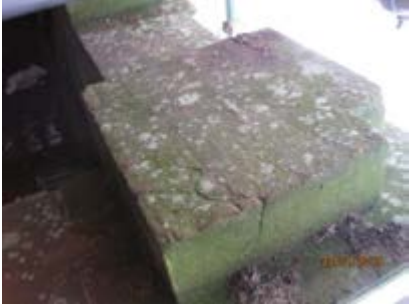
Defect ID	Photo Source	Defect Description	Defect Location	Crack Orientation	Crack Width (mm)	Crack Length (mm)	Comments	Photo	Severity Category
W4.129	IMG_0615, 0618	Vegetation growth/staining	Elevation W4, Wall Balcony feature	n/a	n/a	n/a	Vegetation growth/staining on balcony feature	 	TBC
W4.130	IMG_0616, 0617, 0620	Cracking to sandstone	Elevation W4, Wall Balcony	Diagonal	n/a	n/a	Minor crack to capping stone

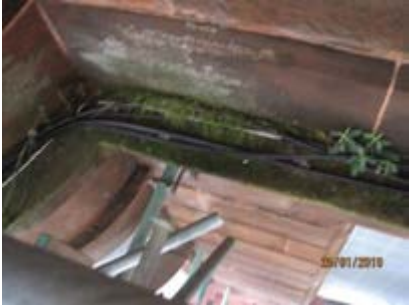
Defect ID	Photo Source	Defect Description	Defect Location	Crack Orientation	Crack Width (mm)	Crack Length (mm)	Comments	Photo	Severity Category
W4.140	IMG_0681, 0682	Vegetation growth	Elevation W4, Wall	n/a	n/a	n/a	Vegetation growth on sandstone ledge feature

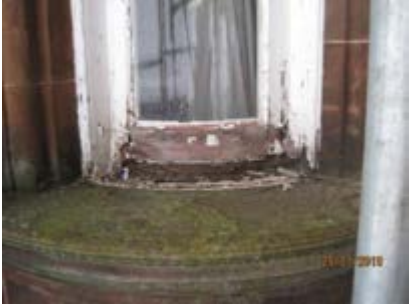
TBC
W4.141	IMG_0683-0690, 0703, 0704	Other	Elevation W4, Wall	n/a	n/a	n/a	Timber frame windows in poor condition
