# **Ayr Station Hotel Structural Condition Factual Report**

Interim Report

19 August 2019

**Document reference:** 399316ZZ-MMD-00-00-RP-S-002

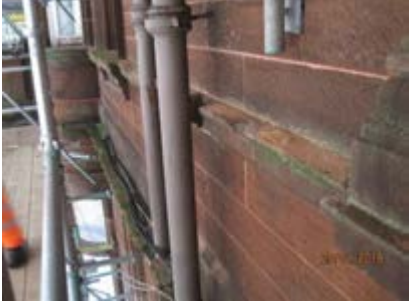
TBC
W4.142	IMG_0707, 0711	Spalled/damaged sandstone	Elevation W4, Wall	n/a	n/a	n/a	Minor delamination/cracked/broken off sandstone along sandstone ledge feature

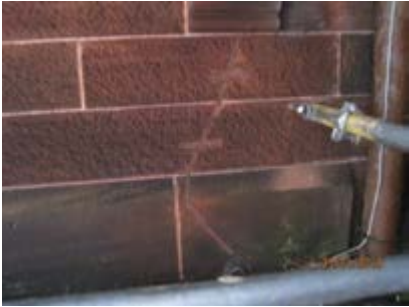
Defect ID	Photo Source	Defect Description	Defect Location	Crack Orientation	Crack Width (mm)	Crack Length (mm)	Comments	Photo	Severity Category
W4.143	IMG_0693, 0694	Cracking to sandstone	Elevation W4, Wall	Diagonal	n/a	600	Crack/defect appears to have been repaired/filled in

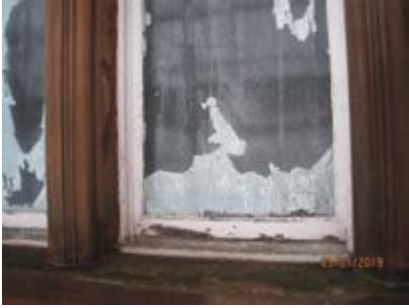
TBC
W4.144	IMG_0705, 0706	Other	Elevation W4, Wall	n/a	n/a	n/a	Cracked window pane

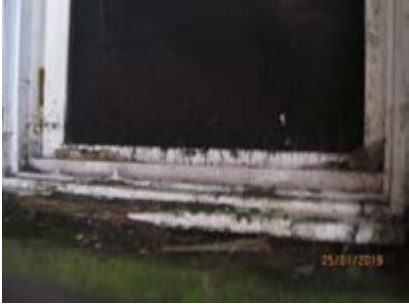
TBC
W4.145	IMG_0697, 0707	Other	Elevation W4, Wall	n/a	n/a	n/a	Timber frame windows in poor condition

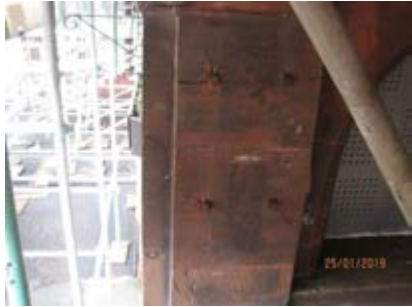
Defect ID	Photo Source	Defect Description	Defect Location	Crack Orientation	Crack Width (mm)	Crack Length (mm)	Comments	Photo	Severity Category
W4.149	IMG_0732-0734	Cracking to sandstone	Elevation W4, Wall	Radial	1-3	100	Cracks emanating from metal inserts

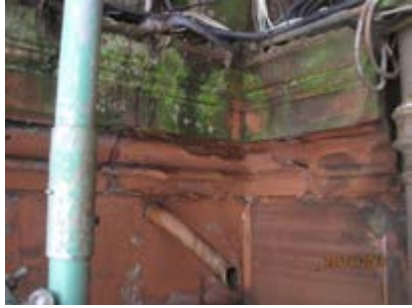
TBC
W4.150	IMG_0736	Spalled/damaged sandstone	Elevation W4, Wall	n/a	n/a	n/a	-

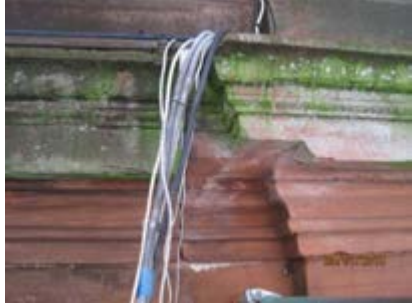
TBC
W4.151	IMG_0738, 0739	Loss of section	Elevation W4, Wall	n/a	n/a	n/a	-

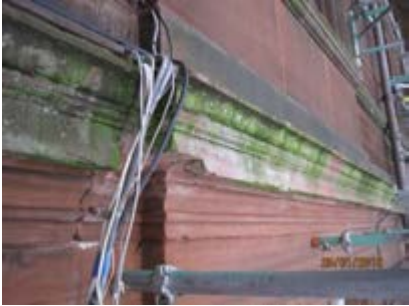
Defect ID	Photo Source	Defect Description	Defect Location	Crack Orientation	Crack Width (mm)	Crack Length (mm)	Comments	Photo	Severity Category
W4.152	IMG_0740-0742	Vegetation growth/staining	Elevation W4, Wall	n/a	n/a	n/a	Vegetation growth/staining along sandstone ledge feature

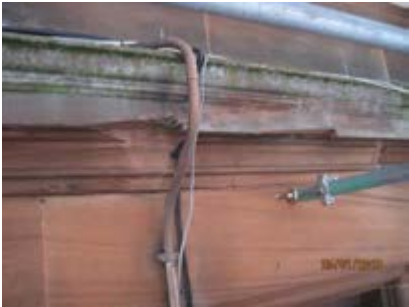
TBC
W4.153	IMG_0745-0748	Loss of section	Elevation W4, Wall	n/a	n/a	n/a	Loss of section to underside of sandstone ledge feature above window

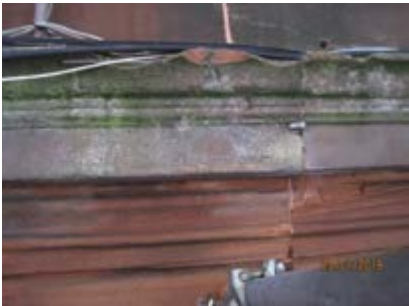
TBC
W4.154	IMG_0749-0751	Spalled/damaged sandstone	Elevation W4, Wall	n/a	n/a	n/a	Cracked/broken off sandstone to sandstone ledge feature due to anchor fixing

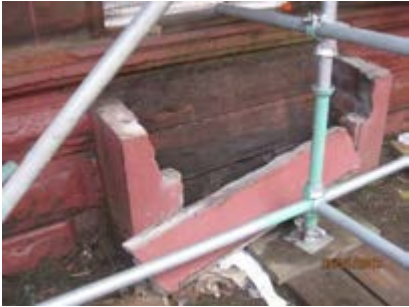
Defect ID	Photo Source	Defect Description	Defect Location	Crack Orientation	Crack Width (mm)	Crack Length (mm)	Comments	Photo	Severity Category
W4.161	IMG_0796, 0799	Spalled/damaged masonry	Elevation W4, Wall	n/a	n/a	n/a	Masonry section detached from external box out/louvre

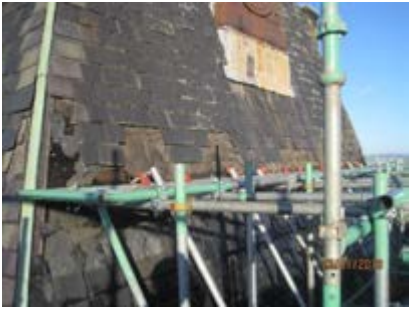
Defect ID	Photo Source	Defect Description	Defect Location	Crack Orientation	Crack Width (mm)	Crack Length (mm)	Comments	Photo	Severity Category
W5.1	IMG_0108	Other	Elevation W5, Roof	n/a	n/a	n/a	Roof tiles removed to allow for scaffold tie connection

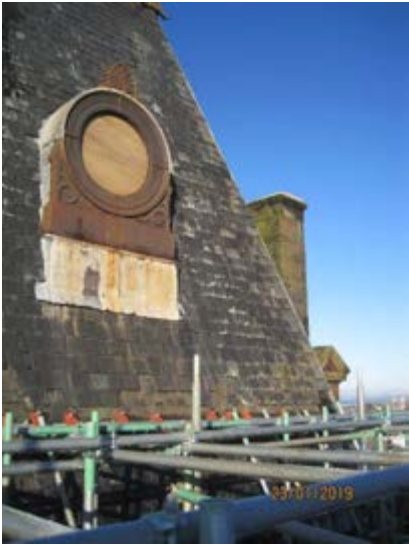
TBC
W5.2	IMG_0109	Vegetation	Elevation W5, Roof	n/a	n/a	n/a	-

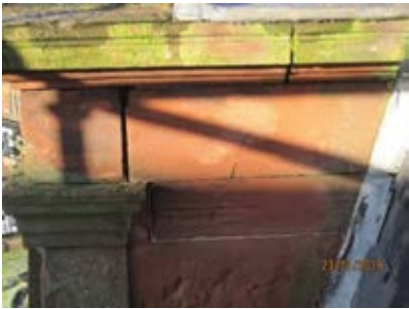
Defect ID	Photo Source	Defect Description	Defect Location	Crack Orientation	Crack Width (mm)	Crack Length (mm)	Comments	Photo	Severity Category
W5.3	IMG_0113	Cracking to sandstone	Elevation W5, Roof	Diagonal	1-2	150	-

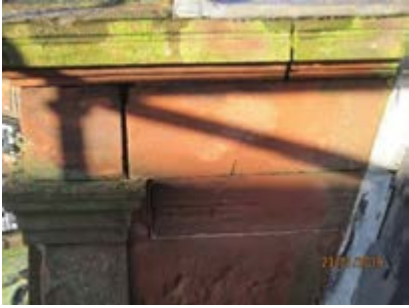
TBC
W5.4	IMG_0114	Cracking to sandstone	Elevation W5, Roof	Diagonal	1-3	300-400	Crack emanating from metal insert	 	TBC
W5.5	IMG_0113	Other	Elevation W5, Roof	n/a	n/a	n/a	Loss of pointing / approx. 10mm vertical gap between masonry blocks.

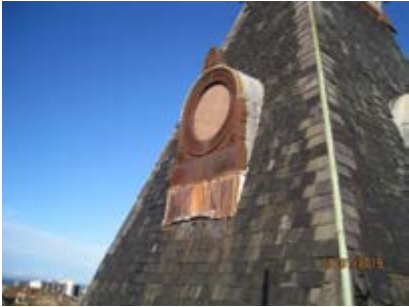
Defect ID	Photo Source	Defect Description	Defect Location	Crack Orientation	Crack Width (mm)	Crack Length (mm)	Comments	Photo	Severity Category
W5.6	IMG_0116	Staining	Elevation W5, Roof	n/a	n/a	n/a	Corrosion staining and damage to roof flashing.

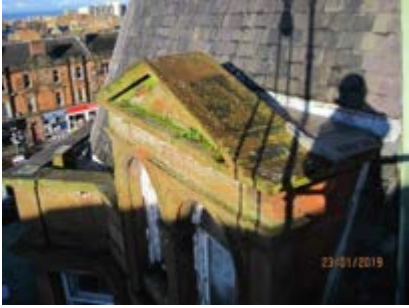
TBC
W5.7	IMG_0117	Vegetation	Elevation W5, Roof	n/a	n/a	n/a	Vegetation on roof capping stone

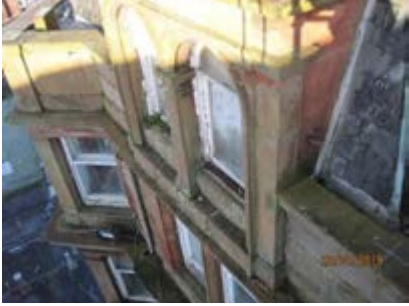
TBC
W5.8	IMG_0118	Other	Elevation W5, Roof	n/a	n/a	n/a	Timber frame windows in poor condition. Vegetation growth along window frame noted

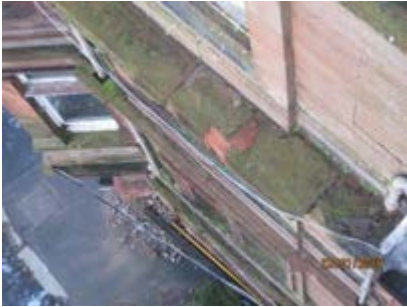
Defect ID	Photo Source	Defect Description	Defect Location	Crack Orientation	Crack Width (mm)	Crack Length (mm)	Comments	Photo	Severity Category
W5.9	IMG_0120	Spalled/damaged sandstone	Elevation W5, Wall	n/a	n/a	n/a	Delamination/erosion of/cracked/broken off sandstone to ledge feature noted

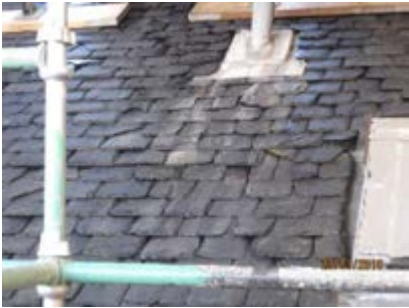
Defect ID	Photo Source	Defect Description	Defect Location	Crack Orientation	Crack Width (mm)	Crack Length (mm)	Comments	Photo	Severity Category
W5.12	IMG_0128	Dislodged/damaged tiles	Elevation W5, Roof	n/a	n/a	n/a	-

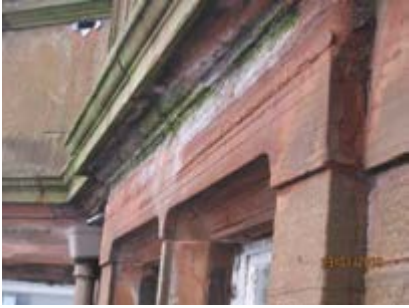
TBC
W5.13	IMG_0214-0216	Spalled/damaged sandstone	Elevation W5, Wall	-	-	-	Sandstone lintel appears to be delaminating

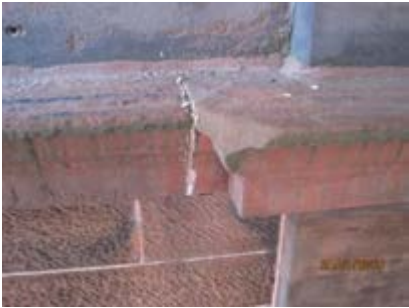
Defect ID	Photo Source	Defect Description	Defect Location	Crack Orientation	Crack Width (mm)	Crack Length (mm)	Comments	Photo	Severity Category
W5.22	IMG_0467	Spalled/damaged sandstone	Elevation W5, Wall	n/a	n/a	n/a	Cracked/broken off sandstone to ledge architectural feature

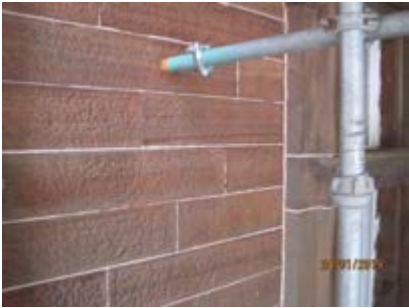
TBC
W5.23	IMG_0517-0519	Cracking to sandstone	Elevation W5, Wall	Horizontal	0-1	50	-

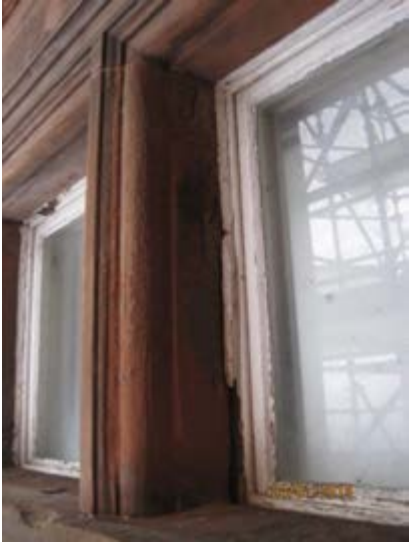
Defect ID	Photo Source	Defect Description	Defect Location	Crack Orientation	Crack Width (mm)	Crack Length (mm)	Comments	Photo	Severity Category
W5.24	IMG_0520-0525	Spalled/damaged sandstone	Elevation W5, Wall	n/a	n/a	n/a	Delamination/erosion of sandstone to window mullion

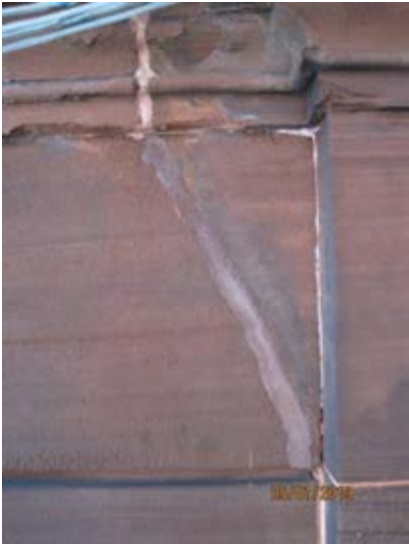
Defect ID	Photo Source	Defect Description	Defect Location	Crack Orientation	Crack Width (mm)	Crack Length (mm)	Comments	Photo	Severity Category
W5.30	IMG_0635, 0636	Cracking to sandstone	Elevation W5, Wall	Diagonal	n/a	400	Possible crack repair

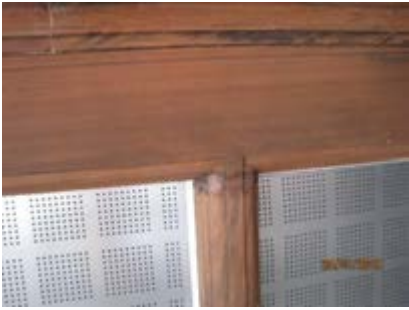
TBC
W5.31	IMG_0637, 0638	Cracking to sandstone	Elevation W5, Wall	Horizontal	n/a	200	Crack/defect appears to have been repaired/filled in

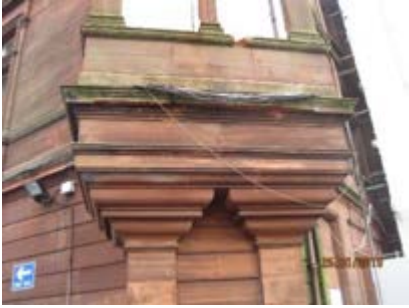
Defect ID	Photo Source	Defect Description	Defect Location	Crack Orientation	Crack Width (mm)	Crack Length (mm)	Comments	Photo	Severity Category
W5.36	IMG_0822, 0825	Spalled/damaged sandstone	Elevation W5, Wall	n/a	n/a	n/a	Cracked/broken off sandstone to sandstone ledge feature	 	TBC
W5.37	IMG_0835-0838	Spalled/damaged sandstone	Elevation W5, Wall	n/a	n/a	n/a	Cracked/broken off sandstone to underside of sandstone ledge feature

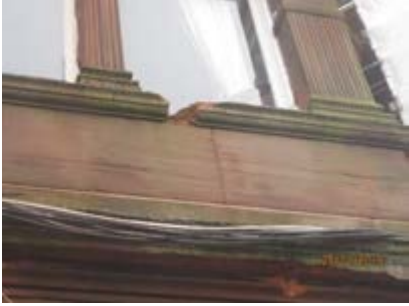
TBC
W5.38	IMG_0839-0842	Loss of section	Elevation W5, Wall	n/a	n/a	n/a	Loss of section to window ledge

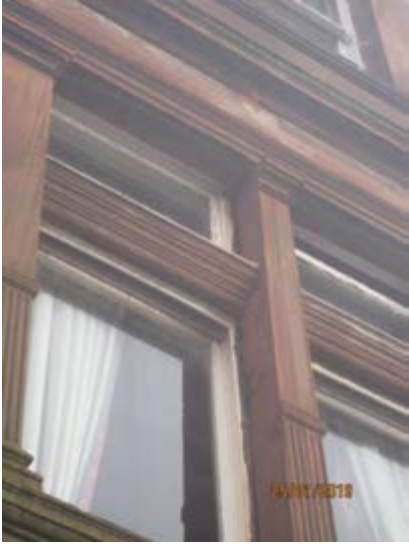
Defect ID	Photo Source	Defect Description	Defect Location	Crack Orientation	Crack Width (mm)	Crack Length (mm)	Comments	Photo	Severity Category
W5.39	IMG_0845-0850	Loss of section	Elevation W5, Wall	n/a	n/a	n/a	Loss of section to vertical sandstone block adjacent window

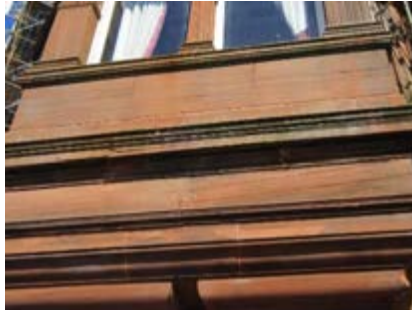
Defect ID	Photo Source	Defect Description	Defect Location	Crack Orientation	Crack Width (mm)	Crack Length (mm)	Comments	Photo	Severity Category
W6.3	IMG_2104	Crack	Elevation W6, Wall	Horizontal	1-5	800	-

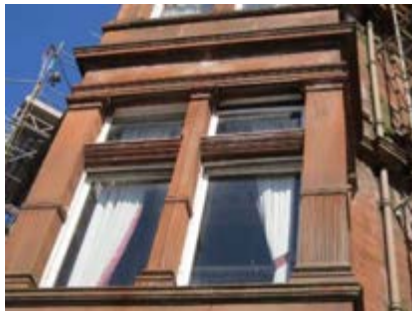
TBC
W6.4	IMG_2106	Other	Elevation W6, Wall	n/a	n/a	n/a	Deteriorating timber window frame and delamination/erosion of sandstone

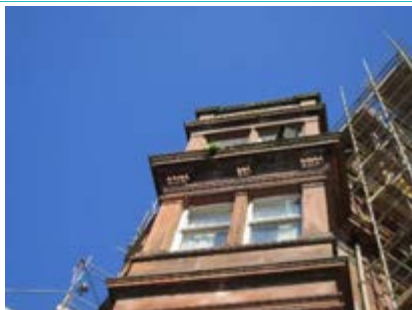
TBC
W6.5	IMG_2105	Vegetation growth	Elevation W6, Wall	n/a	n/a	n/a	-

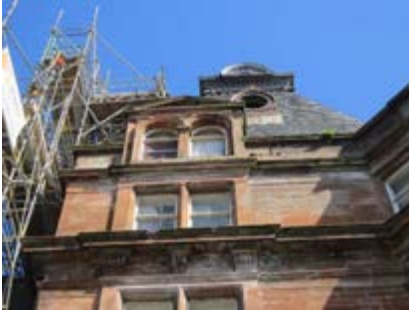
Defect ID	Photo Source	Defect Description	Defect Location	Crack Orientation	Crack Width (mm)	Crack Length (mm)	Comments	Photo	Severity Category
W6.12	IMG_2109	Vegetation growth	Elevation W6, Wall	n/a	n/a	n/a	-

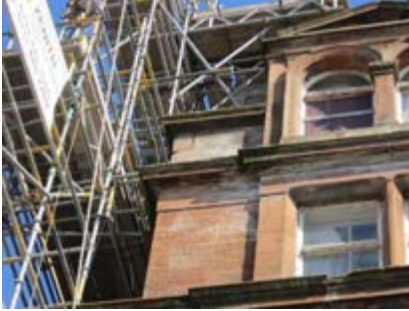
TBC
W6.13	IMG_2107	Displaced corner block	Elevation W6, Wall	n/a	n/a	n/a	Left corner of 4th floor window

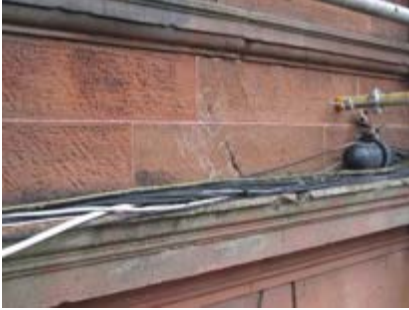
TBC
W6.14	IMG_2328	Crack	Elevation W6, Wall	Diagonal	1-3	200	-

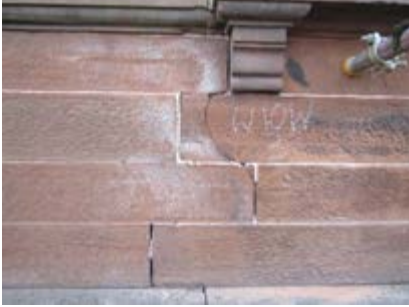
Defect ID	Photo Source	Defect Description	Defect Location	Crack Orientation	Crack Width (mm)	Crack Length (mm)	Comments	Photo	Severity Category
W6.15	IMG_2326	Crack	Elevation W6, Wall	Vertical	1-3	300	-	 	TBC
W6.16	IMG_2343	Crack and loss of mortar joints	Elevation W6, Wall	Step Crack	1-5	800	-	 	TBC
W6.17	IMG_2342	Crack and loss of mortar joints	Elevation W6, Wall	Step Crack	1-5	400	-

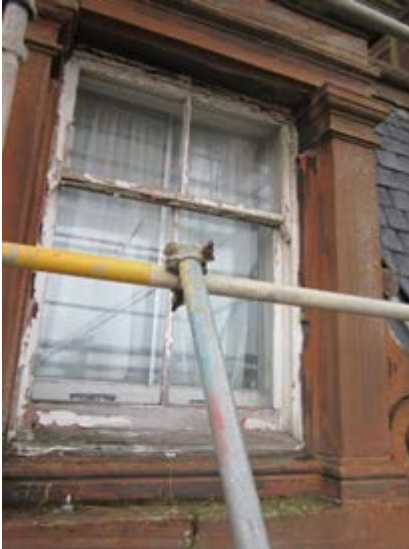
Defect ID	Photo Source	Defect Description	Defect Location	Crack Orientation	Crack Width (mm)	Crack Length (mm)	Comments	Photo	Severity Category
W6.20	IMG_2355	Poor timber window frame	Elevation W6, Wall	n/a	n/a	n/a	-

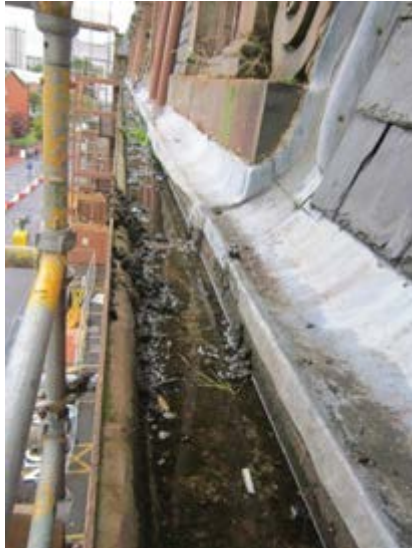
Defect ID	Photo Source	Defect Description	Defect Location	Crack Orientation	Crack Width (mm)	Crack Length (mm)	Comments	Photo	Severity Category
W6.21	IMG_2357	Vegetation growth	Elevation W6, Wall	n/a	n/a	n/a	In gutters

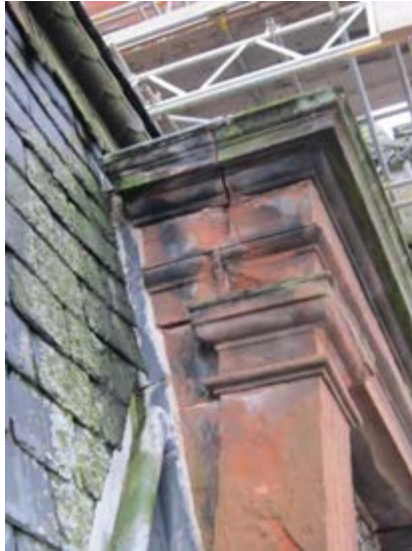
Defect ID	Photo Source	Defect Description	Defect Location	Crack Orientation	Crack Width (mm)	Crack Length (mm)	Comments	Photo	Severity Category
W6.22	IMG_2360	Mortar loss, possible crack and Spalled/damaged sandstone	Elevation W6, Wall	n/a	n/a	n/a	Significant delamination/erosion of sandstone to side face of window pilaster

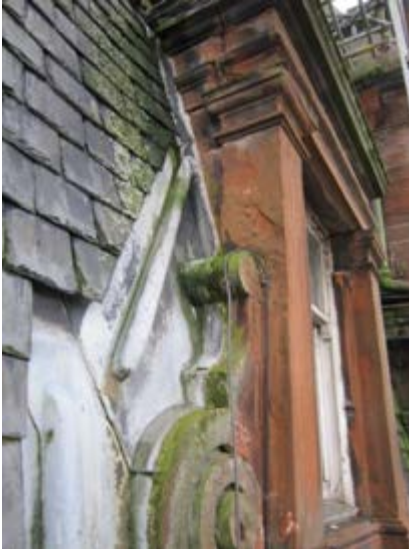
Defect ID	Photo Source	Defect Description	Defect Location	Crack Orientation	Crack Width (mm)	Crack Length (mm)	Comments	Photo	Severity Category
W6.23	IMG_2352 & 2353	Spalled/damaged sandstone	Elevation W6, Wall	n/a	n/a	n/a	Delamination/erosion of sandstone to side face of window pilaster

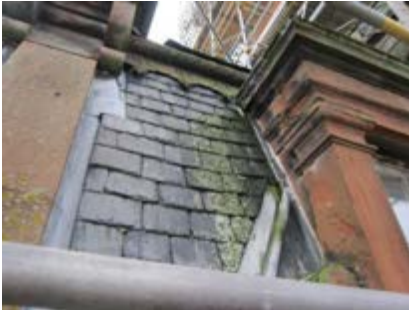
TBC
W6.24	IMG_2354	Significant vegetation growth	Elevation W6, Wall	n/a	n/a	n/a	-

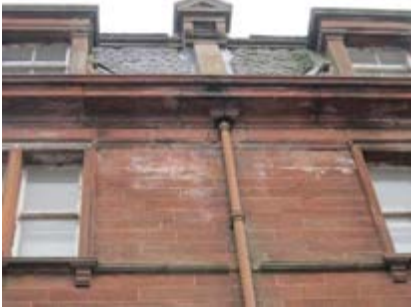
Defect ID	Photo Source	Defect Description	Defect Location	Crack Orientation	Crack Width (mm)	Crack Length (mm)	Comments	Photo	Severity Category
W6.37	IMG_2158	Possible loss of section	Elevation W6, Wall	n/a	n/a	n/a	-

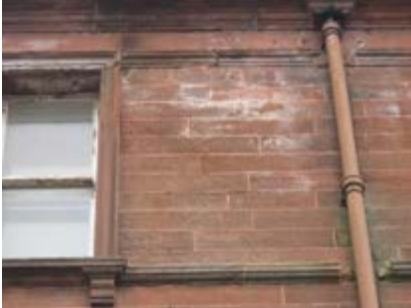
TBC
W6.38	IMG_2159	Possible loss of pointing	Elevation W6, Wall	n/a	n/a	n/a	-

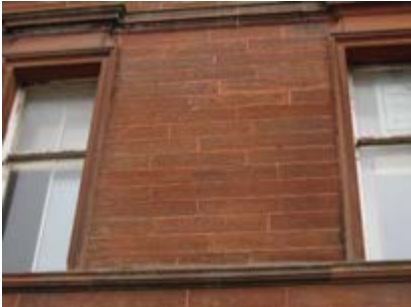
TBC
W6.39	IMG_2161	Loss of section	Elevation W6, Wall	n/a	n/a	n/a	-

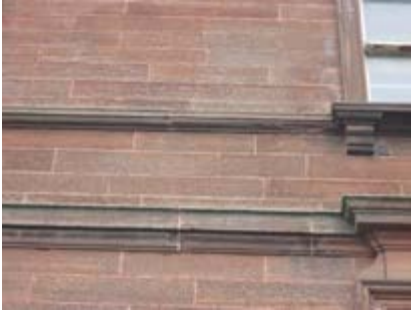
Defect ID	Photo Source	Defect Description	Defect Location	Crack Orientation	Crack Width (mm)	Crack Length (mm)	Comments	Photo	Severity Category
W6.40	IMG_2162	Loss of section	Elevation W6, Wall	n/a	n/a	n/a	-

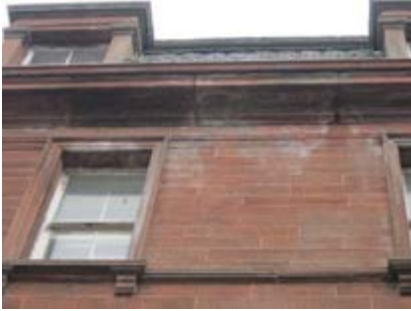
TBC
W6.41	IMG_2165	Mineral staining efflorescence	Elevation W6, Wall	n/a	n/a	n/a	Staining on 2nd floor window cills

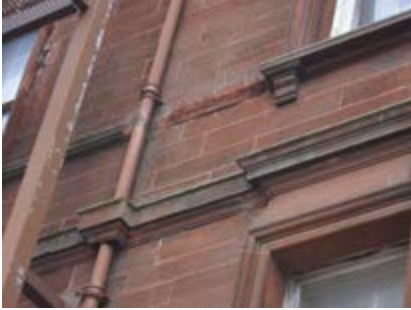
TBC
W6.42	IMG_2164	Loss of section	Elevation W6, Wall	n/a	n/a	n/a	-

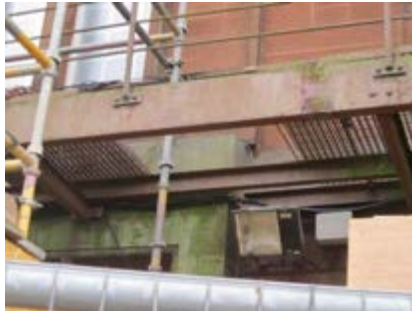
Defect ID	Photo Source	Defect Description	Defect Location	Crack Orientation	Crack Width (mm)	Crack Length (mm)	Comments	Photo	Severity Category
W6.43	IMG_2169 to 2175	Other	Elevation W6, Wall	n/a	n/a	n/a	Deterioration of paint finish, vegetation growth and localised surface corrosion to steelwork. Missing platform grating.

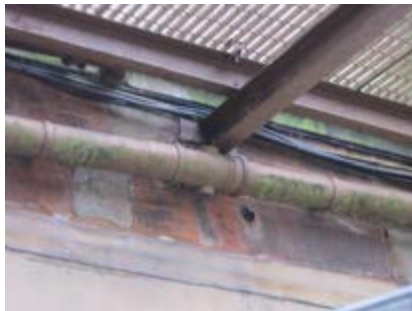
TBC
W6.44	IMG_2180 & 2183	Corrosion	Elevation W6, Wall	n/a	n/a	n/a	Surface corrosion to end plate connection of outrigger

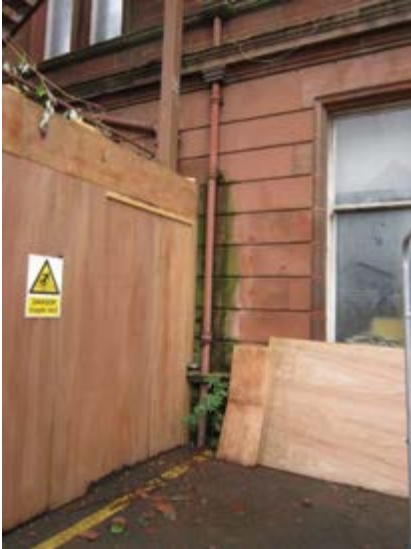
Defect ID	Photo Source	Defect Description	Defect Location	Crack Orientation	Crack Width (mm)	Crack Length (mm)	Comments	Photo	Severity Category
W6.45	IMG_2184	Vegetation staining	Elevation W6, Wall	n/a	n/a	n/a	Looks to be caused by back-up of rainwater downpipe, and water seeping/flowing from joint. Below ground drainage issue

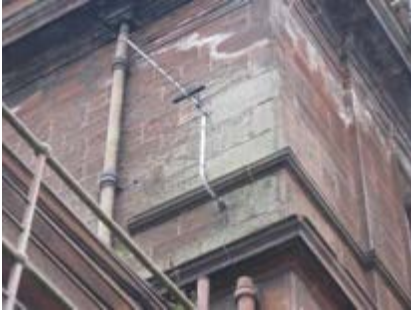
Defect ID	Photo Source	Defect Description	Defect Location	Crack Orientation	Crack Width (mm)	Crack Length (mm)	Comments	Photo	Severity Category
W6.50	IMG_2215 & 2216	Vegetation growth & staining	Elevation W6, Wall	n/a	n/a	n/a	-

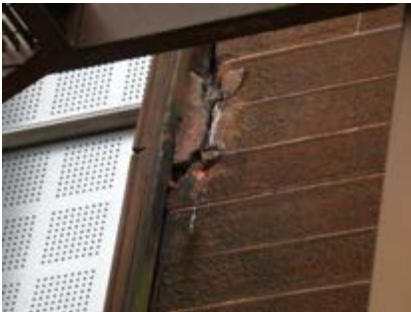
TBC
W6.51	P1000430	Cracking to sandstone	Elevation W6, Wall	Radial	n/a	n/a	Cracking caused by corrosion of wrought iron insert

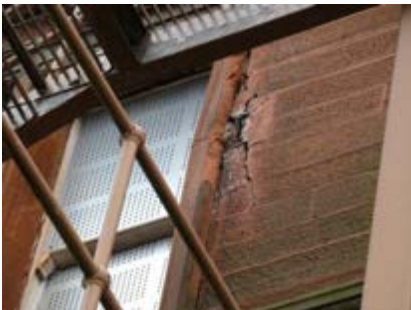
TBC
W6.52	P1000435	Cracking to sandstone	Elevation W6, Wall	Radial	n/a	n/a	Cracking caused by corrosion of wrought iron insert

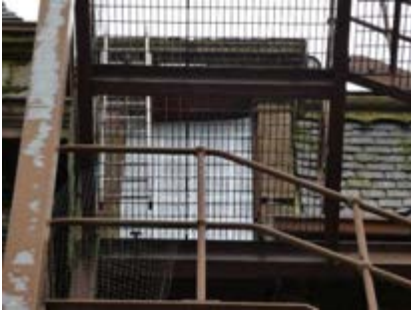
Defect ID	Photo Source	Defect Description	Defect Location	Crack Orientation	Crack Width (mm)	Crack Length (mm)	Comments	Photo	Severity Category
W6.53	P1000465	Spalled/damaged sandstone	Elevation W6, Wall	n/a	n/a	n/a	-

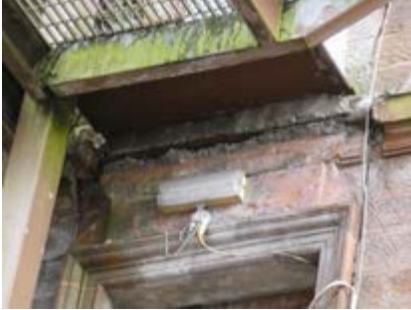
TBC
W6.54	P1000487	Spalled/damaged sandstone	Elevation W6, Wall	n/a	n/a	n/a	-	 	TBC
W6.55	P1000494	Spalled/damaged sandstone	Elevation W6, Wall	n/a	n/a	n/a	-

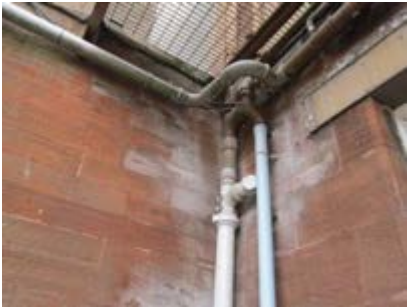
Defect ID	Photo Source	Defect Description	Defect Location	Crack Orientation	Crack Width (mm)	Crack Length (mm)	Comments	Photo	Severity Category
W7.1	IMG_2206	Spalled/damaged sandstone, Mineral staining efflorescence	Elevation W7, Wall	n/a	n/a	n/a	Minor delamination/erosion of sandstone blocks

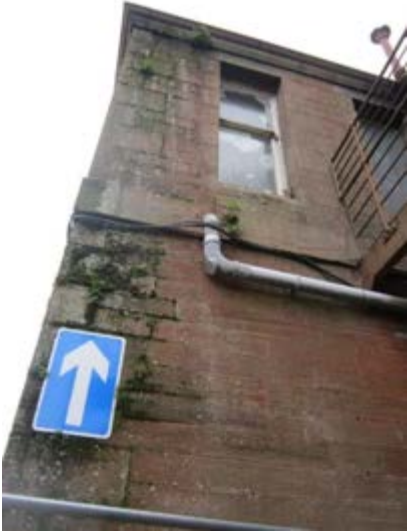
TBC
W7.2	IMG_2205	Vegetation growth/staining	Elevation W7, Wall	n/a	n/a	n/a	Vegetation growth travelling along pointing. It appears pointing is missing and have been replaced with vegetation. Vegetation expands both floors

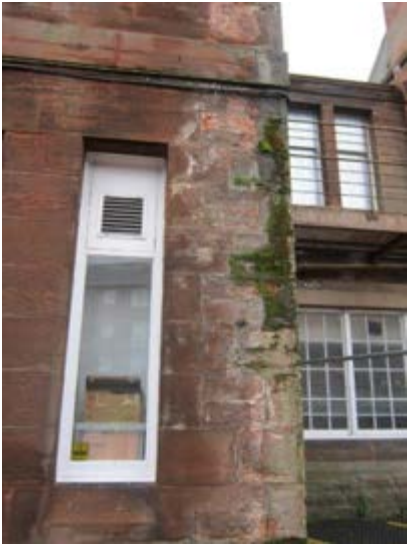
Defect ID	Photo Source	Defect Description	Defect Location	Crack Orientation	Crack Width (mm)	Crack Length (mm)	Comments	Photo	Severity Category
W8.1	IMG_2236	Spalled/damaged sandstone, Vegetation growth/staining	Elevation W8, Wall	n/a	n/a	n/a	-

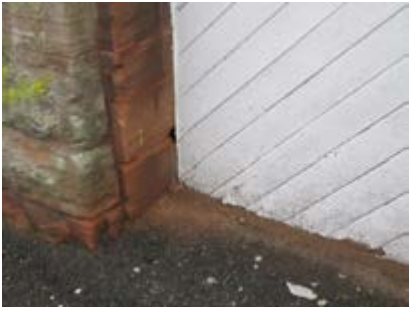
Defect ID	Photo Source	Defect Description	Defect Location	Crack Orientation	Crack Width (mm)	Crack Length (mm)	Comments	Photo	Severity Category
W8.3	IMG_2242	Spalled/damaged sandstone, Mineral staining efflorescence	Elevation W8, Wall	n/a	n/a	n/a	-	 	TBC
W8.4	IMG_2244	Missing section	Elevation W8, Wall	n/a	n/a	n/a	Near timber panelling under window

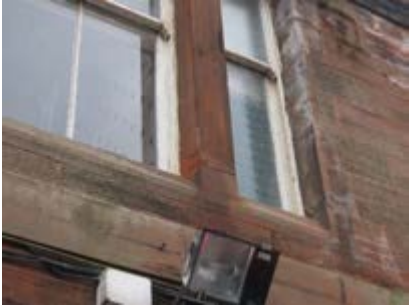
TBC
W8.5	IMG_2238	Spalled/damaged sandstone	Elevation W8, Wall	n/a	n/a	n/a	Minor delamination/erosion of sandstone on window mullion

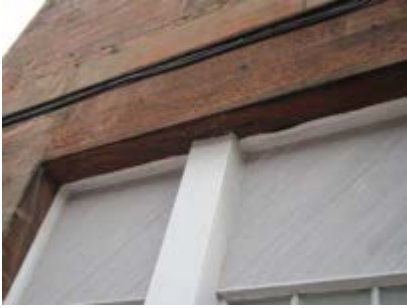
TBC
W8.7	IMG_2251	Spalled/damaged sandstone	Elevation W8, Wall	n/a	n/a	n/a	Underside of upper projected feature

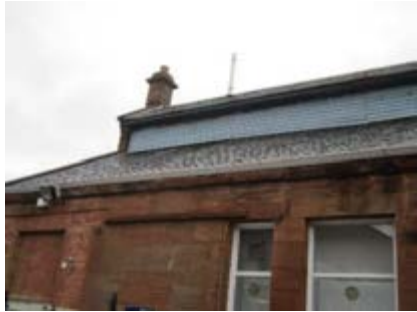
Defect ID	Photo Source	Defect Description	Defect Location	Crack Orientation	Crack Width (mm)	Crack Length (mm)	Comments	Photo	Severity Category
W10.1	IMG_2266	Loose cladding	Elevation W10, Wall	n/a	n/a	n/a	Cladding is in poor condition

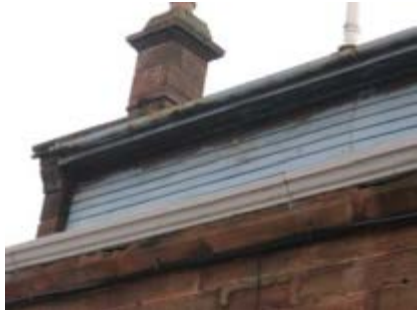
TBC
W10.2	IMG_2269	Corrosion	Elevation W10, Wall	n/a	n/a	n/a	Gutters are exhibiting corrosion

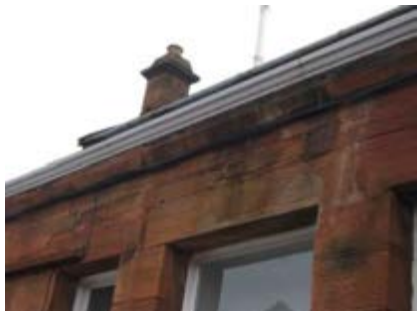
TBC
W10.3	IMG_2270 to 2272	Spalled/ damaged sandstone	Elevation W10, Wall	n/a	n/a	n/a	Localized along the whole length of wall at eaves level

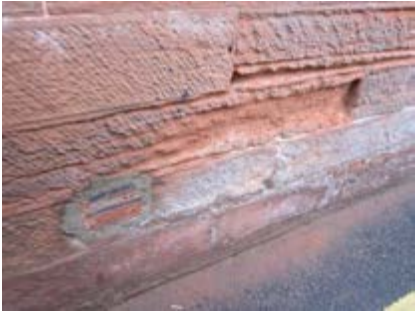
Defect ID	Photo Source	Defect Description	Defect Location	Crack Orientation	Crack Width (mm)	Crack Length (mm)	Comments	Photo	Severity Category
W10.4	IMG_2279	Spalled/damaged sandstone	Elevation W10, Wall	n/a	n/a	n/a	Spalling/delamination/erosion of sandstone

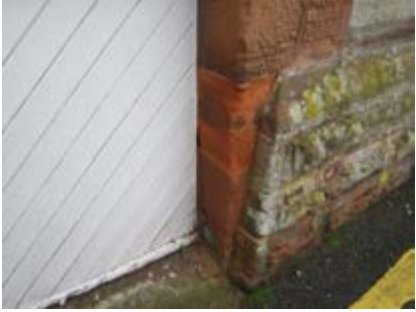
TBC
W10.5	IMG_2299	Spalled/damaged sandstone	Elevation W10, Wall	n/a	n/a	n/a	Delamination/erosion of sandstone on either side of the timber panelling

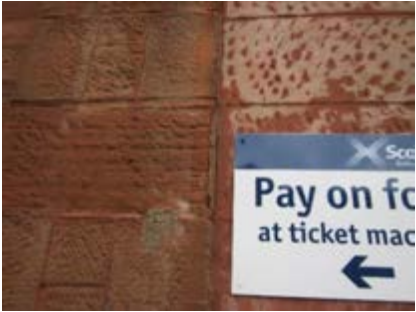
TBC
W10.6	IMG_2281	Crack	Elevation W10, Wall	Vertical	1-2	400	-

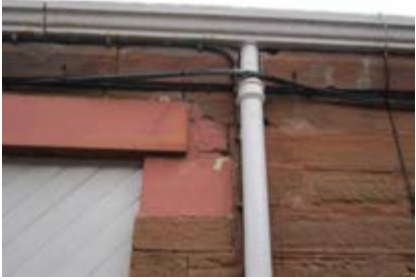
Defect ID	Photo Source	Defect Description	Defect Location	Crack Orientation	Crack Width (mm)	Crack Length (mm)	Comments	Photo	Severity Category
W10.10	IMG_2308	Cracking to lintel	Elevation W10, Wall	Horizontal	1-5	2000	Crack along lintel with spalling of surface, lintel appears to be a reinforced concrete lintel	 	TBC
W10.11	IMG_2313	Spalled/damaged sandstone	Elevation W10, Wall	n/a	n/a	n/a	Delamination/erosion of/cracked/broken off sandstone to blocks along roof eaves level, at multiple locations

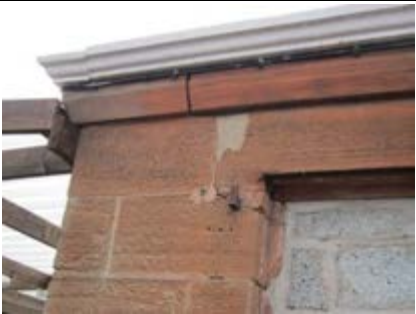
Defect ID	Photo Source	Defect Description	Defect Location	Crack Orientation	Crack Width (mm)	Crack Length (mm)	Comments	Photo	Severity Category
W10.13	IMG_2322	Crack	Elevation W10, Wall	Radial	1-5	150	Radial cracks around metal inserts, left of door frame

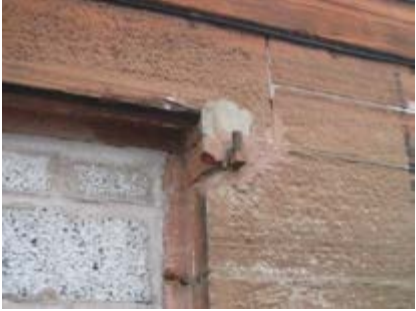
TBC
W10.14	IMG_2321	Crack	Elevation W10, Wall	Radial	1-5	150	Radial cracks around metal inserts, right of door frame

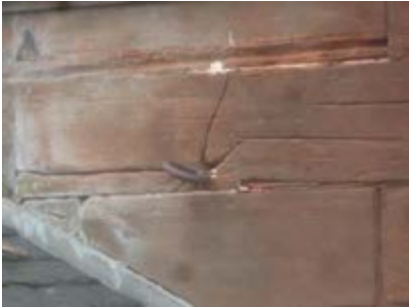
Defect ID	Photo Source	Defect Description	Defect Location	Crack Orientation	Crack Width (mm)	Crack Length (mm)	Comments	Photo	Severity Category
R1.3	P1190534	Cracking to sandstone	Chimney stack	Radial	-	-	Cracking to sandstone blocks around deadbolt anchor location

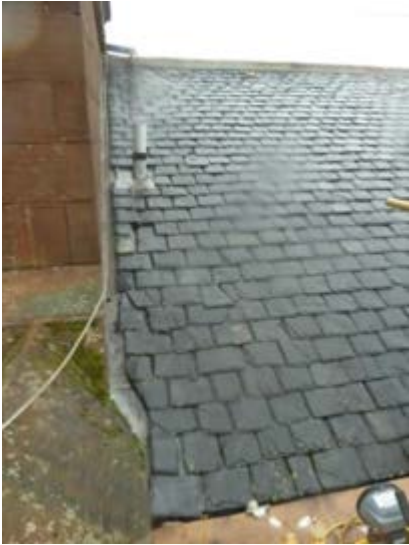
TBC
R1.4	P1190535	Missing/damaged tiles/roof	Pitched roof	n/a	n/a	n/a	-

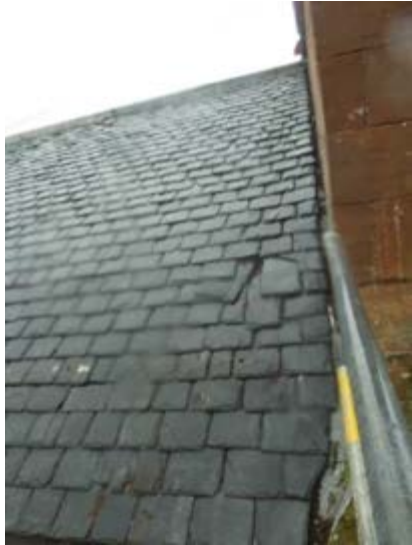
Defect ID	Photo Source	Defect Description	Defect Location	Crack Orientation	Crack Width (mm)	Crack Length (mm)	Comments	Photo	Severity Category
R1.5	P1190539	Missing/damaged tiles/roof	Pitched roof	n/a	n/a	n/a	-

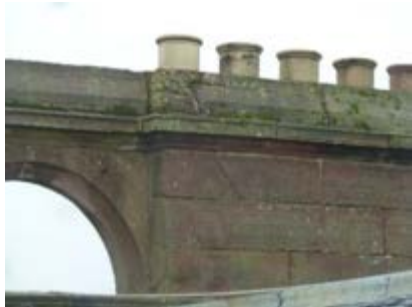
TBC
R1.6	P1190547	Cracking to sandstone	Chimney stack	Diagonal	2	300	-

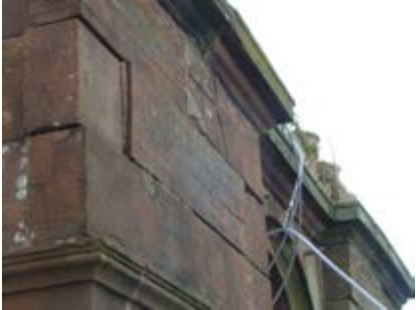
Defect ID	Photo Source	Defect Description	Defect Location	Crack Orientation	Crack Width (mm)	Crack Length (mm)	Comments	Photo	Severity Category
R2.4	P1190568	Cracking to sandstone	Chimney stack	Vertical	2	400	-

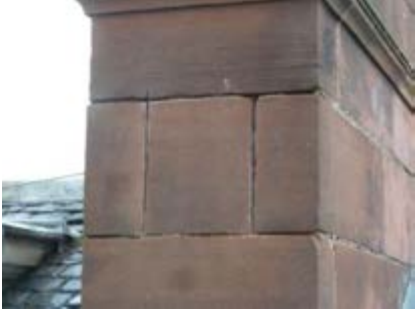
TBC
R2.5	P1190569	Other	Chimney stack	n/a	n/a	n/a	Mortar loss to sandstone blocks. Evidence of movement to edge blocks and risk of further movement. Evidence of saw cutting to mortar joints/block

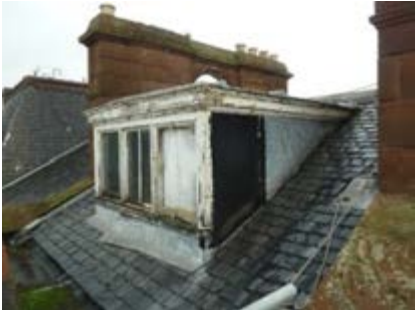
TBC
R2.6	P1190570, 0579	Other	Window framing	n/a	n/a	n/a	Degraded timber elements and flashing to dormer structure

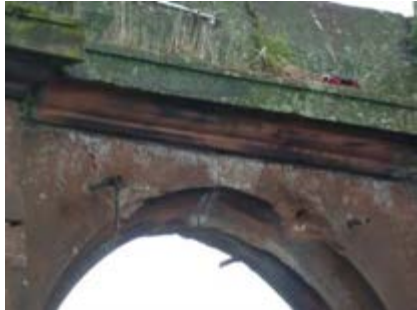
Defect ID	Photo Source	Defect Description	Defect Location	Crack Orientation	Crack Width (mm)	Crack Length (mm)	Comments	Photo	Severity Category
R2.7	P1190571, 0572	Cracking to sandstone	Chimney stack	n/a	n/a	n/a	Crack through arch block

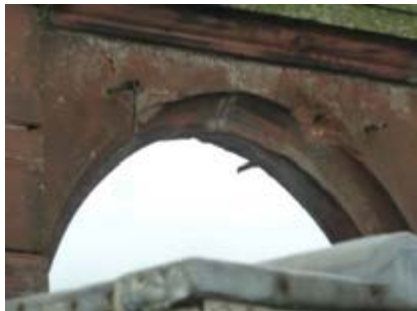
TBC
R2.8	P1190571, 0572	Spalled/damaged sandstone	Chimney stack	n/a	n/a	n/a	Cracked/broken off sandstone. Evidence of former penetration point to block

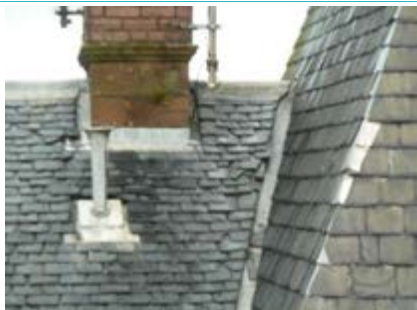
TBC
R2.9	P1190573	Missing/damaged tiles/roof	Pitched roof	n/a	n/a	n/a	-

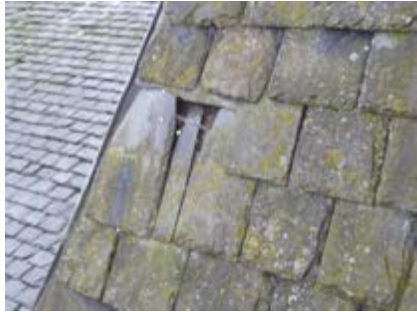
Defect ID	Photo Source	Defect Description	Defect Location	Crack Orientation	Crack Width (mm)	Crack Length (mm)	Comments	Photo	Severity Category
R3.1	P1190600	Missing/damaged tiles/roof	Tower	n/a	n/a	n/a	Missing slates, exposed timbers

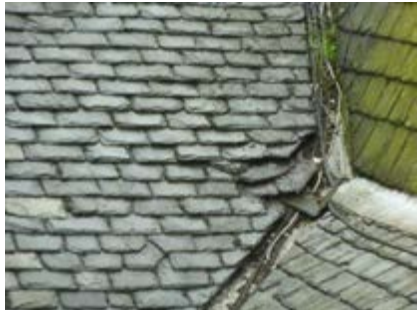
TBC
R3.2	P1190601	Missing/damaged tiles/roof	Pitched roof	n/a	n/a	n/a	-

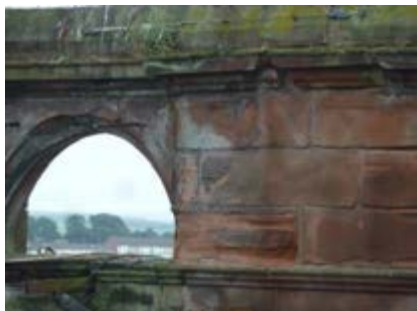
TBC
R3.3	P1190602	Spalled/damaged sandstone	Chimney stack	n/a	n/a	n/a	Delamination/erosion of sandstone blocks to chimney stack

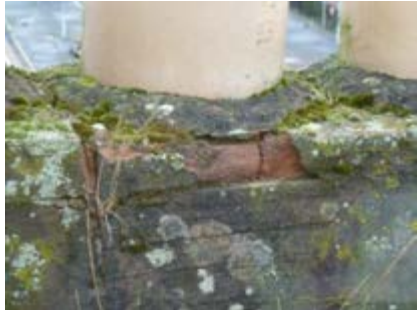
Defect ID	Photo Source	Defect Description	Defect Location	Crack Orientation	Crack Width (mm)	Crack Length (mm)	Comments	Photo	Severity Category
R3.10	P1190613	Spalled/damaged sandstone	Chimney stack	n/a	n/a	n/a	-

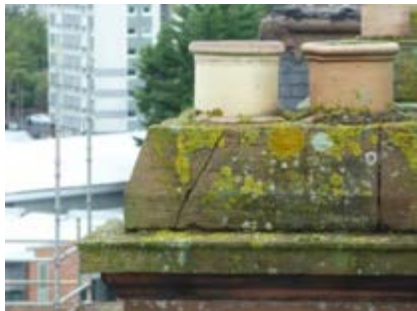
TBC
R3.11	P1190614	Cracking to sandstone		Diagonal	3	300	Crack to sandstone block around chimney pot location

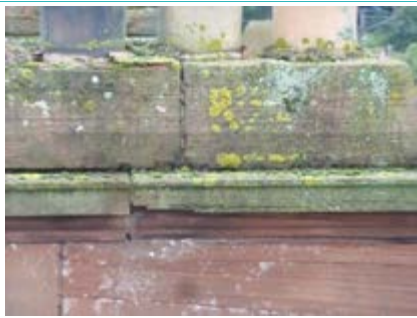
TBC
R3.12	P1190615	Spalled/damaged sandstone	Chimney stack	n/a	n/a	n/a	-

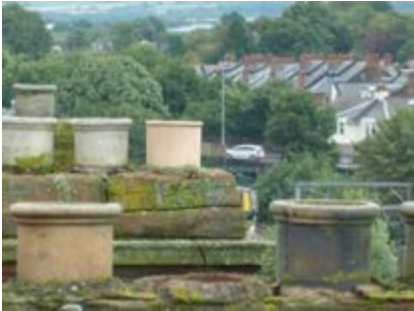
Defect ID	Photo Source	Defect Description	Defect Location	Crack Orientation	Crack Width (mm)	Crack Length (mm)	Comments	Photo	Severity Category
R3.13	P1190616	Cracking to sandstone	Chimney stack	Vertical	4	300	Crack through blockwork Sandstone ledge features tone and block below. Full extent of defect not visible from survey location

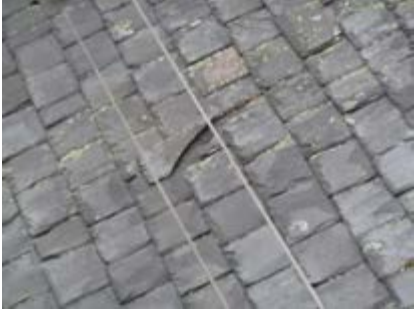
TBC
R3.14	P1190617, 0618	Missing/damaged tiles/roof	Roof	n/a	n/a	n/a	-

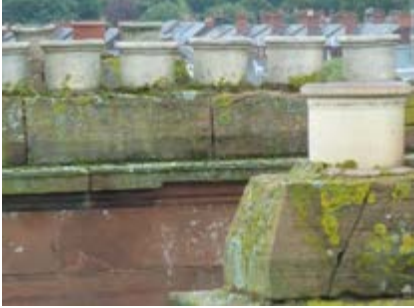
TBC
R3.15	P1190619	Spalled/damaged sandstone	Chimney stack	n/a	n/a	n/a	-

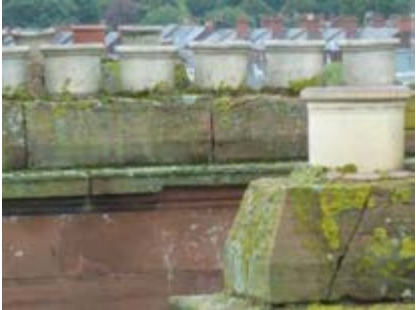
Defect ID	Photo Source	Defect Description	Defect Location	Crack Orientation	Crack Width (mm)	Crack Length (mm)	Comments	Photo	Severity Category
R3.16	P1190619	Cracking to sandstone	Chimney stack	n/a	n/a	n/a	-

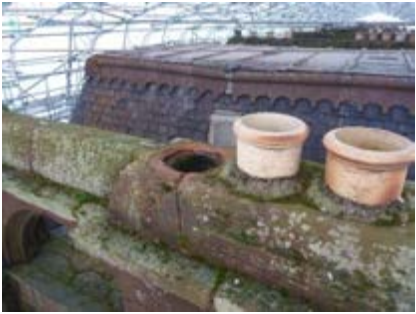
Defect ID	Photo Source	Defect Description	Defect Location	Crack Orientation	Crack Width (mm)	Crack Length (mm)	Comments	Photo	Severity Category
R4.1	P1200539	Cracking to sandstone, Other	Roof chimney	Vertical	4	300	Chimney pot missing, crack in sandstone.

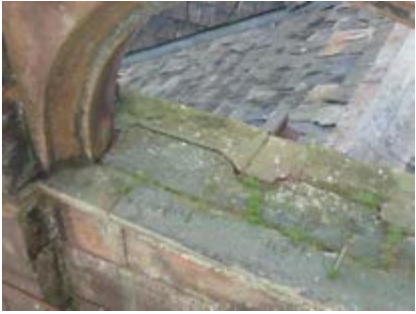
TBC
R4.2	P1200540	Cracking to sandstone	Roof chimney	Horizontal	3	1000	Crack on chimney frame.

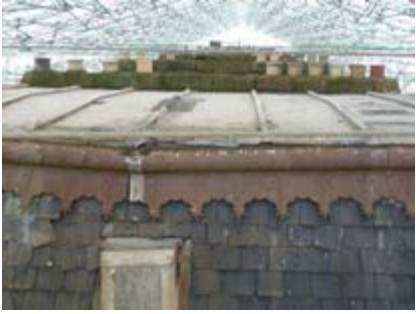
TBC
R4.3	P1200541	Damaged cast iron fittings	Roof ridge	n/a	n/a	n/a	Cast iron features detaching.

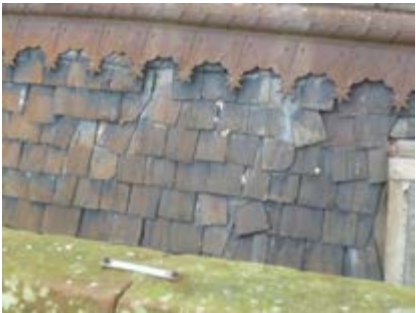
Defect ID	Photo Source	Defect Description	Defect Location	Crack Orientation	Crack Width (mm)	Crack Length (mm)	Comments	Photo	Severity Category
R4.4	P1200542	Missing/damaged tiles/roof	Roof	n/a	n/a	n/a	Various tiles loose/missing.

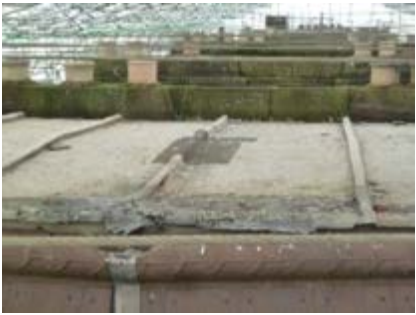
TBC
R4.5	P1200543 - 546	Other	Flat roof	n/a	n/a	n/a	Flat roof waterproofing finish shows signs of cracking and fatigue

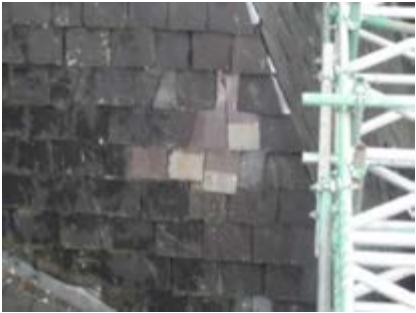
TBC
R4.6	P1200547	Missing/damaged tiles/roof	Roof	n/a	n/a	n/a	Various tiles loose.

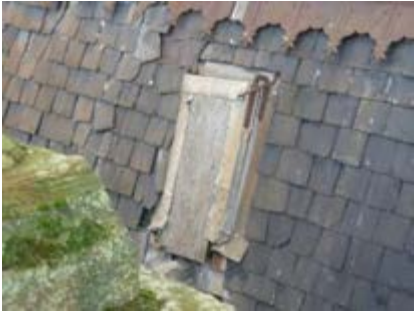
Defect ID	Photo Source	Defect Description	Defect Location	Crack Orientation	Crack Width (mm)	Crack Length (mm)	Comments	Photo	Severity Category
R4.7	P1200548	Other	Roof access hatch	n/a	n/a	n/a	Damage to door of roof access hatch.

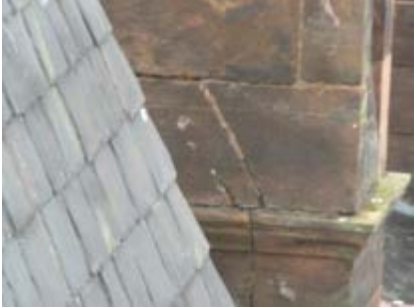
TBC
R4.8	P1200549 - 552	Missing/damaged tiles/roof, Damaged cast iron fittings, Other	Roof ridge	n/a	n/a	n/a	Cast iron features missing. Various tiles loose/missing. Exposed timber rotting.	 	TBC
R4.9	P1200553	Cracking to sandstone	Chimney	Diagonal	3	300	Crack on sandstone.

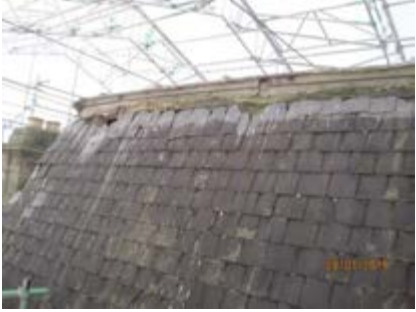
Defect ID	Photo Source	Defect Description	Defect Location	Crack Orientation	Crack Width (mm)	Crack Length (mm)	Comments	Photo	Severity Category
R4.13	IMG_0857	Missing/damaged tiles/roof	Roof	n/a	n/a	n/a	Missing/loose tiles.	 	TBC
R4.14	IMG_0858	Missing/damaged tiles/roof, Damaged cast iron fittings, Other	Roof	n/a	n/a	n/a	Cast iron features missing. Rotten roof timber beams. Exposed timber. 6m long horizontally. Loose/missing tiles.

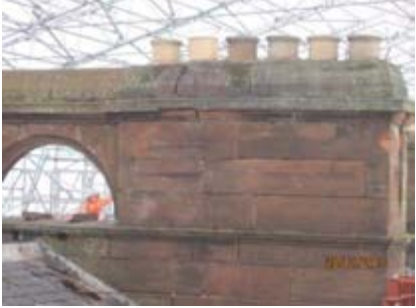
TBC
R4.15	IMG_0859	Cracking to sandstone, Spalled/damaged sandstone	Chimney stack	Diagonal	5	300	Crack on sandstone block below chimney pots. Delamination/erosion of/cracked/broken off sandstone at various locations

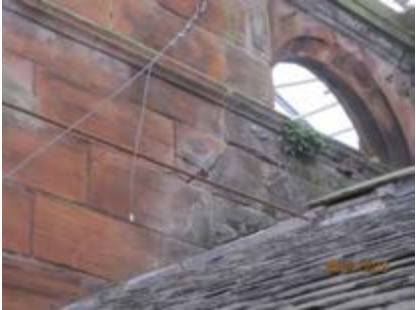
Defect ID	Photo Source	Defect Description	Defect Location	Crack Orientation	Crack Width (mm)	Crack Length (mm)	Comments	Photo	Severity Category
R4.16	IMG_0860	Cracking to sandstone	Chimney stack	Diagonal	5	400	Crack through sandstone.

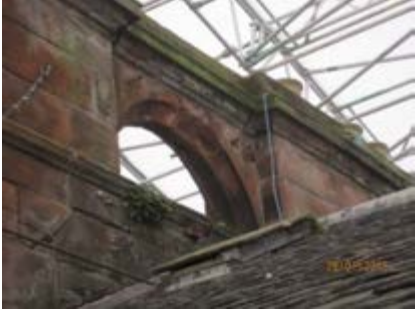
TBC
R4.17	IMG_0861	Spalled/damaged sandstone	Chimney stack	n/a	n/a	n/a	Delamination/erosion of sandstone above arch

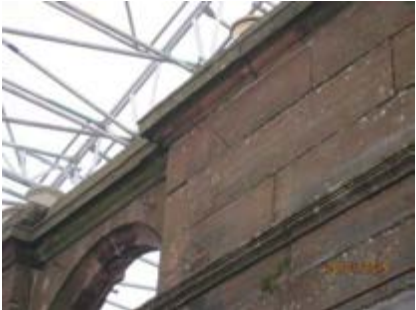
TBC
R4.18	IMG_0862	Cracking to sandstone	Chimney stack	Diagonal	2	400	Crack on sandstone block.

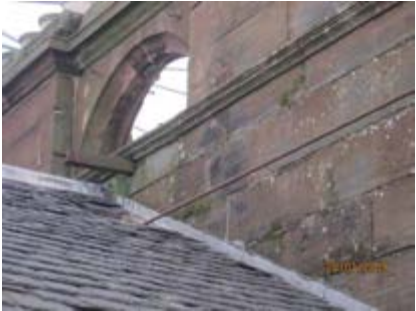
Defect ID	Photo Source	Defect Description	Defect Location	Crack Orientation	Crack Width (mm)	Crack Length (mm)	Comments	Photo	Severity Category
R4.19	IMG_0863	Cracking to sandstone	Chimney stack	Diagonal	2	800	Crack on 2 sandstone blocks (> shape).

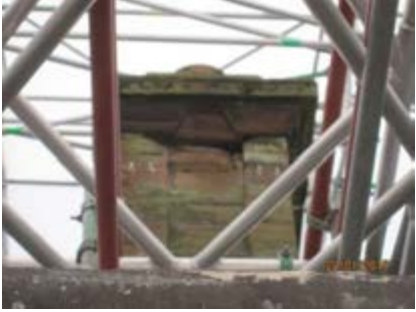
TBC
R4.20	IMG_0864	Spalled/damaged sandstone	Chimney stack	n/a	n/a	n/a	Delamination/erosion of sandstone at last block of wall with gap/loss of section observed

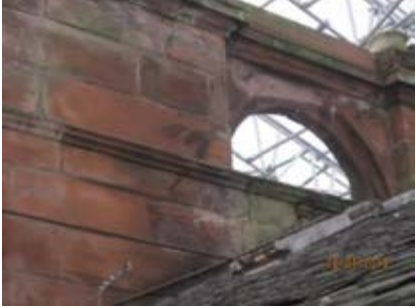
TBC
R4.21	IMG_0865	Cracking to sandstone	Chimney stack	Diagonal	2	400	Repaired cracks on sandstone blocks

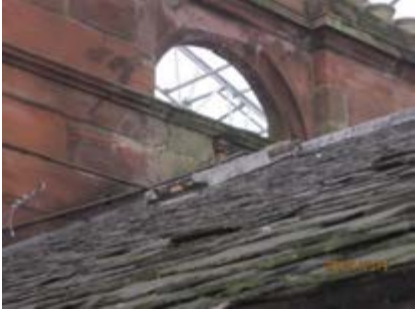
Defect ID	Photo Source	Defect Description	Defect Location	Crack Orientation	Crack Width (mm)	Crack Length (mm)	Comments	Photo	Severity Category
R4.22	IMG_0866	Spalled/damaged sandstone	Chimney stack	n/a	n/a	n/a	Delamination/erosion of/cracked/broken off sandstone above arch	 	TBC
R4.23	IMG_0867	Spalled/damaged sandstone	Pipe	n/a	n/a	n/a	Small area of delamination/erosion of/cracked/broken off sandstone next to pipe

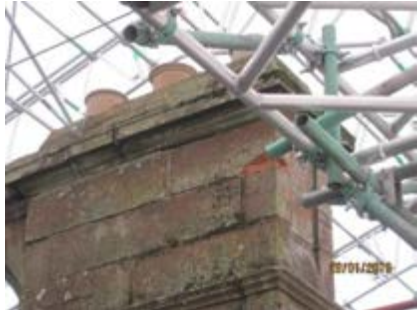
Defect ID	Photo Source	Defect Description	Defect Location	Crack Orientation	Crack Width (mm)	Crack Length (mm)	Comments	Photo	Severity Category
R4.25	IMG_0869	Spalled/damaged sandstone	Chimney stack	n/a	n/a	n/a	Cracked/broken off sandstone to chimney stack wall

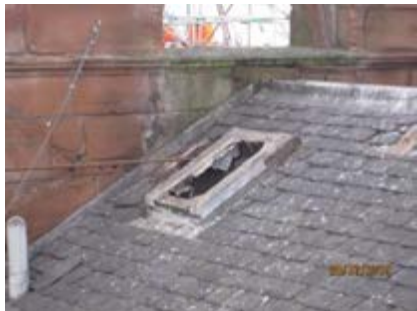
TBC
R4.26	IMG_0870, 0873	Other	Roof	n/a	n/a	n/a	Skylight window broken

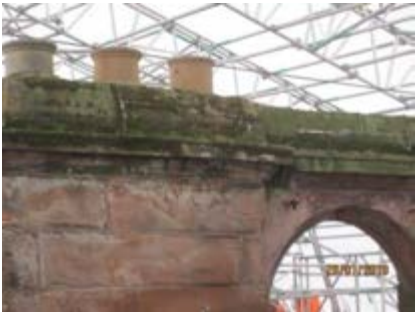
Defect ID	Photo Source	Defect Description	Defect Location	Crack Orientation	Crack Width (mm)	Crack Length (mm)	Comments	Photo	Severity Category
R4.28	IMG_0872	Spalled/damaged sandstone	Chimney stack	n/a	n/a	n/a	Delamination/erosion of/cracked/broken off sandstone on arch	 	TBC
R4.29	IMG_0874	Water staining efflorescence	Chimney stack	n/a	n/a	n/a	Water staining below chimney pots. General comment for all chimney stacks	 	TBC
R4.30	IMG_0875	Cracking to sandstone	Chimney stack	Diagonal	3mm	400mm	Diagonal crack on sandstone block

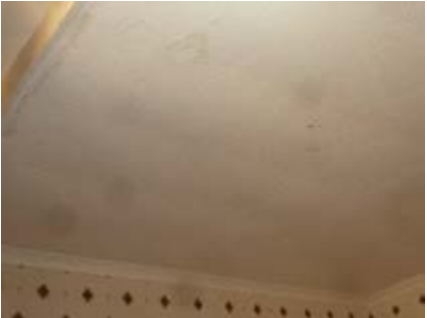
WE2.3	P1200 803-812	Evidence of vermin, Dampness/water ingress	Bedroom 208	n/a	n/a	n/a	Evidence of vermin (808) Dampness/water ingress (809-810, 811, 812)

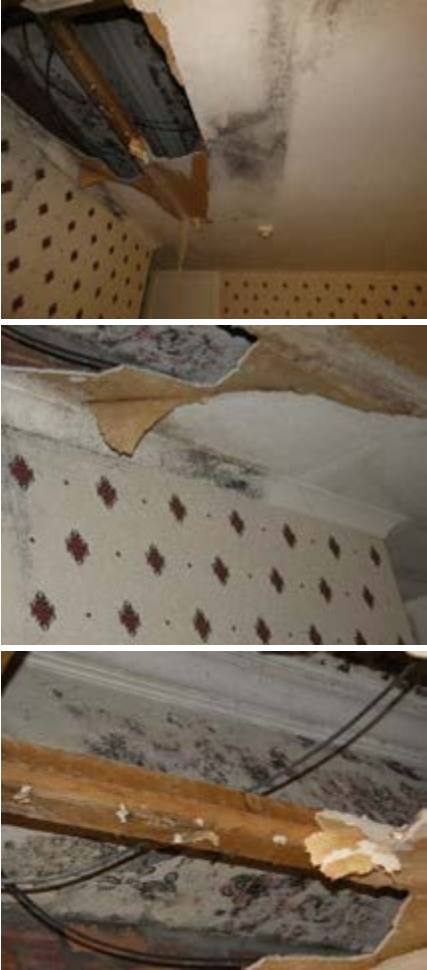
WE2.7	P1010 094-115	Collapsed ceiling plaster, Staining	Bedroom 214	n/a	n/a	n/a	Localised collapse of false ceiling at corner of room (109) Black staining to ceiling, possibly mould (107) Staining to cornice (112) Staining to wall above false ceiling (113) Staining to wall below false ceiling (110, 115)	 	TBC

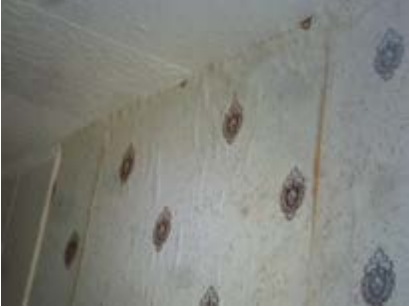
WE2.8	P1200 768-774	Dampness/water ingress	En suite (adj. Bedroom 216)	n/a	n/a	n/a	Dampness/water ingress (773, 774)

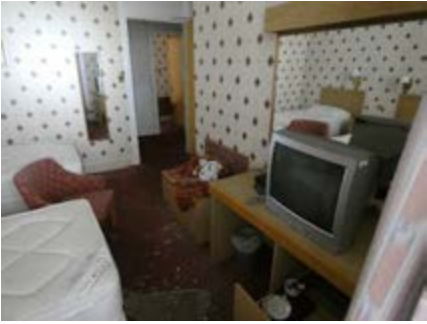
Defect ID	Photo Source	Defect Description	Defect Location	Crack Orientation	Crack Width (mm)	Crack Length (mm)	Comments	Photo	Severity Category
WE2.9	P1010 081-090	Other	Bedroom 216	n/a	n/a	n/a	No obvious defects observed

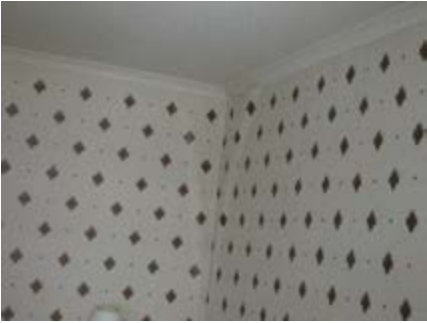
TBC
WE2.10	P1010 068-080	Other	Bedroom 218	n/a	n/a	n/a	Peeling wallpaper to wall (080)

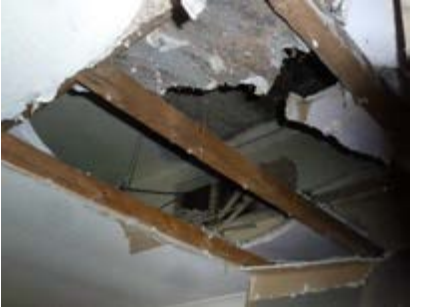
TBC
WE2.11	P1200 750-767	Collapsed ceiling plaster, Collapsed wall plaster, Dampness/water ingress, Plaster crack	Bedroom 220	n/a	n/a	n/a	Plaster collapse to suspended ceiling and main ceiling above, approx. 10% area (755-758) Plaster collapse to side wall. Approx. 0.5m2 (759-760) Dampness/water ingress (763) Collapsed ceiling plaster (764) Dampness/water ingress (765, 766) Plaster crack (767)
