# **Ayr Station Hotel Structural Condition Factual Report**

Interim Report

19 August 2019

**Document reference:** 399316ZZ-MMD-00-00-RP-S-002

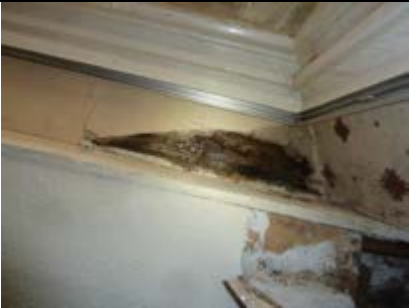
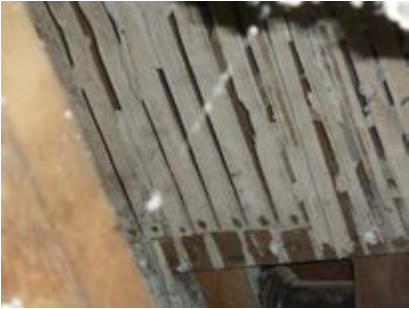
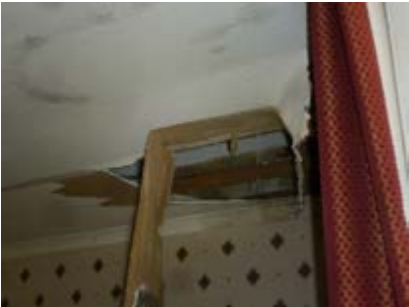
WE2.12	P1200 734-747	Collapsed ceiling plaster, Dampness/water ingress, Plaster crack	Bedroom 222	Horizontal	2	300	Plaster collapse to suspended ceiling (738-742) Dampness/water ingress (743) Plaster crack (744-745) Dampness/water ingress (746) Dampness/water ingress (747)

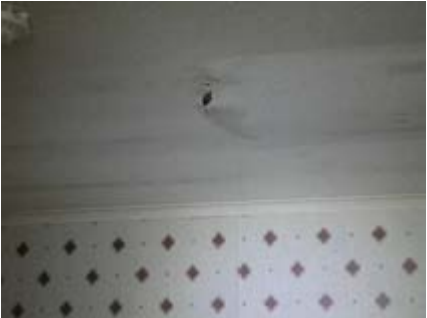
TBC
WN2.2	P1010 244-270	Dampness/water ingress, Staining, Other	Bedroom 202	n/a	n/a	n/a	Water ingress/visible water dripping from middle of ceiling onto bed (256) Ceiling bulging (270) Black staining to edges of ceiling, likely to be mould (267) Peeling and bubbling wallpaper (262) White staining to wall (264) Room generally very damp/wet, carpet appears to be saturated (260)

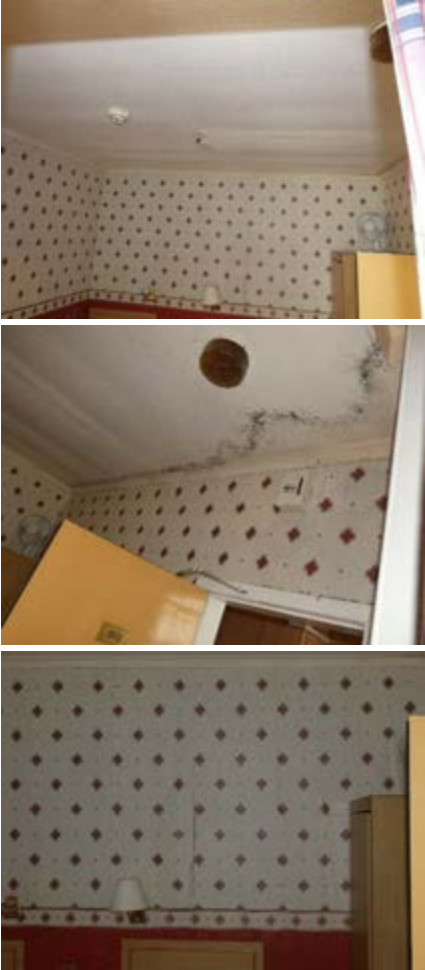
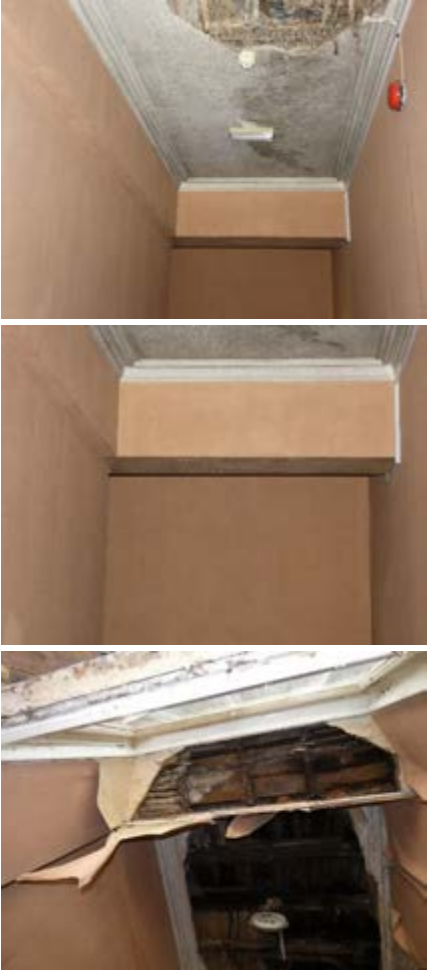
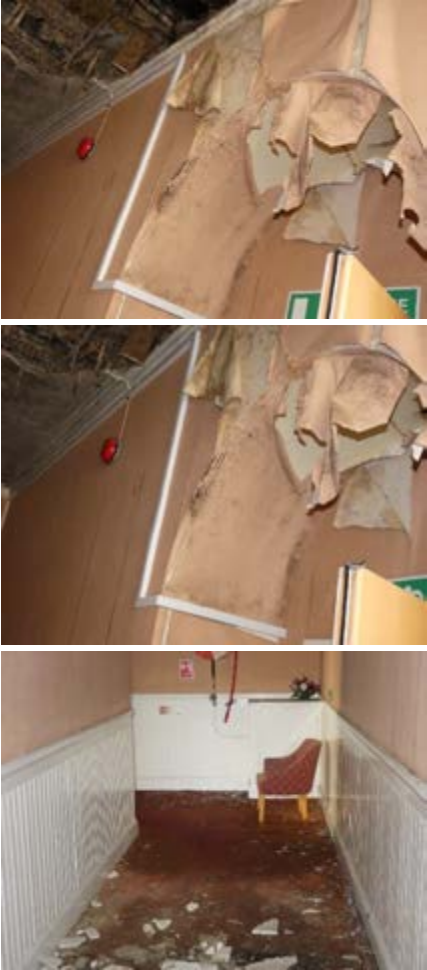
WN2.3	P1010 273-313	Collapsed ceiling plaster, Dampness/water ingress, Staining, Other	Hallway (adj. Bedroom 203)	n/a	n/a	n/a	Approx. 50% of the original ceiling collapsed (298) Patches of dampness on ceiling, possibly mould (282) Water ingress/dripping from soffit and areas of collapsed ceiling (285) Collapsed ceiling plaster adjacent to window (294) Extensive peeling of wallpaper and bulging noted above doorway (292) Evidence of black mould above doorway (304) Floor damp due to constant dripping from ceiling (286)	 	TBC

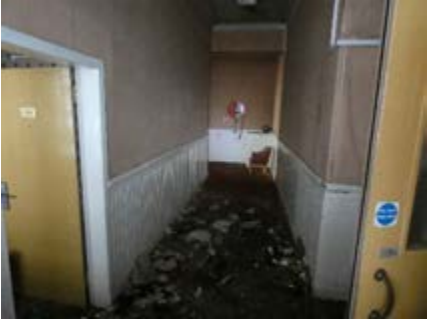
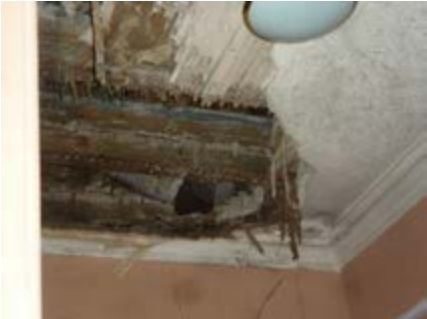
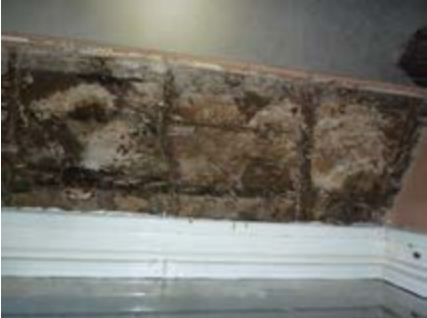
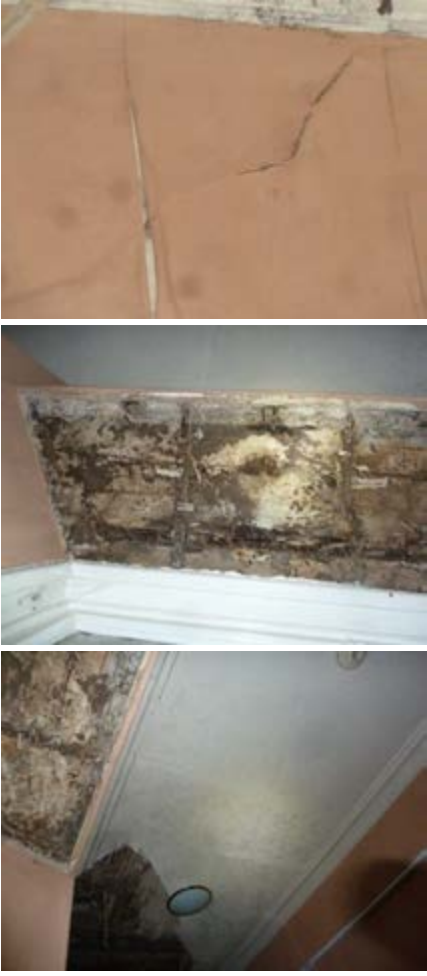
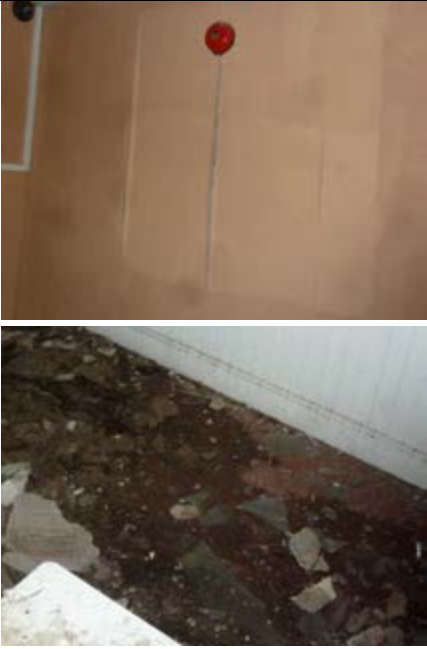
WN2.4	P1200 818-837	Collapsed ceiling plaster, Timber degradation, Plaster crack, Dampness/water ingress	Hallway (adj. Bedroom 203)	Diagonal	1	300	Plaster collapse to main ceiling above, approx. 2m2 area (825) Evidence of timber degradation of suspended floor joists above (826-828) Plaster crack (829) Water ingress, loss of plaster to ceiling directly above window (830-834) Dampness/water ingress (835) Dampness/water ingress (836) Dampness/water ingress (837)

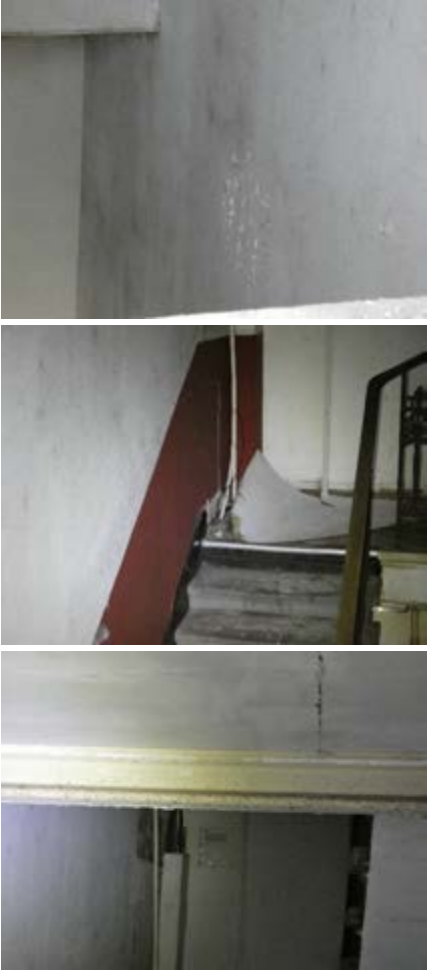
Defect ID	Photo Source	Defect Description	Defect Location	Crack Orientation	Crack Width (mm)	Crack Length (mm)	Comments	Photo	Severity Category
WS2.2	P1200 685-693	Plaster crack, Dampness/ water ingress	Bedroom 203	Horizontal	>1	10	Plaster crack (691) Dampness/water ingress (692, 693)

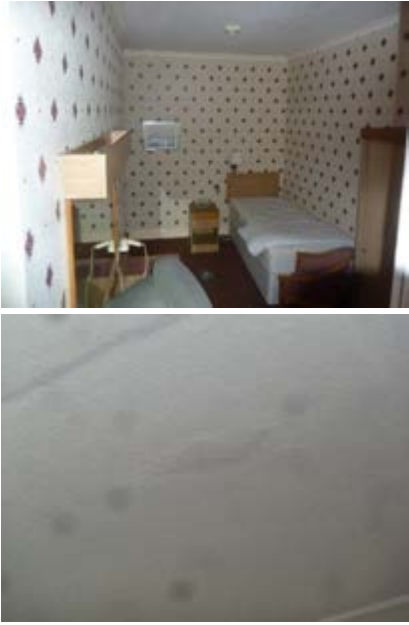
Defect ID	Photo Source	Defect Description	Defect Location	Crack Orientation	Crack Width (mm)	Crack Length (mm)	Comments	Photo	Severity Category
WW2.6	P1200708-713	Dampness/ water ingress, Evidence of vermin	Bedroom 217	n/a	n/a	n/a	Evidence of pigeon infestation (712) Evidence of damp staining to ceiling behind finishes (713)

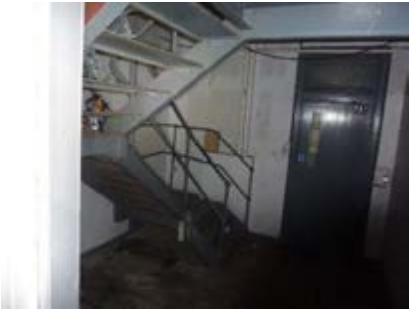
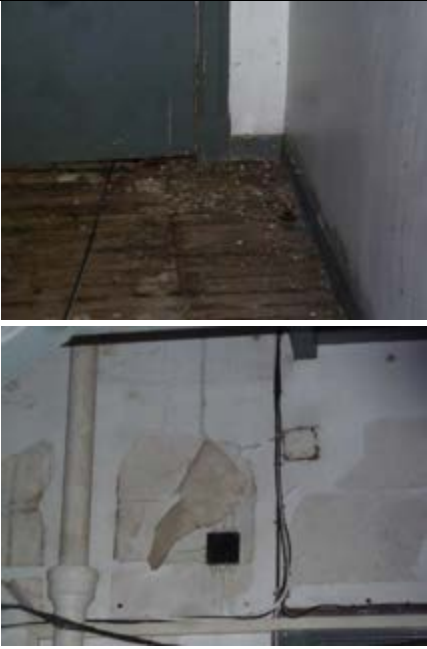
TBC
WW2.7	P1200 714-733	Dampness/ water ingress, Plaster crack, Metal corrosion, Evidence of vermin	Stair well (adj. Bedroom 217)	n/a	n/a	n/a	Dampness/water ingress (719) Dampness/water ingress (720, 721) Dampness/water ingress (722) Plaster crack (723) Plaster crack (724) Plaster crack (725, 726) Mild corrosion to stairwell support beam (727, 728) Dampness/water ingress (729) Evidence of vermin (730) Dampness/water ingress (731) Plaster crack (732)

Defect ID	Photo Source	Defect Description	Defect Location	Crack Orientation	Crack Width (mm)	Crack Length (mm)	Comments	Photo	Severity Category
							Peeling wallpaper. Possible evidence of dampness behind (733)

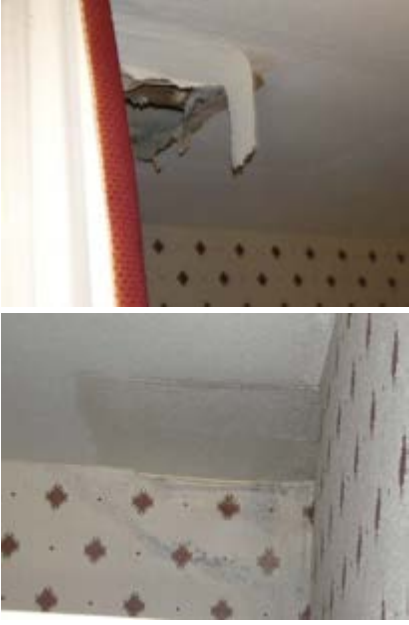
Defect ID	Photo Source	Defect Description	Defect Location	Crack Orientation	Crack Width (mm)	Crack Length (mm)	Comments	Photo	Severity Category
WE3.1	P1000556-568	Collapsed ceiling plaster, Staining, Other	Bedroom 324	n/a	n/a	n/a	Partial collapse of ceiling plaster (561) Stain noted on wall and ceiling (564, 565) Debris from collapsed ceiling on floor (567)

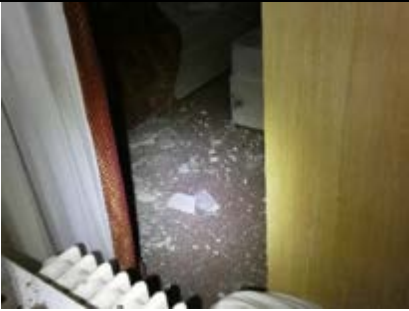
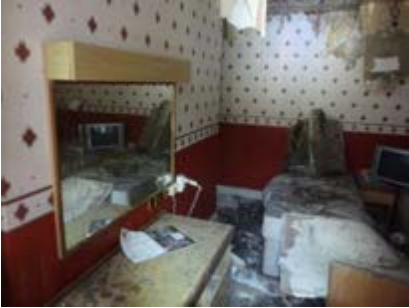
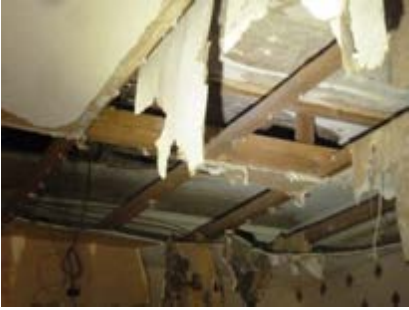
WE3.2	P1200609-621	Collapsed ceiling plaster, Dampness/water ingress, Evidence of vermin	Bedroom 322	n/a	n/a	n/a	Plaster collapse to suspended ceiling and main ceiling above (615) Dampness/water ingress (610, 620) Evidence of vermin (621)

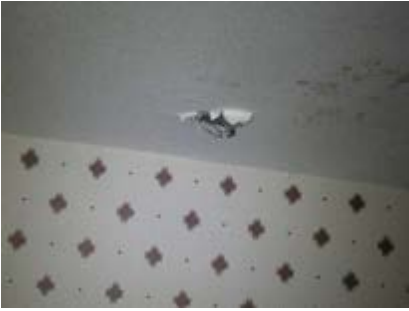
WE3.3	P1000569-578	Collapsed ceiling plaster, Evidence of vermin, Dampness/water ingress, Staining	Bedroom 320	n/a	n/a	n/a	Localised collapse of ceiling plaster (573) Staining to ceiling (574) Patch noted on ceiling (572) Staining on wall, and possible dampness (575) Bubbling behind wallpaper indicates possible dampness (575) Evidence of vermin (576)

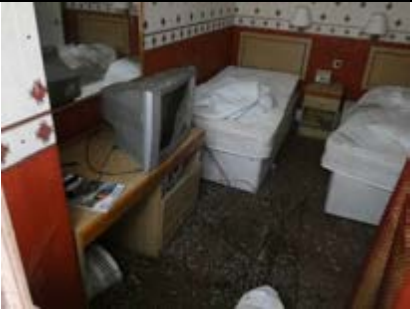
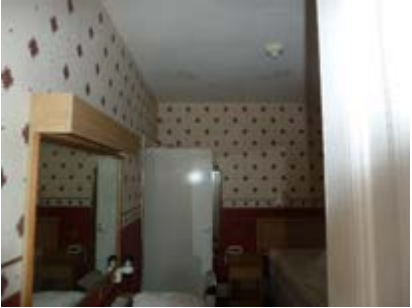
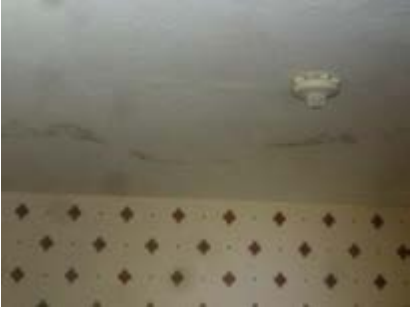
WE3.4	P1200 622-627	Dampness/water ingress, Evidence of vermin	Bedroom 318	n/a	n/a	n/a	Dampness/water ingress (625, 626) Evidence of vermin (627)

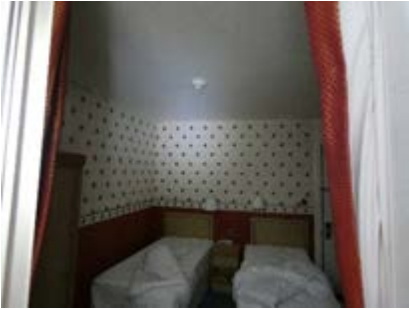
Defect ID	Photo Source	Defect Description	Defect Location	Crack Orientation	Crack Width (mm)	Crack Length (mm)	Comments	Photo	Severity Category
WE3.5	P1000 579-586	Other	Bedroom 316	n/a	n/a	n/a	No obvious defects observed Possible ceiling plaster joint lines noted

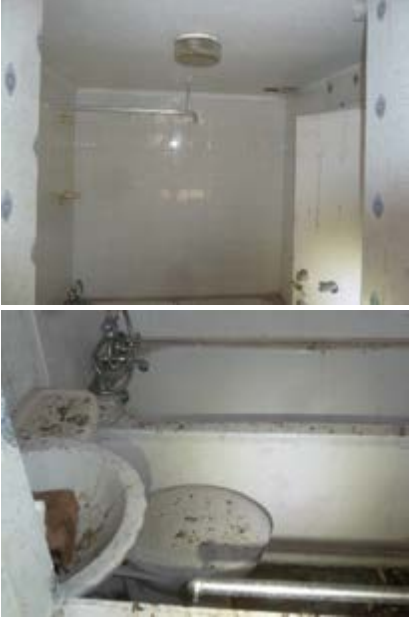
TBC
WE3.6	P1200 628-630	Evidence of vermin	En suite (adj. Bedroom 314)	n/a	n/a	n/a	Evidence of vermin (630)

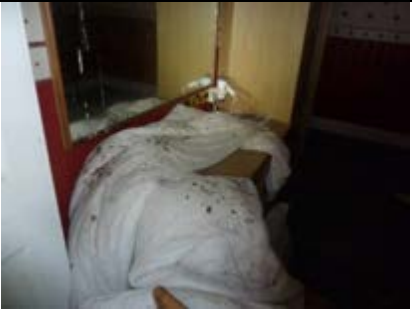
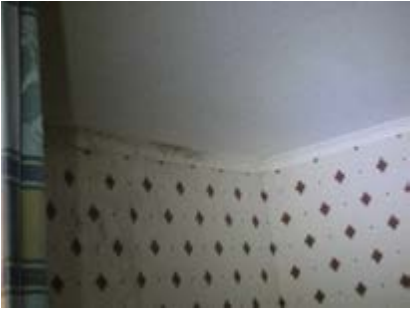
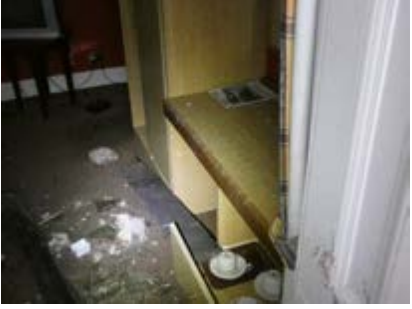
WE3.11	P1000 611-623	Collapsed ceiling plaster, Evidence of vermin, Staining	Bedroom 306	Horizontal	1	500	Staining at cornices (614) Evidence of vermin (615, 616) Minor ceiling crack (620)

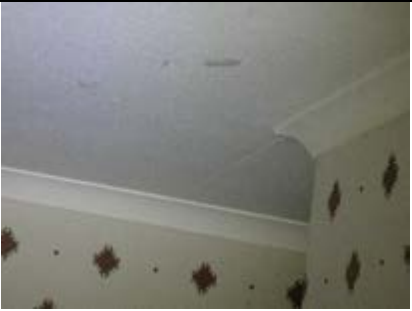
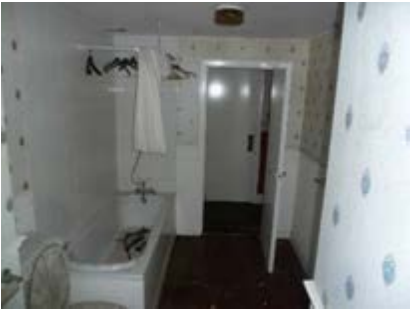
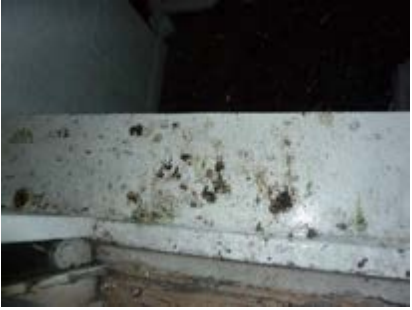
WE3.12	P1200 649-653	Dampness/water ingress, Evidence of vermin	En suite (adj. Bedroom 304)	n/a	n/a	n/a	Dampness/water ingress (651, 652) Evidence of vermin (653)

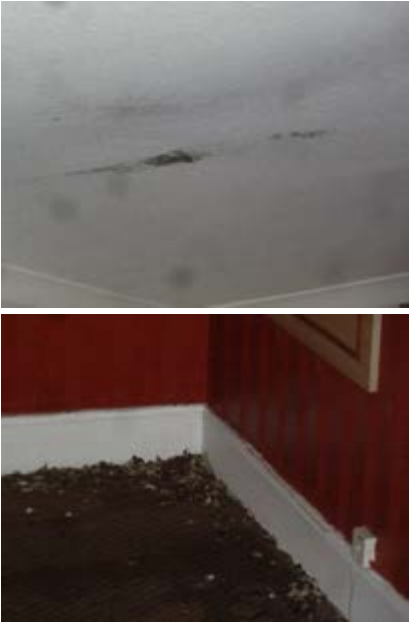
Defect ID	Photo Source	Defect Description	Defect Location	Crack Orientation	Crack Width (mm)	Crack Length (mm)	Comments	Photo	Severity Category
WE3.13	P1200 654-659	Dampness/water ingress, Evidence of vermin	Bedroom 304	n/a	n/a	n/a	Dampness/water ingress (659) Evidence of vermin (658)

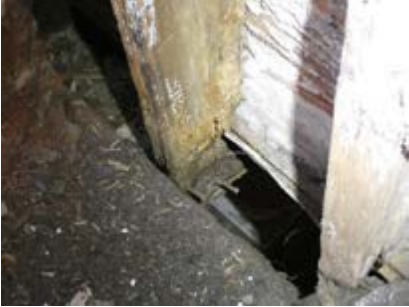
TBC
WE3.14	P1000 674-688	Deteriorating/rotting timber, Dampness/water ingress, Other	Exposed section of mansard roof (External inspection)	n/a	n/a	n/a	Vertical roof posts are side fixed to horizontal joists below, but post ends have now rotted away and are no longer connected (674-680). Possible onset of rot/decay Significant deterioration of horizontal timber roof beam (681-688)

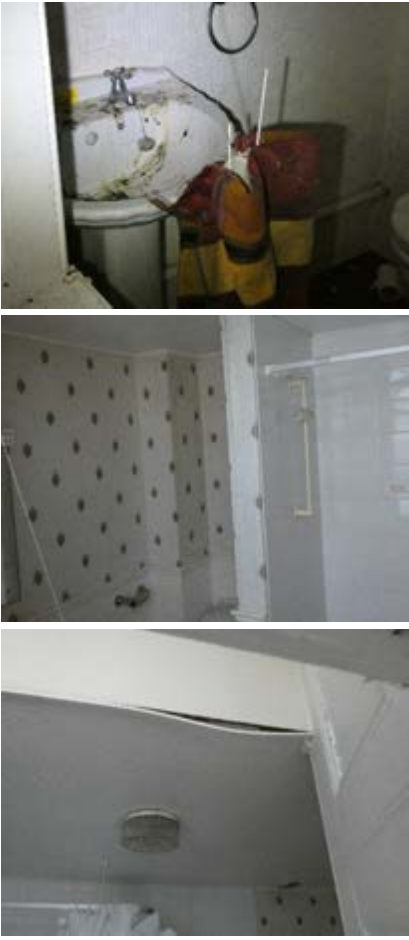
Defect ID	Photo Source	Defect Description	Defect Location	Crack Orientation	Crack Width (mm)	Crack Length (mm)	Comments	Photo	Severity Category
WN3.1	P1000 624-638	Evidence of vermin, Dampness/water ingress, Staining, Collapsed ceiling plaster	Bathroom (adj. Bedroom 302)	n/a	n/a	n/a	Evidence of vermin (628, 629) Water staining and evidence of water ingress (626) Ceiling sagging (634)

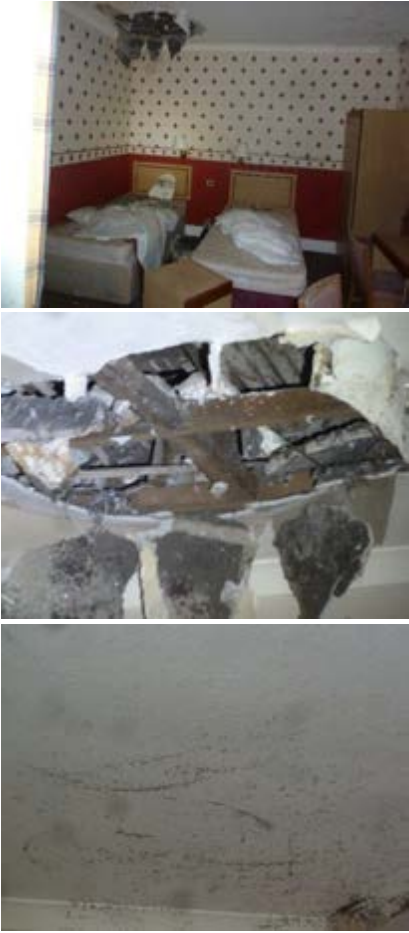
Defect ID	Photo Source	Defect Description	Defect Location	Crack Orientation	Crack Width (mm)	Crack Length (mm)	Comments	Photo	Severity Category
WN3.2	P1200 660-670	Collapsed ceiling plaster, Dampness/water ingress, Evidence of vermin	Bedroom 302	n/a	n/a	n/a	Plaster collapse to ceiling (664) Dampness/water ingress (668, 670) Evidence of vermin (669)

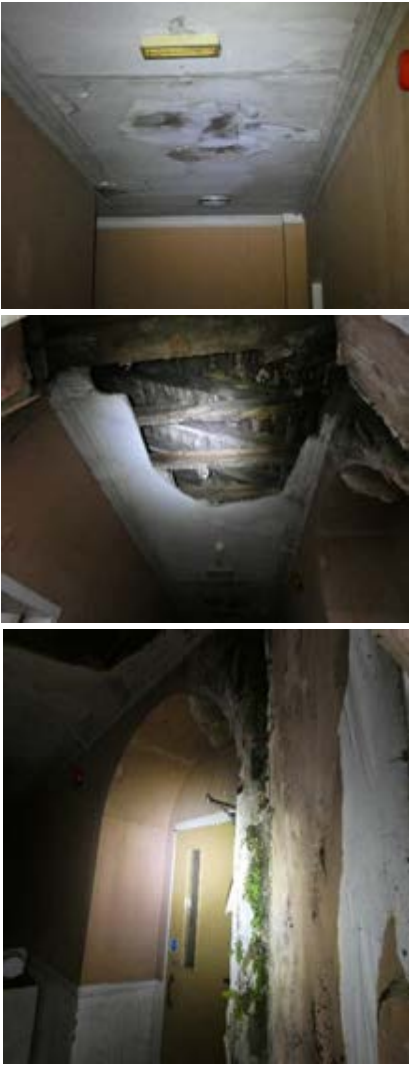
Defect ID	Photo Source	Defect Description	Defect Location	Crack Orientation	Crack Width (mm)	Crack Length (mm)	Comments	Photo	Severity Category
WN3.3	P1000 639-658	Collapsed ceiling plaster, Collapsed wall plaster, Deteriorating/rotting timber, Evidence of vermin, Dampness/water ingress, Staining, Other	Hallway (near Bedroom 302)	n/a	n/a	n/a	Black mould stain and evidence of water ingress to ceiling (642) Significant failure of ceiling, exposed timber joists (645) Dampness/vegetation growth to wall (653) Collapsed section of roof timbers (650) LHS water ingress (647) Evidence of vermin (658)

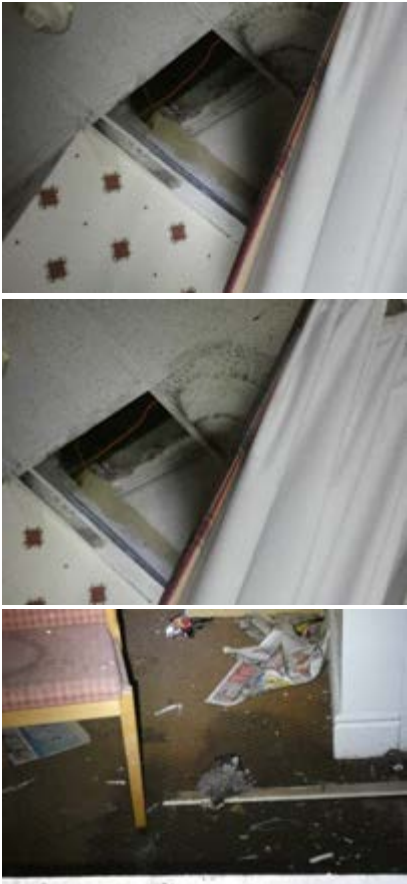
Defect ID	Photo Source	Defect Description	Defect Location	Crack Orientation	Crack Width (mm)	Crack Length (mm)	Comments	Photo	Severity Category
WS3.1	P1000 760-773	Collapsed ceiling plaster, Evidence of vermin, Staining	Bedroom 303	n/a	n/a	n/a	Missing false ceiling tiles (771, 773) Staining to false ceiling tile (770) Evidence of vermin (764)

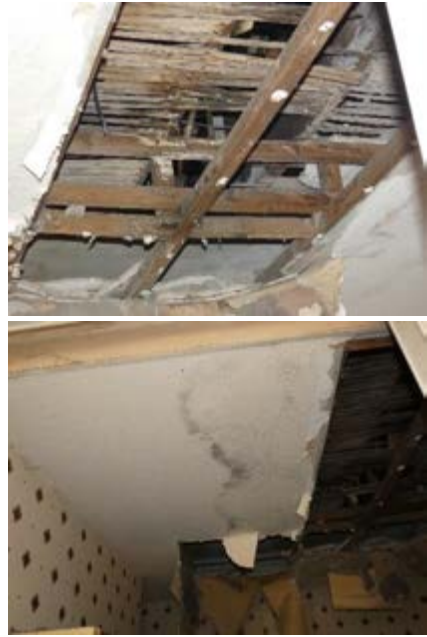
Defect ID	Photo Source	Defect Description	Defect Location	Crack Orientation	Crack Width (mm)	Crack Length (mm)	Comments	Photo	Severity Category
WW3.1	P1000 941-973	Collapsed ceiling plaster, Evidence of vermin, Staining	Bedroom 321	n/a	n/a	n/a	Significant collapse of false ceiling and original ceiling above it, roof void above visible (949-952) Staining on ceiling (955) Staining on wall (953) Evidence of vermin (947)

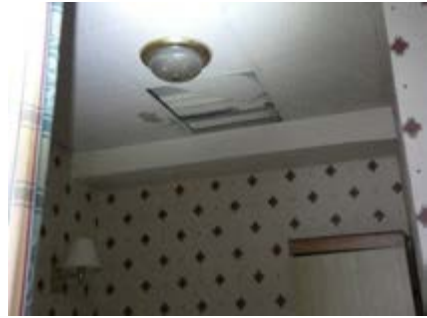
WW3.2	P1000 732-759	Collapsed ceiling plaster, Evidence of vermin, Staining	Bedroom 319	n/a	n/a	n/a	Significant collapse of ceiling (761) 2x Staining on ceiling (744, 746) 2x Staining on wall (748, 751) Evidence of vermin (754)

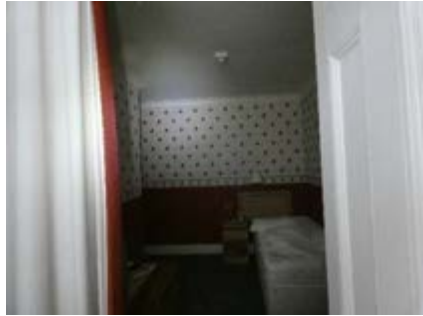
TBC
WW3.5	P1000 868-881	Staining	Bedroom 315	n/a	n/a	n/a	Staining on ceiling (876) Staining on wall, possible water ingress (878)

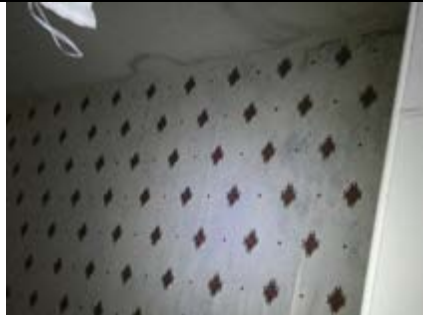
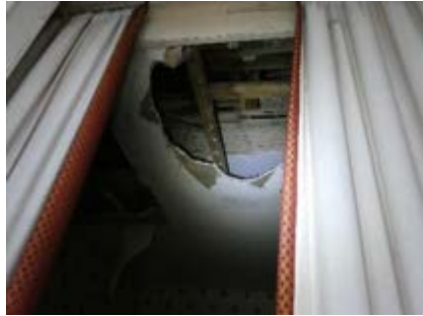
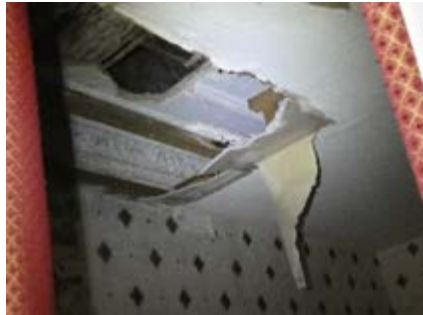
Defect ID	Photo Source	Defect Description	Defect Location	Crack Orientation	Crack Width (mm)	Crack Length (mm)	Comments	Photo	Severity Category
WW3.6	P1000 846-867	Collapsed ceiling plaster	Bedroom 311	n/a	n/a	n/a	Significant collapse of false ceiling and original ceiling above it (862, 867)

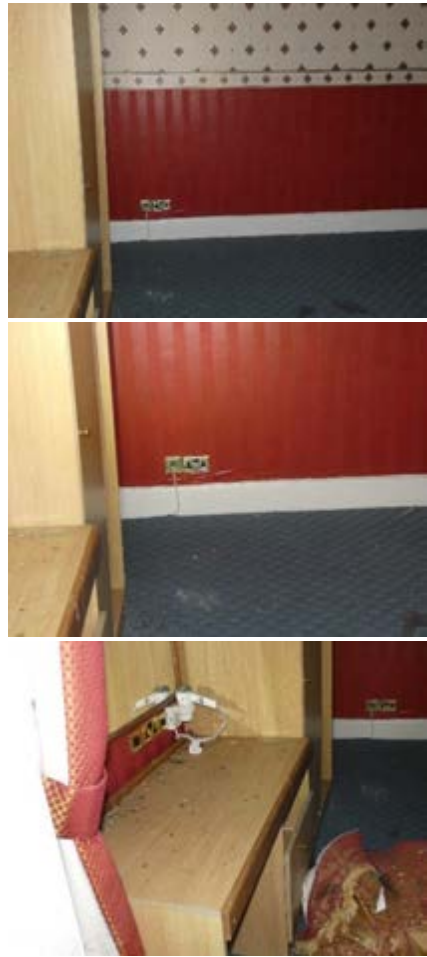
Defect ID	Photo Source	Defect Description	Defect Location	Crack Orientation	Crack Width (mm)	Crack Length (mm)	Comments	Photo	Severity Category
WW3.7	P1000 831-845	Collapsed wall plaster	Bedroom 309	n/a	n/a	n/a	Small area of bubbling wallpaper, mad indicate dampness (839, 840) Evidence of vermin (843)

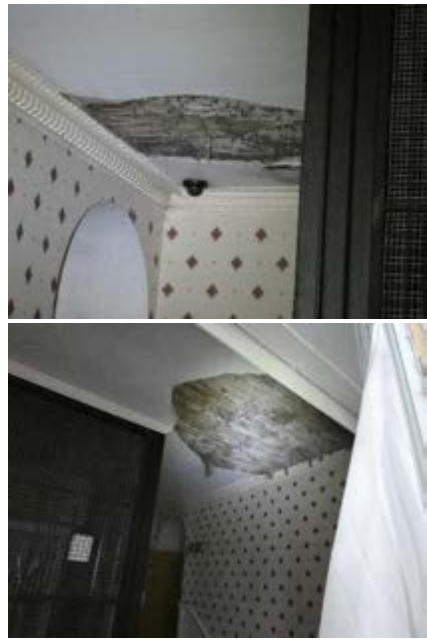
TBC
WW3.9	P1000 787-819	Collapsed ceiling plaster, Collapsed wall plaster, Staining, Bulging/collapsed	Stair well/lift shaft	n/a	n/a	n/a	Partial collapse of ceiling plaster at 3x locations (791, 794, 797) Staining on ceiling (800) Staining on floor (804) Staining on wall (802, 806)

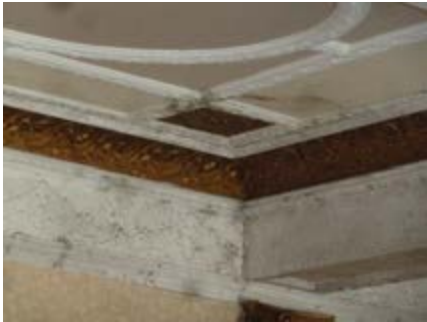
Defect ID	Photo Source	Defect Description	Defect Location	Crack Orientation	Crack Width (mm)	Crack Length (mm)	Comments	Photo	Severity Category
WW1.2	P1210076-079	Dampness/water ingress	Arran room	n/a	n/a	n/a	Damp staining to cornicing

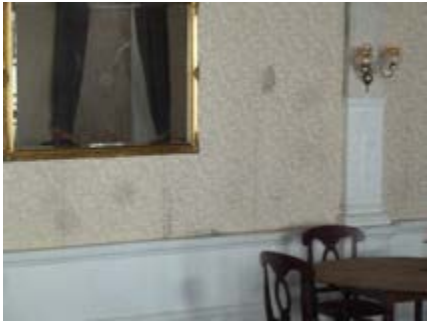
TBC
WW1.2	P1210080	Dampness/water ingress	Arran room	n/a	n/a	n/a	Damp staining to wall

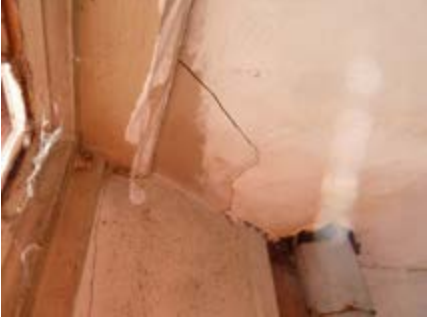
TBC
WS1.1	P1210086	Plaster crack	Stairwell	n/a	n/a	n/a	Crack to ceiling plaster

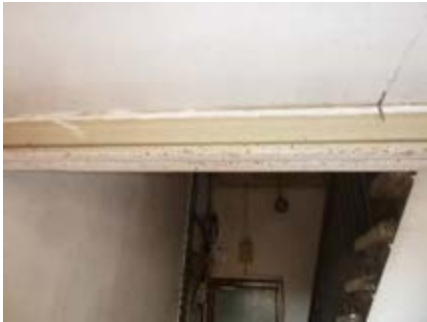
Defect ID	Photo Source	Defect Description	Defect Location	Crack Orientation	Crack Width (mm)	Crack Length (mm)	Comments	Photo	Severity Category
WS1.1	P1210087	Metal corrosion	Stairwell	n/a	n/a	n/a	Mild corrosion to metal beams

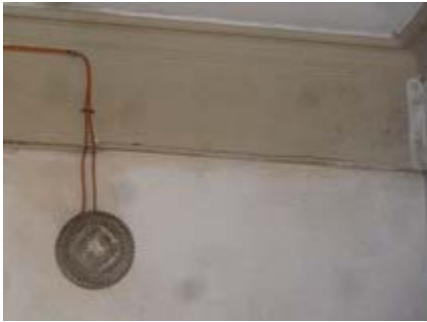
TBC
WS1.1	P1210088	Plaster crack	Stairwell	Vertical	2	1000	-

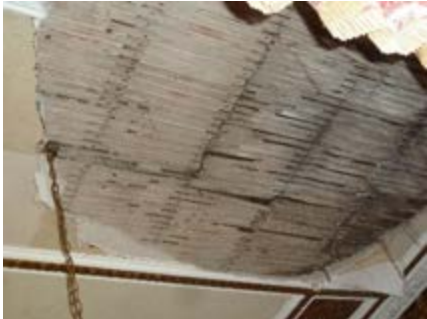
n/a
WE1.1	P1200 910-912	Collapsed ceiling plaster	Conference/ dining room	n/a	n/a	n/a	Collapsed ceiling plaster. Approx. 2x3m

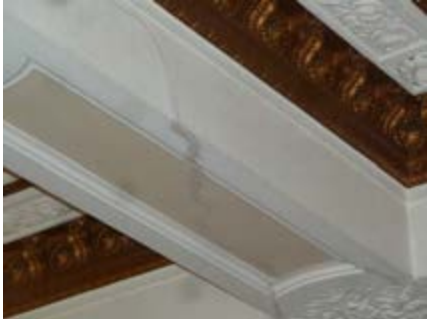
Defect ID	Photo Source	Defect Description	Defect Location	Crack Orientation	Crack Width (mm)	Crack Length (mm)	Comments	Photo	Severity Category
WE1.1	P1200918	Plaster crack	Conference/ dining room	Diagonal	2	800	Diagonal crack to ceiling downstand

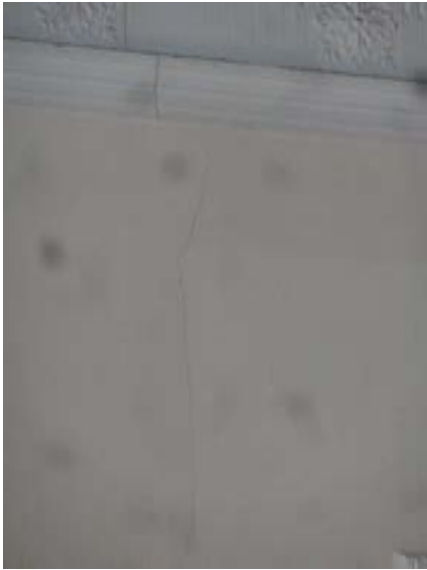
TBC
WE1.1	P1200919	Plaster crack	Conference/ dining room	Vertical	1	1000

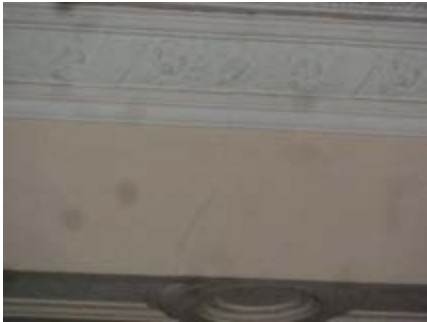
Defect ID	Photo Source	Defect Description	Defect Location	Crack Orientation	Crack Width (mm)	Crack Length (mm)	Comments	Photo	Severity Category
WE1.2	P1200995	Plaster crack	Lounge/ bar area	Vertical	1	400	Plaster crack to ceiling downstand

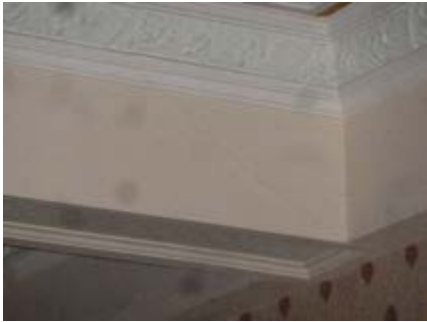
TBC
WE1.2	P1200996	Plaster crack	Lounge/ bar area	Diagonal	1	500	Plaster crack to ceiling downstand

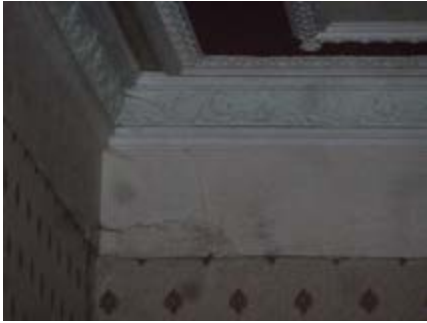
TBC
WE1.2	P1200997	Plaster crack	Lounge/ bar area	Vertical	1	300	Plaster crack to wall

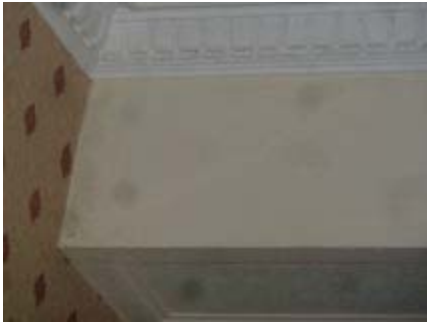
Defect ID	Photo Source	Defect Description	Defect Location	Crack Orientation	Crack Width (mm)	Crack Length (mm)	Comments	Photo	Severity Category
WE1.2	P1200998	Plaster crack	Lounge/ bar area	Diagonal	1	500	Diagonal crack to ceiling downstand

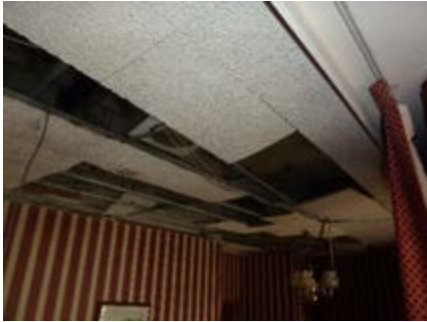
n/a
WE1.3	P1210041-042	Ceiling collapse	Corridor	n/a	n/a	n/a	Large number of collapsed false ceiling tiles

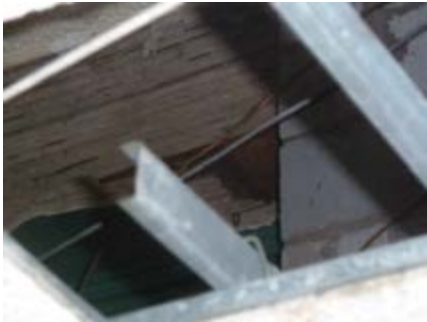
Defect ID	Photo Source	Defect Description	Defect Location	Crack Orientation	Crack Width (mm)	Crack Length (mm)	Comments	Photo	Severity Category
WE1.3	P1210 043-044	Collapsed ceiling plaster	Corridor	n/a	n/a	n/a	Collapsed plaster from ceiling (above false ceiling)

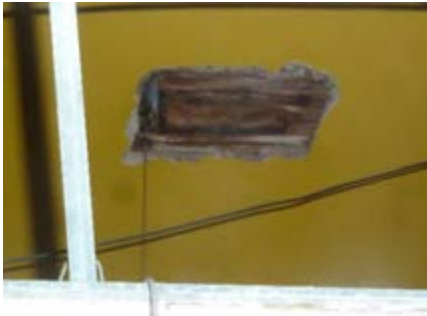
TBC
WE1.3	P1210 045-046	Collapsed ceiling plaster	Corridor	n/a	n/a	n/a	Collapsed plaster from ceiling (above false ceiling)

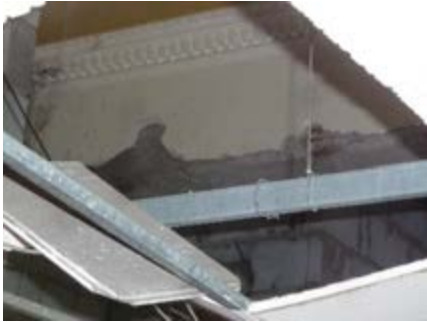
TBC
WE1.3	P1210 047-050	Collapsed ceiling plaster	Corridor	n/a	n/a	n/a	Collapsed ceiling plaster to ceiling downstand

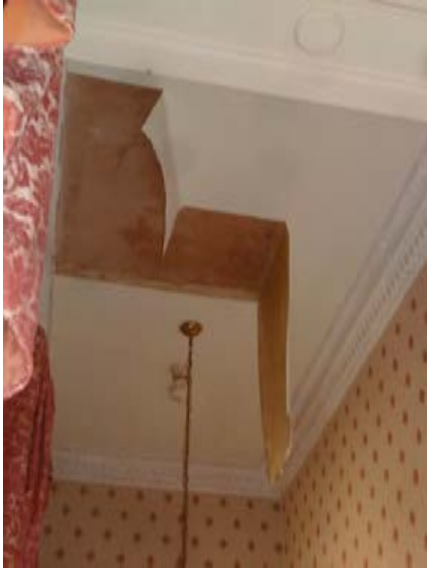
Defect ID	Photo Source	Defect Description	Defect Location	Crack Orientation	Crack Width (mm)	Crack Length (mm)	Comments	Photo	Severity Category
WE1.4	P1200928	Dampness/water ingress	Corridor	n/a	n/a	n/a	Peeling wallpaper to ceiling. Possible indication of damp

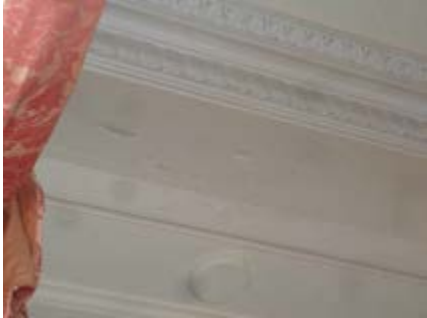
TBC
WE1.4	P1200929-930	Plaster crack	Corridor	Horizontal	1	1000	Cracking to window downstand

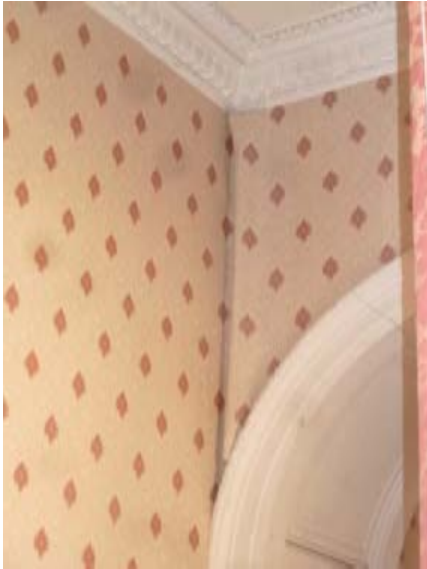
Defect ID	Photo Source	Defect Description	Defect Location	Crack Orientation	Crack Width (mm)	Crack Length (mm)	Comments	Photo	Severity Category
WE1.4	P1200934	Dampness/water ingress	Corridor	n/a	n/a	n/a	Peeling wallpaper to arch. Possible indication of damp

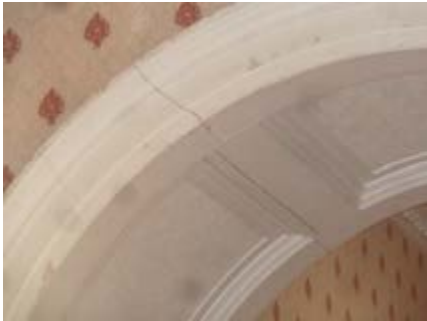
TBC
WE1.4	P1200935-937	Plaster crack	Corridor	Varies	1	200-1000	Cracks to arch

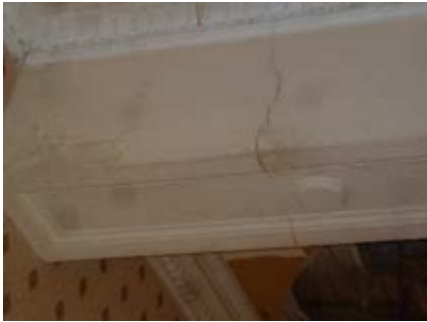
TBC
WE1.5	P1200970-971	Plaster crack	Corridor	Vertical	1	200-300	Various cracks to downstand beam

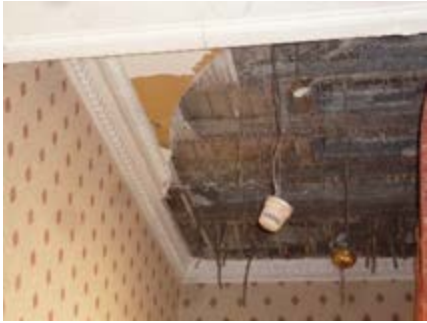
TBC
WE1.5	P1200972-974	Collapsed ceiling plaster	Corridor	n/a	n/a	n/a	Large section of collapsed ceiling plaster 3x2m. Timber joists above exposed

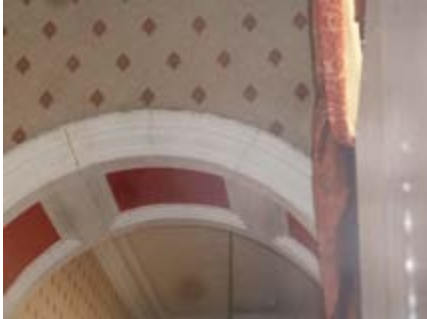
Defect ID	Photo Source	Defect Description	Defect Location	Crack Orientation	Crack Width (mm)	Crack Length (mm)	Comments	Photo	Severity Category
WE1.5	P1200975	Plaster crack	Corridor		2	300	Cracks to plaster around collapsed ceiling

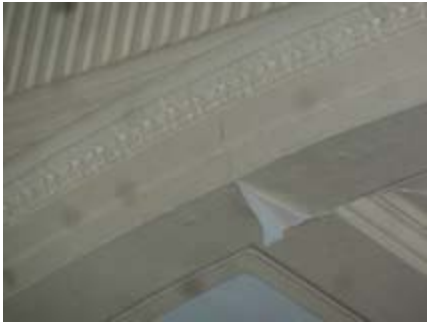
Defect ID	Photo Source	Defect Description	Defect Location	Crack Orientation	Crack Width (mm)	Crack Length (mm)	Comments	Photo	Severity Category
WE1.7	P1210031	Plaster crack	Stairwell		1	100	Crack to feature arch

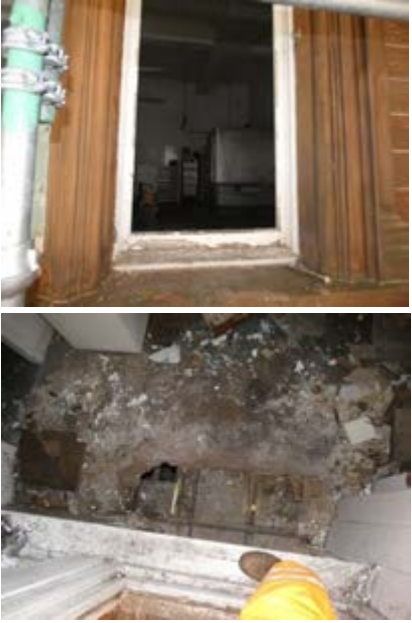
Defect ID	Photo Source	Defect Description	Defect Location	Crack Orientation	Crack Width (mm)	Crack Length (mm)	Comments	Photo	Severity Category
WW1.1	P1020 250-262	Other	Dry goods store	n/a	n/a	n/a	Joist timbers in satisfactory condition

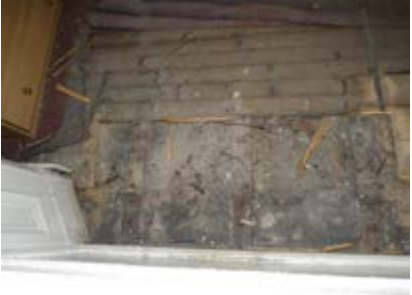
n/a
WW2.4	P1020 231-236	Evidence of water ingress	Bedroom 211	n/a	n/a	n/a	Joists ends connection to wall. Evidence of water ingress. Minimal section loss noted

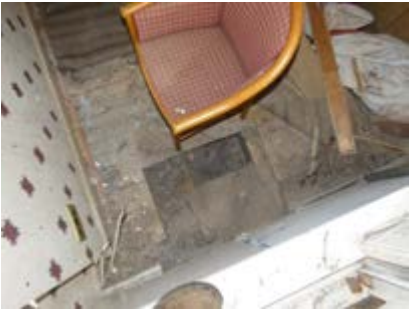
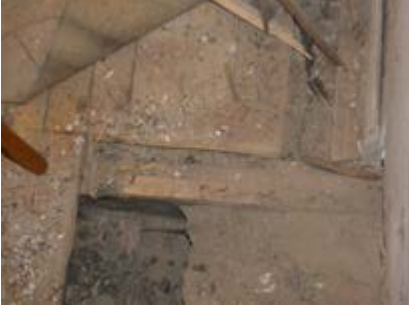
WW2.6	P1020 214-222	Other	Bedroom 217	n/a	n/a	n/a	Joist timbers in satisfactory condition

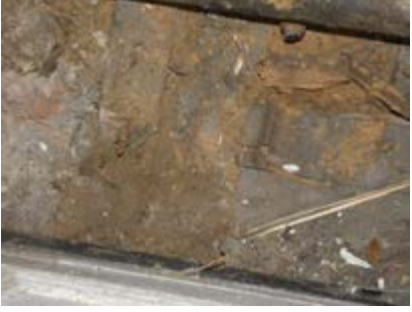
n/a
WW3.2	P1010 841	Degraded timber/loss of section	Bedroom 319	n/a	n/a	n/a	Evidence of water ingress and section loss to timber at connection to wall. Approx. 300mm length and up to 80mm section loss from top of section. Joist notched to allow pipe run through joist.

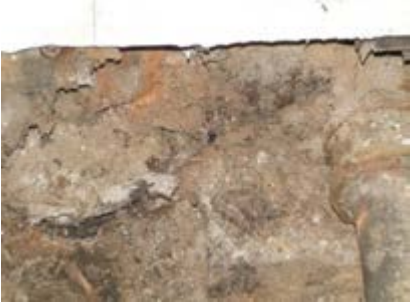
TBC
WW3.2	P1010 840	Other	Bedroom 319	n/a	n/a	n/a	Evidence of sandstone crumbling behind timber facing panel at window

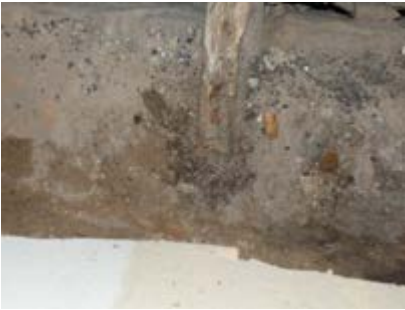
n/a
WW3.7	P1010 827	Degraded timber/loss of section	Bedroom 309	n/a	n/a	n/a	Evidence of water ingress and section loss to timber at connection to wall. Approx. 300mm length and up to 50mm section loss from top of section. Joist notched to allow pipe run through joist.

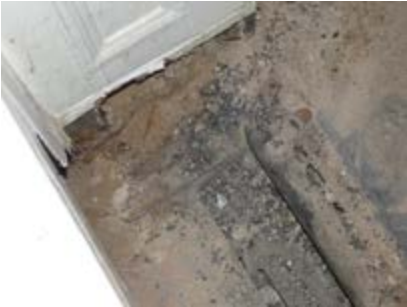
Defect ID	Photo Source	Defect Description	Defect Location	Crack Orientation	Crack Width (mm)	Crack Length (mm)	Comments	Photo	Severity Category
WW3.7	P1010 823	Other	Bedroom 309	n/a	n/a	n/a	Evidence of sandstone crumbling behind timber facing panel at window

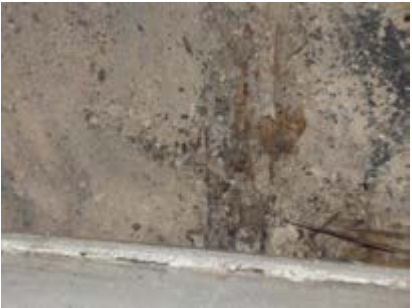
Defect ID	Photo Source	Defect Description	Defect Location	Crack Orientation	Crack Width (mm)	Crack Length (mm)	Comments	Photo	Severity Category
WW3.10	P1010 817	Degraded timber/loss of section	Bedroom 305	n/a	n/a	n/a	Section loss to timber at connection point with wall. Approx. 300mm length and up to 50mm section loss from top of section

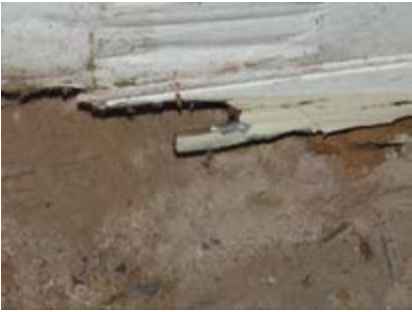
TBC
WW3.10	P1010 818	Other	Bedroom 305	n/a	n/a	n/a	Evidence of sandstone crumbling behind timber facing panel at window

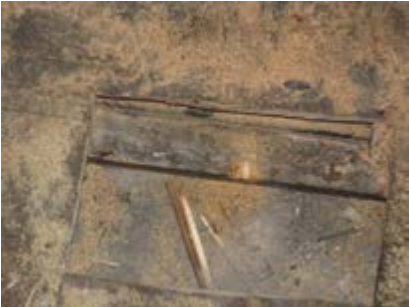
Defect ID	Photo Source	Defect Description	Defect Location	Crack Orientation	Crack Width (mm)	Crack Length (mm)	Comments	Photo	Severity Category
WE1.1	P1020 676	Other	Conference room	n/a	n/a	n/a	Timbers generally in good condition. Joists run North-South (parallel with wall) some signs of water ingress to joist ends. Minimal section loss. Timbers generally in good condition

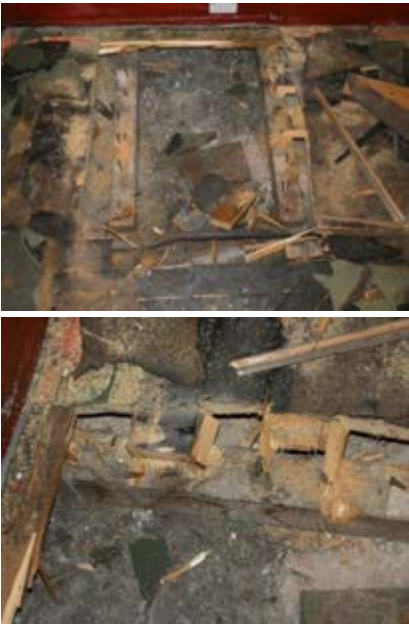
TBC
WE1.2	P1020 699-703	Other	Lounge / Bar area	n/a	n/a	n/a	General room photos. Timbers generally in good condition. Timbers notched to approx. half depth of joist

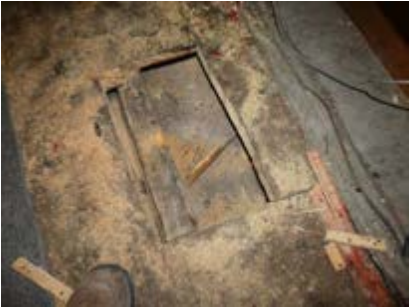
Defect ID	Photo Source	Defect Description	Defect Location	Crack Orientation	Crack Width (mm)	Crack Length (mm)	Comments	Photo	Severity Category
WE1.3	P1020 681	Other	Corridor	n/a	n/a	n/a	General room photos. Timbers generally in good condition. Joists running north-south supported on intermediate blockwork wall. No section loss

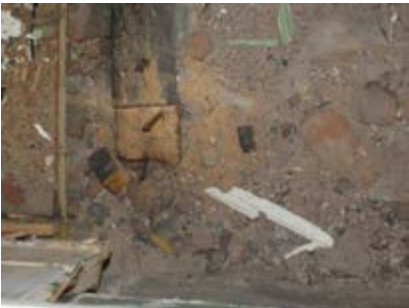
TBC
WE2.1	P1020 647-653	Other	Bedroom 204	n/a	n/a	n/a	general room photos. Timbers in good condition. Notched at ends. No signs of degradation

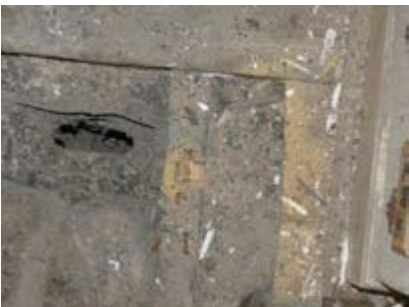
TBC
WE2.5	P1020 654-662	Other	Bedroom 210	n/a	n/a	n/a	General room photos. Timbers in good condition. Evidence of water ingress at connection to wall. Minimal section loss to timber.

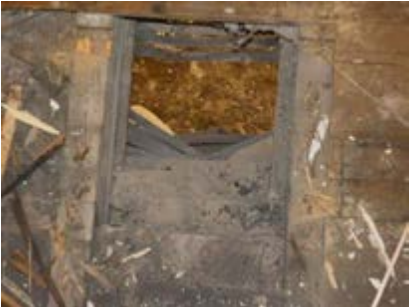
Defect ID	Photo Source	Defect Description	Defect Location	Crack Orientation	Crack Width (mm)	Crack Length (mm)	Comments	Photo	Severity Category
WE2.9	P1020 663-674	Other	Bedroom 216	n/a	n/a	n/a	General room photos. Timbers generally in good condition. Signs of water ingress at connection to wall. Minimal section loss to timber

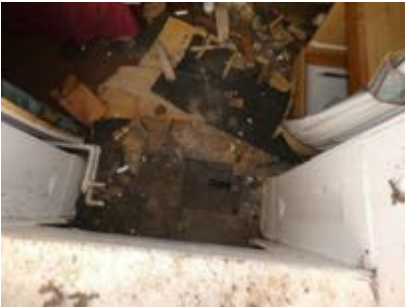
Defect ID	Photo Source	Defect Description	Defect Location	Crack Orientation	Crack Width (mm)	Crack Length (mm)	Comments	Photo	Severity Category
WE3.11	P1010808-8011	Other	Bedroom 306	n/a	n/a	n/a	General photos

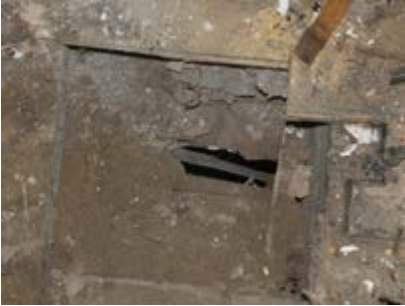
TBC
WE3.11	P10108010	Other	Bedroom 306	n/a	n/a	n/a	Mild degradation to joists at wall. Minor section loss. Timbers generally in good condition.

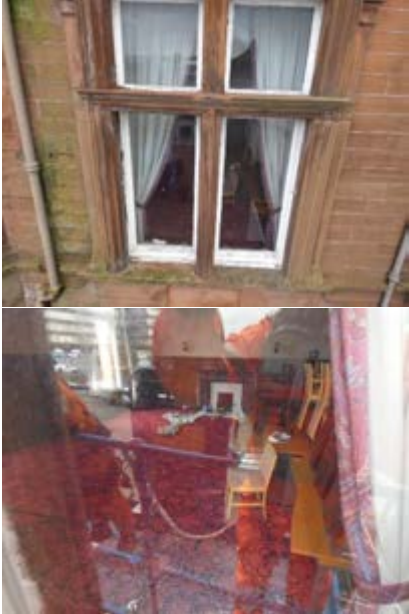
Defect ID	Photo Source	Defect Description	Defect Location	Crack Orientation	Crack Width (mm)	Crack Length (mm)	Comments	Photo	Severity Category
CP1	P1020290-291	n/a	Carrick Room adj. Bedroom 103	n/a	n/a	n/a	No defects noted

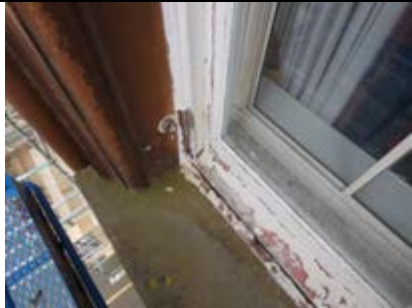
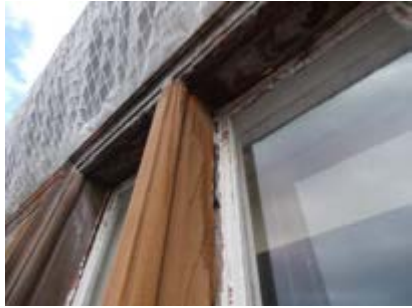
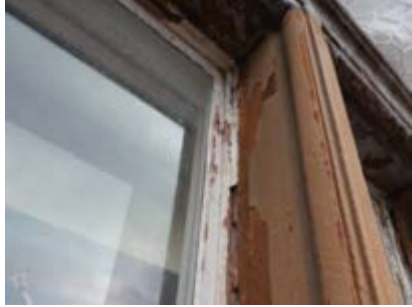
CP15	P1020394-409	Other	Bedroom 241	n/a	n/a	n/a	No internal defects noted. Mullion separating from surrounding frame (external defect)

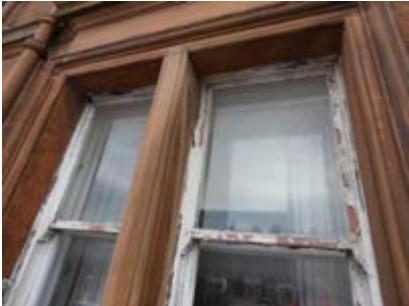
Defect ID	Photo Source	Defect Description	Defect Location	Crack Orientation	Crack Width (mm)	Crack Length (mm)	Comments	Photo	Severity Category
CP16	P1020410-417	Other	Bedroom 243	n/a	n/a	n/a	No internal defects noted. Crack in lintel (external defect)	 	TBC
CP17	P1020377-393	Other	Bedroom 105	n/a	n/a	n/a	No internal defects noted. Separation of frame from blockwork to LHS of window (external defect)

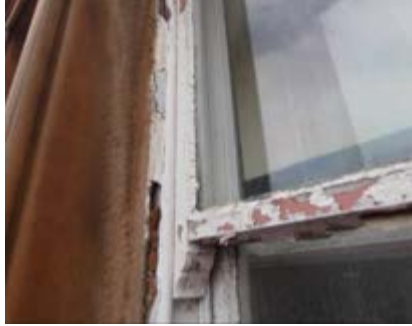
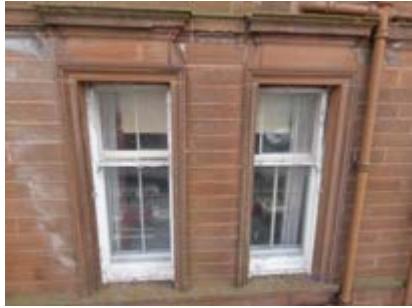
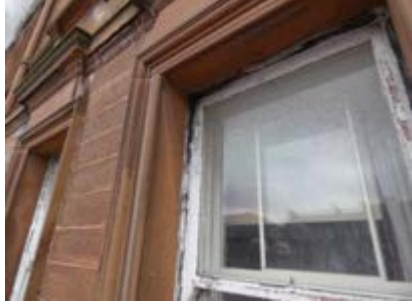
CP18	P1020366-376	Other	Bedroom 107	n/a	n/a	n/a	No internal defects noted. Cracking/gap to lintel to RHS of window (external defect)

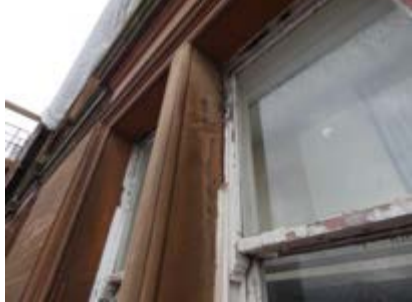
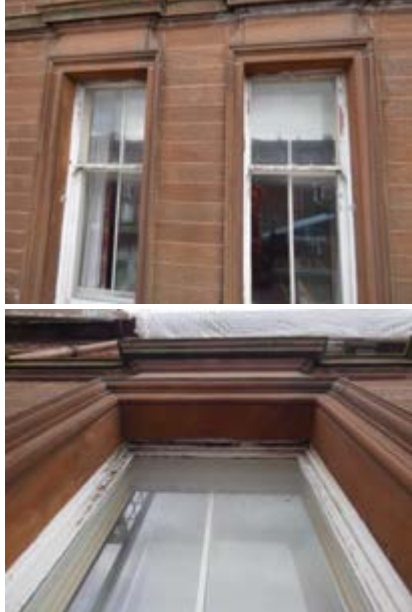
CP21	P1020418-426	Other	Bedroom 117	n/a	n/a	n/a	No internal defects noted. Separation of lintel from frame (external defect)

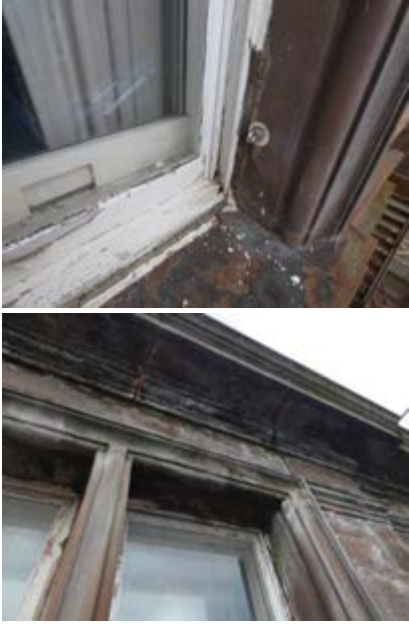
Defect ID	Photo Source	Defect Description	Defect Location	Crack Orientation	Crack Width (mm)	Crack Length (mm)	Comments	Photo	Severity Category
CP22	P1020448-462	Other	Bedroom 347	n/a	n/a	n/a	No internal defects noted. Separation of mullion from frame (external defect)
