# **Ayr Station Hotel Structural Condition Factual Report**

Interim Report

19 August 2019

**Document reference:** 399316ZZ-MMD-00-00-RP-S-002

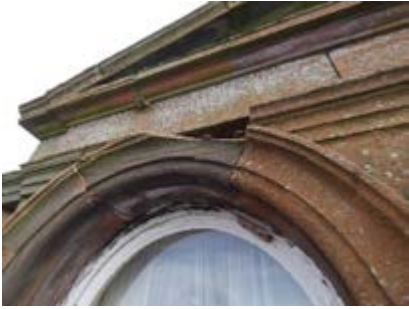
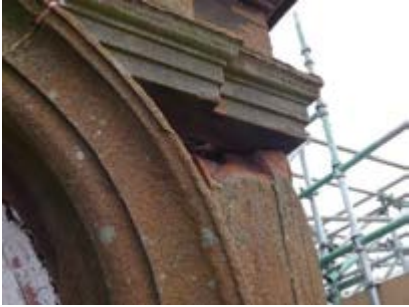
TBC
CP23	P1020266-270	Spalled/damaged sandstone	Stairs adj. Bedroom 301	n/a	n/a	n/a	No internal defects noted. Cracked/broken off sandstone to window arch and below ledge feature (external defects)

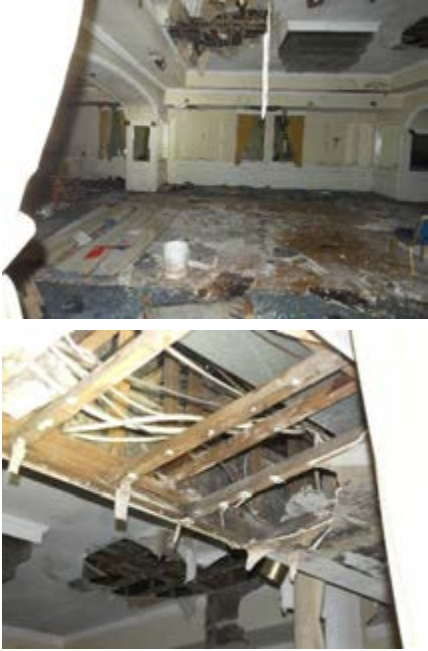
Defect ID	Photo Source	Defect Description	Defect Location	Crack Orientation	Crack Width (mm)	Crack Length (mm)	Comments	Photo	Severity Category
FO01	P1020 716-727, 742-750	Ceiling bulkhead removed, Mould	South Block, Ground level, Kintyre Suite	n/a	n/a	n/a	<p>Looking into the Kintyre Suite, room generally ok.</p> <p>Ceiling removed within bulkhead, support timbers exposed (742, 743), cannot see joists.</p> <p>Ceiling where not removed appears ok. Walls also ok, painted paper on plaster.</p> <p>Some areas of plaster have black mould (749, 750)</p> <p>Carpet in centre lifted, levelling screed on timber battens.</p> <p>The floorboards span onto timber joists. joists sit onto hard floor – possibly concrete. Not just sound deadening material.</p> <p>Floor opened up at window, joists looked dry, sample taken (746, 747).</p>

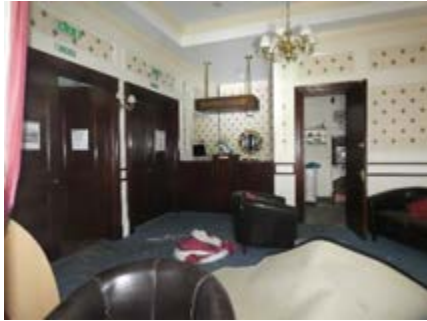
FO02	P1020 731-741	Dampness/water ingress, Other	South block, Ground level, Reception area	n/a	n/a	n/a	<p>Reception area in very good state. Ceiling all intact.</p> <p>Walls also intact – one area of damp (732, 734)</p> <p>Carpet still down on most floor area.</p> <p>Floor opened up, timber boards in good condition. Boards on timber joists on hard floor – possibly concrete (735-739).</p>

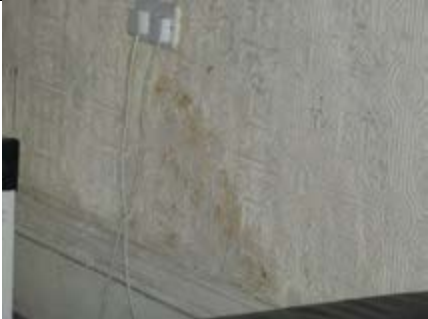
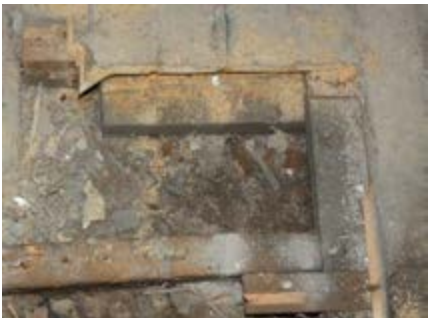
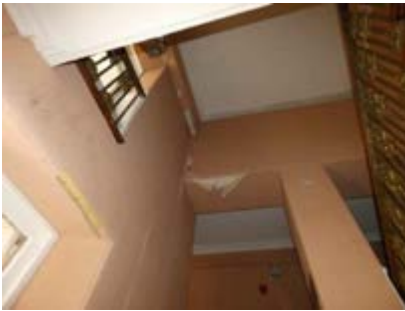
FO03	P1020 463-485	Dampness/ water ingress, Degradation to timbers, Plaster crack, Stain, Other	North block, Staircase (2 <sup>nd</sup> floor)	n/a	n/a	n/a	General condition of area is fair. Signs of water ingress and cracking to plaster. Floor timbers appear in fair condition. Minor signs of damp/water ingress and degradation to joist timbers. Minimal section loss (463-471) Crack to ceiling plaster (472) Crack to ceiling plaster (473) damp stain to wall (474) ceiling collapse to corridor (475- 478)

Defect ID	Photo Source	Defect Description	Defect Location	Crack Orientation	Crack Width (mm)	Crack Length (mm)	Comments	Photo	Severity Category
							<p>Damp staining to wall. Evidence of water ingress (479-482)</p> <p>damp staining to internal wall above window (483)</p> <p>minor signs of degradation to joist timbers. Minimal section loss (484, 485)</p>

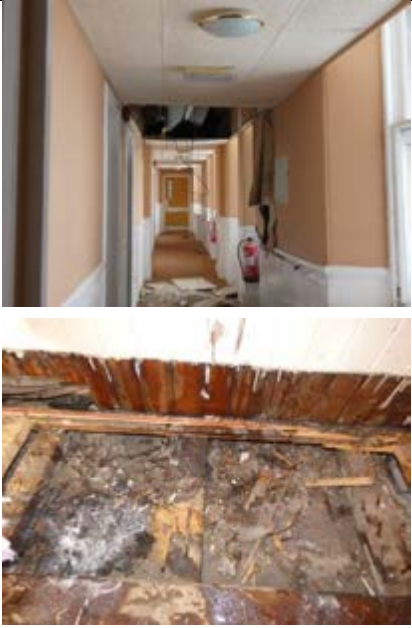
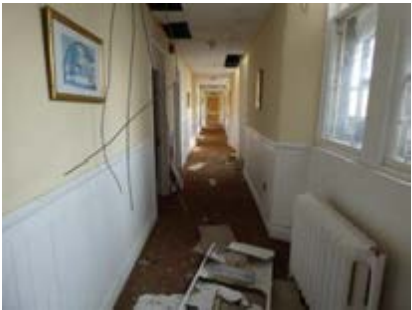
FO04	P1020494-510	Timber degradation, Crack to masonry, Other	North block, Corridor (1 <sup>st</sup> floor)	n/a	n/a	n/a	<p>Joist timbers in good condition. Beam ends supported on soleplate on wall. Minimal section loss to timbers (494-500)</p> <p>Suspended ceiling tile collapse. Possibly taken down by thieves. Evidence of copper pipes removed (499)</p> <p>Crack to masonry at ceiling arch above false ceiling (509, 5110)</p>

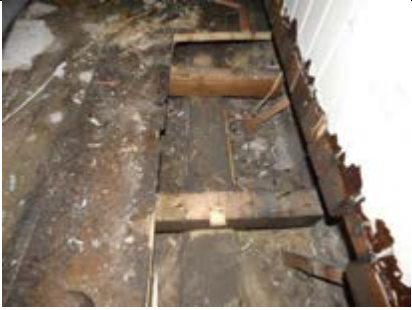
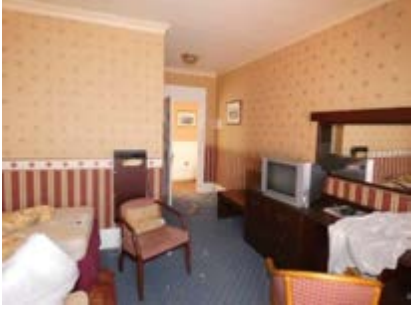
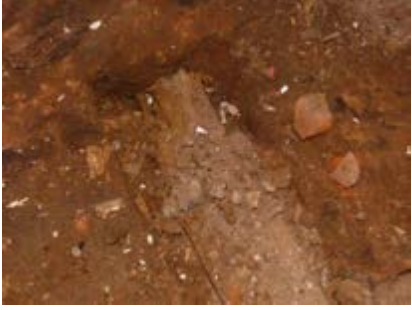
FO05	P1020517-525	Timber degradation	North block, Bedroom 339	n/a	n/a	n/a	General condition is good. Timber joists built into sandstone walls (approx. 200mm bearing). Timbers generally in good condition. Section over walls show minor sign of degradation. Section loss to top of timbers (approx. 30-50mm) noted.

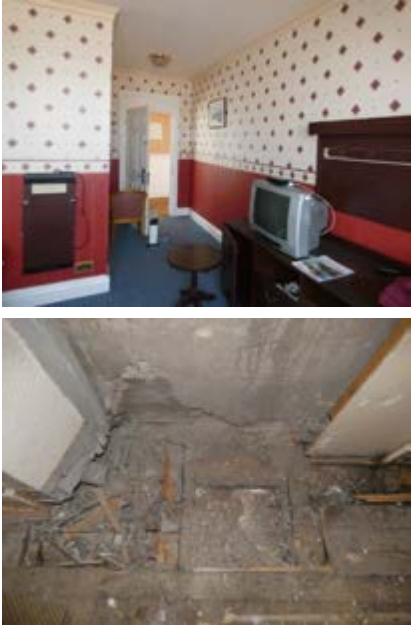
Defect ID	Photo Source	Defect Description	Defect Location	Crack Orientation	Crack Width (mm)	Crack Length (mm)	Comments	Photo	Severity Category
FO06	P1020532-544	Timber degradation	North block, Bedroom 239	n/a	n/a	n/a	<p>General condition is good. Timber joists built into sandstone walls (approx. 200mm bearing). Timbers generally in good condition. Section over walls show minor sign of degradation. Section loss to top of timbers (approx. 30-50mm) noted (532-544).</p> <p>Section loss to top of timber floor joists, top 30-50mm (523).</p>

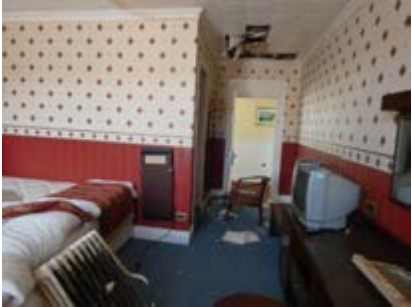
TBC
FO07	P1020548-555	Evidence of water ingress, Collapsed ceiling tiles	North block, Bedroom 111	n/a	n/a	n/a	<p>General condition is fair. Evidence of water ingress to ceiling. Collapsed tiles and signs of water damage. Floor joists run North-South (parallel to wall), timber joists in good condition (548-554).</p> <p>Signs of water ingress to ceiling. Isolated area of collapsed tiles (551).</p> <p>Evidence of water ingress at cornice level (555).</p>

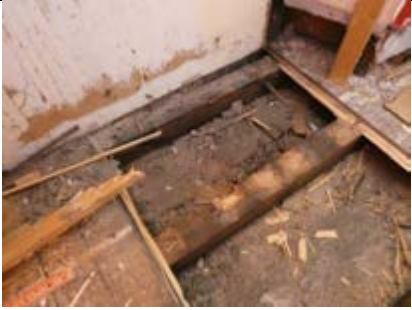
FO08	P1020 555-568	Timber degradation, Evidence of water ingress, Damp staining, Collapsed ceiling tiles	North block, Bedroom 331 / office	n/a	n/a	n/a	<p>General condition is fair/ Timber joists built into sandstone walls (approx. 200mm bearing). Timbers generally in good condition. Section over walls show minor sign of degradation. Minimal section loss to timber noted (556-568).</p> <p>Minor signs of water ingress and related degradation to timber floor joists (558).</p> <p>Damp staining to ceiling tiles (564). Collapsed/removed ceiling tiles (567).</p>

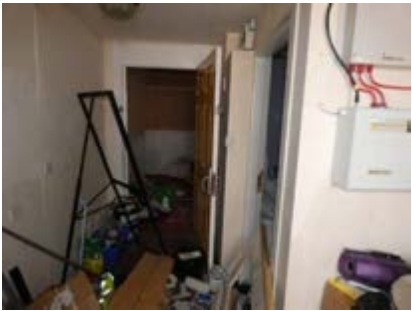
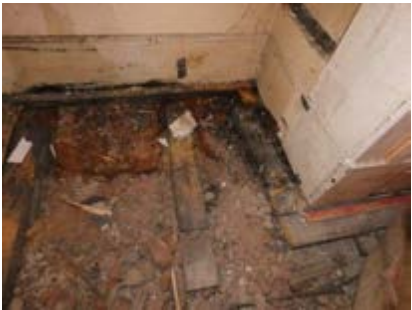
Defect ID	Photo Source	Defect Description	Defect Location	Crack Orientation	Crack Width (mm)	Crack Length (mm)	Comments	Photo	Severity Category
FO09	P1020 569-577	Other	North block, Bedroom 231	n/a	n/a	n/a	General condition is good. Timber joists built into sandstone walls with cantilever end (approx. 150mm). Timbers generally in good condition. No signs of degradation. Room in good condition (569-574).  External defect. Mullion displaced. Evidence of movement away from frame (575-577).

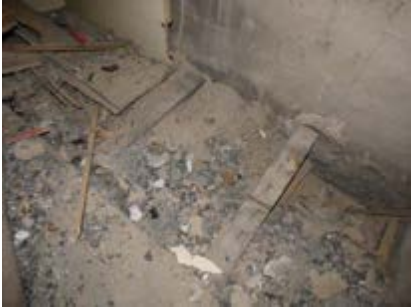
TBC
FO10	P1020 577-591	Other	North block, Bedroom 103 / office	n/a	n/a	n/a	General condition is good. Timber joists built into sandstone walls. Timbers generally in good condition.

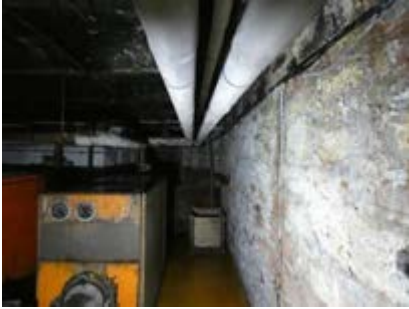
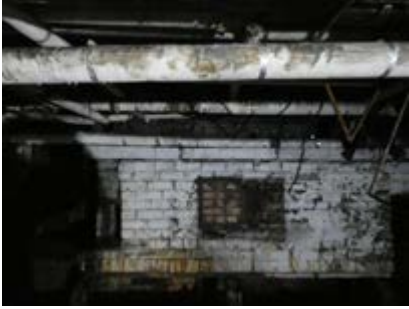
Defect ID	Photo Source	Defect Description	Defect Location	Crack Orientation	Crack Width (mm)	Crack Length (mm)	Comments	Photo	Severity Category
1.1	P1020922-0927	Water ingress	Boilerhouse - ceiling	n/a	n/a	n/a	Water ingress through ceiling. Location of room below leaking tank in roof (likely source of water) water ingress through joints and various spalled/damaged concrete.

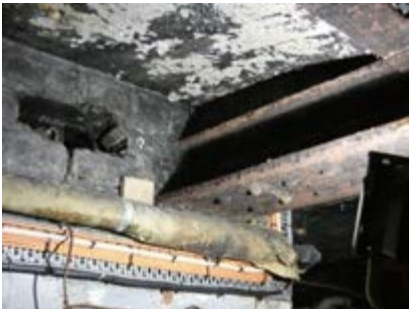
Defect ID	Photo Source	Defect Description	Defect Location	Crack Orientation	Crack Width (mm)	Crack Length (mm)	Comments	Photo	Severity Category
1.5	P1020940	Metal corrosion	Boilerhouse - ceiling	n/a	n/a	n/a	Mild corrosion to 2ndary supporting beams. Minimal section loss

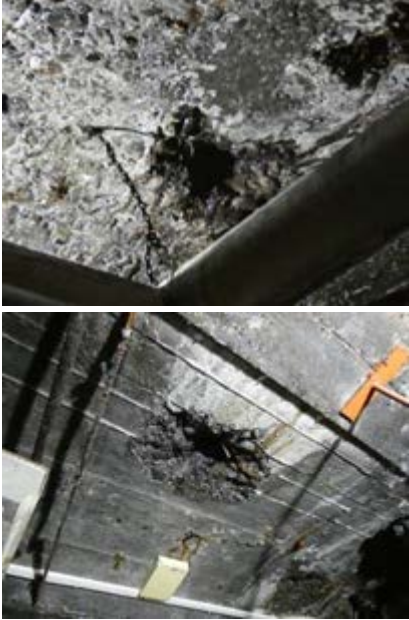
Defect ID	Photo Source	Defect Description	Defect Location	Crack Orientation	Crack Width (mm)	Crack Length (mm)	Comments	Photo	Severity Category
1.7	P1020942	Spalled concrete	Boilerhouse - ceiling	n/a	n/a	n/a	Spalling concrete from arched concrete ceiling.

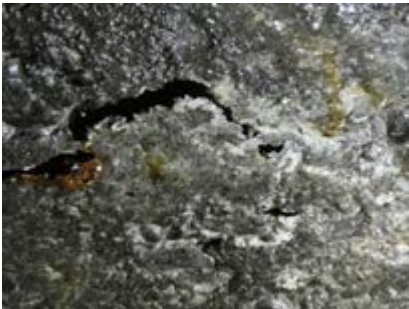
TBC
1.8	P1020954-957	Honeycombing to concrete	Boilerhouse - ceiling	n/a	n/a	n/a	Honeycombing, gaps to concrete where concrete arch meets metal beam. Construction of arch appears to be in-situ concrete cast between web of metal beam

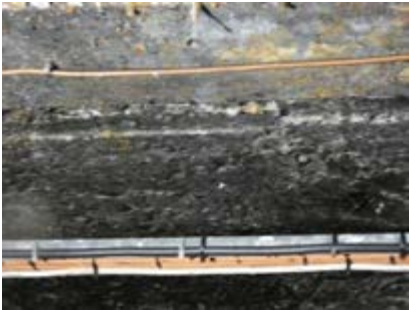
TBC
1.9	P1020973-975	Crumbling/recessed masonry wall	Boilerhouse - ceiling	n/a	n/a	n/a	Crumbling/recessed masonry at junction between wall and concrete arch. 6no. Locations

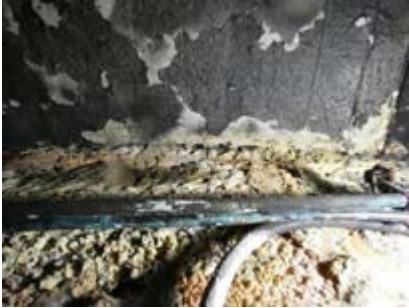
Defect ID	Photo Source	Defect Description	Defect Location	Crack Orientation	Crack Width (mm)	Crack Length (mm)	Comments	Photo	Severity Category
1.10	P1020925, 927	Poor quality concrete	Boilerhouse - ceiling	n/a	n/a	n/a	Poor quality concrete to arches. Aggregate and honeycombing evident. No sign of reinforcement at locations where concrete has collapsed

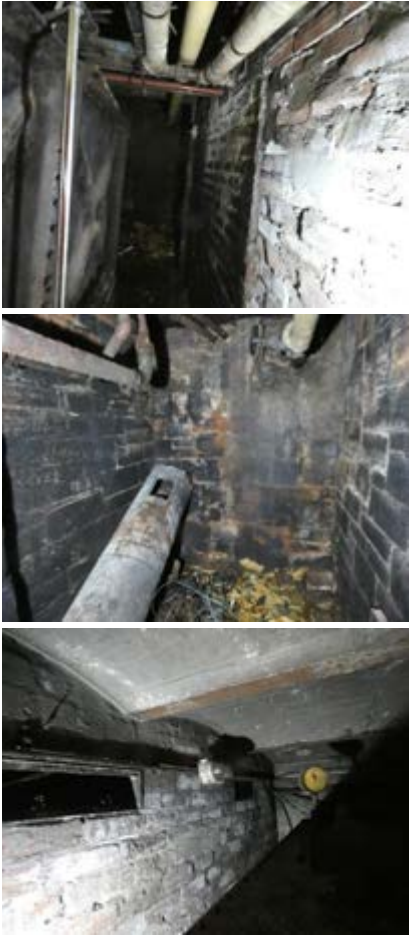
Defect ID	Photo Source	Defect Description	Defect Location	Crack Orientation	Crack Width (mm)	Crack Length (mm)	Comments	Photo	Severity Category
2.1	P1020991-995	Spalled concrete	Oil Tank - ceiling	n/a	n/a	n/a	Spalled concrete to arched roof. 6No. Locations. Approx. 100mm <sup>2</sup> each

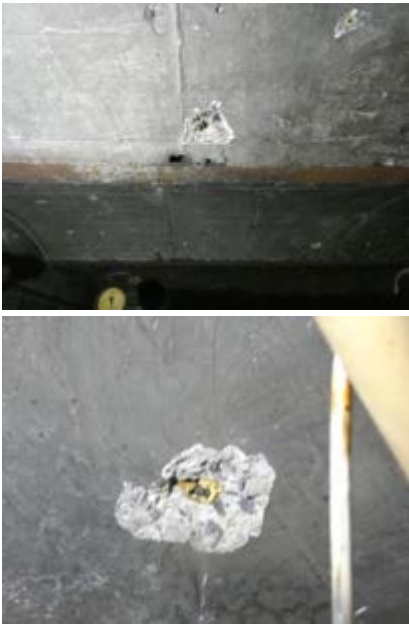
TBC
2.2	P1030016	Metal corrosion	Oil Tank - ceiling	n/a	n/a	n/a	Loose/corroded metal plate to underside of concrete arch. Possible formwork for concrete pour

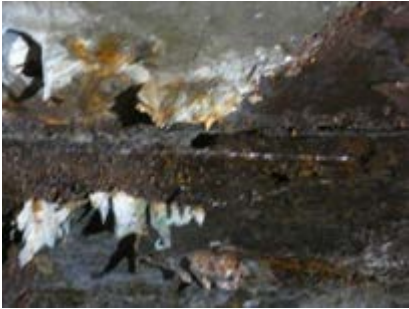
Defect ID	Photo Source	Defect Description	Defect Location	Crack Orientation	Crack Width (mm)	Crack Length (mm)	Comments	Photo	Severity Category
2.3	P1030008	Metal corrosion	Oil Tank - ceiling	n/a	n/a	n/a	Mild corrosion to metal support beam. Minimal section loss

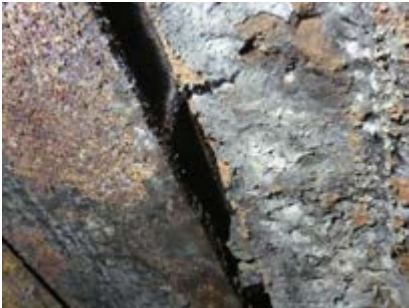
TBC
2.4	P1020985	Poor quality masonry	Oil Tank - walls	n/a	n/a	n/a	Poor quality masonry work to internal walls. Large masonry joints. Loss of mortar.

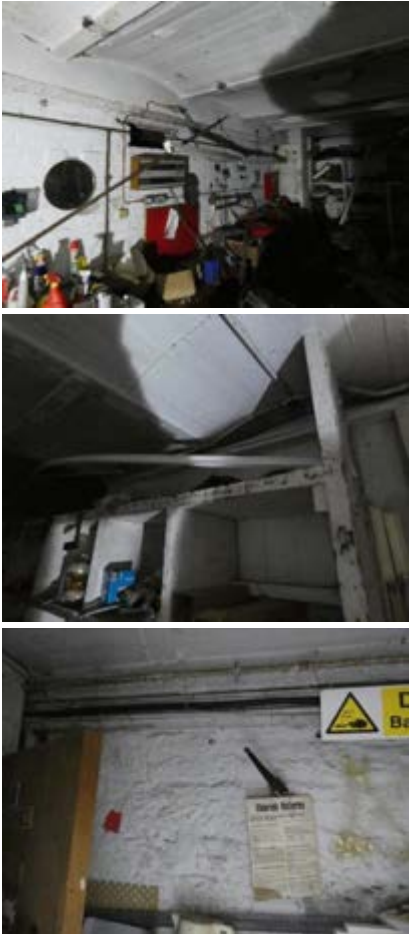
Defect ID	Photo Source	Defect Description	Defect Location	Crack Orientation	Crack Width (mm)	Crack Length (mm)	Comments	Photo	Severity Category
3.1	P1030034-052	Spalled/missing concrete	Battery Room - ceiling	n/a	n/a	n/a	Spalled/missing concrete to arched roof. 12No. Locations. Approx. 100mm <sup>2</sup> each

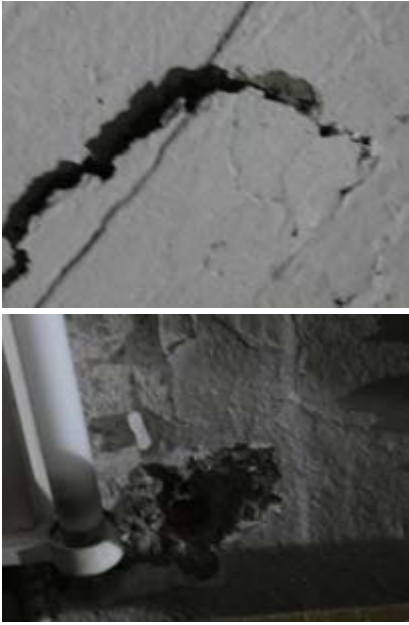
TBC
3.2	P1030056-058	Missing/dislodged concrete	Battery Room - ceiling	n/a	n/a	n/a	Missing/dislodged concrete to arched ceiling

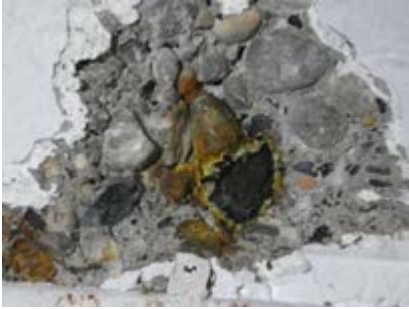
3.3	P1030059-060	Gap in concrete at beam	Battery Room - ceiling	n/a	n/a	n/a	Missing concrete around beam at connection with concrete arch

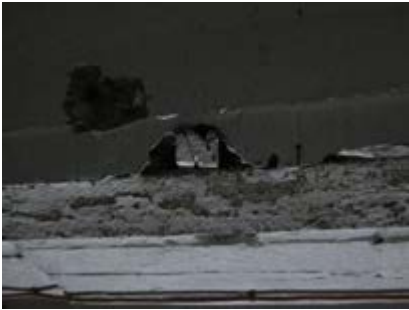
TBC
3.4	P1030061-063	Spalled concrete	Battery Room - ceiling	n/a	n/a	n/a	Spalled concrete patch. No evidence of rebar in concrete

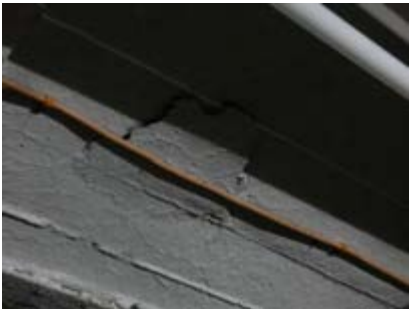
Defect ID	Photo Source	Defect Description	Defect Location	Crack Orientation	Crack Width (mm)	Crack Length (mm)	Comments	Photo	Severity Category
3.5	P1030064-065	Spalled concrete	Battery Room - ceiling	n/a	n/a	n/a	Spalled concrete patch. No evidence of rebar in concrete

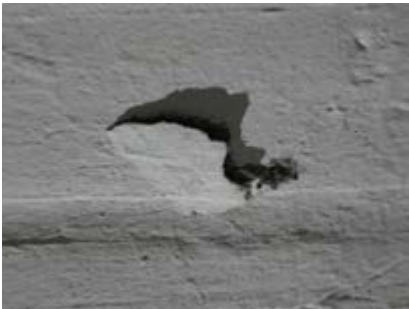
TBC
3.6	P1030066-073	Concrete embedment	Battery Room - ceiling	n/a	n/a	n/a	Wooden wedges embedded in concrete arch. Appears to be left over from construction of arches.

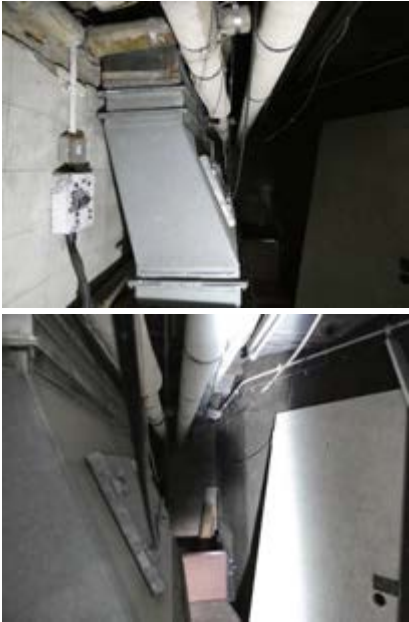
TBC
4.1	P1030084	Metal corrosion	Store 1 - ceiling	n/a	n/a	n/a	Moderate corrosion to metal beam. Minimal section loss. Surrounding concrete breaking away from beam.

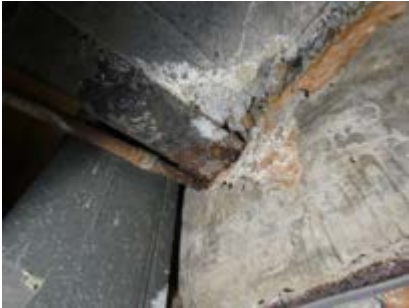
Defect ID	Photo Source	Defect Description	Defect Location	Crack Orientation	Crack Width (mm)	Crack Length (mm)	Comments	Photo	Severity Category
4.2	P1030086-087	Metal corrosion	Store 1 - ceiling	n/a	n/a	n/a	Mild corrosion to metal beam at connection to wall

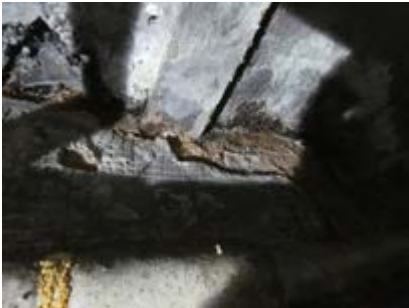
TBC
4.3	P1030088-089 (MP4 file)	Concrete repair	Store 1 - ceiling	n/a	n/a	n/a	Missing concrete patch to ceiling

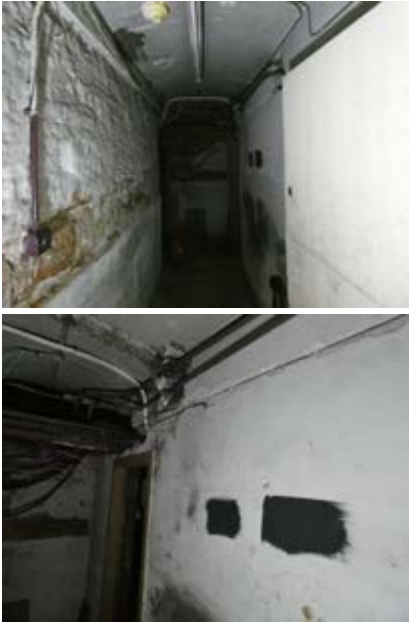
TBC
5.1	P1030164-165	Void in wall	Store 2 – wall	n/a	n/a	n/a	Hole knocked through wall to allow service penetrations. No lintel or support from framing noted

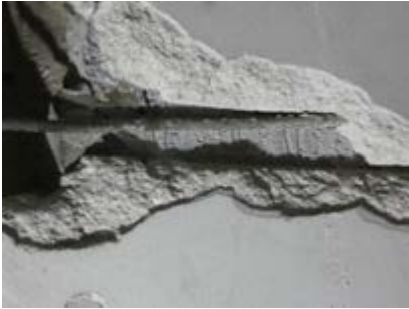
Defect ID	Photo Source	Defect Description	Defect Location	Crack Orientation	Crack Width (mm)	Crack Length (mm)	Comments	Photo	Severity Category
5.2	P1030166-169	Void in wall	Store 2 – wall	n/a	n/a	n/a	Hole knocked through wall to allow service penetrations. No lintel or support from framing noted

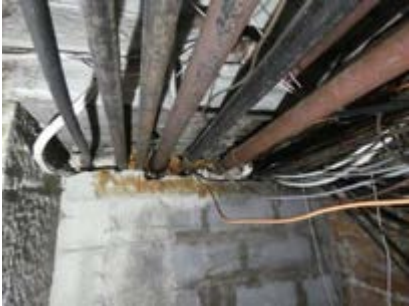
Defect ID	Photo Source	Defect Description	Defect Location	Crack Orientation	Crack Width (mm)	Crack Length (mm)	Comments	Photo	Severity Category
5.4	P1030172-173	Void in wall	Store 2 – wall	n/a	n/a	n/a	Hole knocked through wall to allow service penetrations. No lintel or support from framing noted

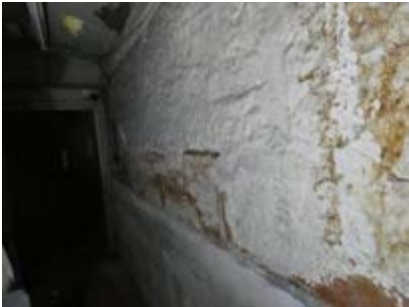
TBC
5.5	P1030174-175	Staining	Store 2 – wall	n/a	n/a	n/a	Staining to wall. Indicative of damp

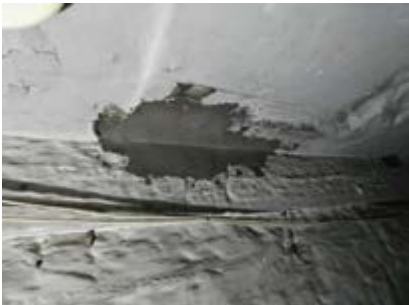
TBC
5.6	P1030176-177	Concrete loss	Store 2 – ceiling	n/a	n/a	n/a	Evidence of spalled/missing concrete. Historic concrete repair noted

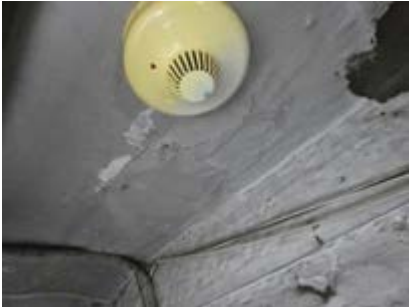
Defect ID	Photo Source	Defect Description	Defect Location	Crack Orientation	Crack Width (mm)	Crack Length (mm)	Comments	Photo	Severity Category
5.7	P1030178-181	Spalled concrete	Store 2 – ceiling	n/a	n/a	n/a	Cracks to concrete. Possible indication of early stages of spalling

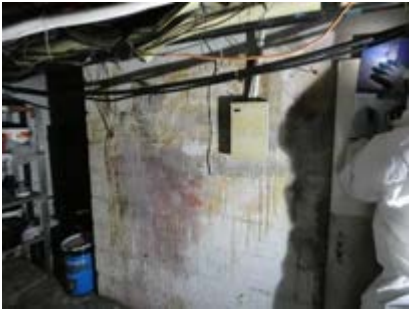
TBC
6.1	P1030138	Staining	Store 3 - wall	n/a	n/a	n/a	Staining to wall. Indicative of damp

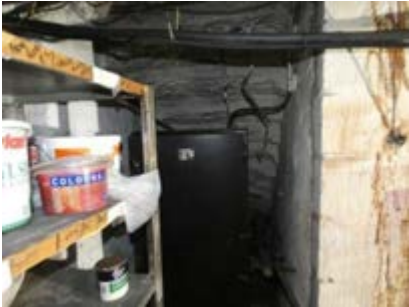
Defect ID	Photo Source	Defect Description	Defect Location	Crack Orientation	Crack Width (mm)	Crack Length (mm)	Comments	Photo	Severity Category
6.2	P1030139-140	Staining	Store 3 - wall	n/a	n/a	n/a	Staining to wall. Indicative of damp

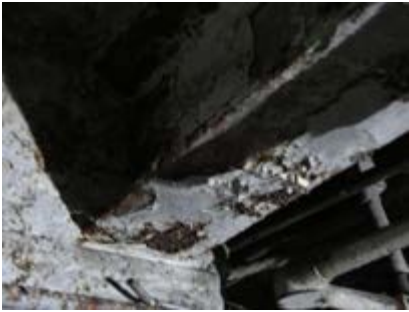
TBC
6.3	P1030143-144	Metal corrosion	Store 3 - wall	n/a	n/a	n/a	Minor corrosion to metal beam end at connection to wall. Minimal section loss

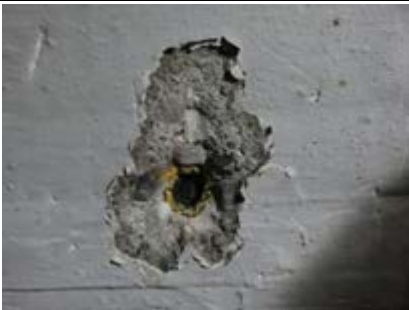
Defect ID	Photo Source	Defect Description	Defect Location	Crack Orientation	Crack Width (mm)	Crack Length (mm)	Comments	Photo	Severity Category
6.5	P1030147-148	Spalled/missing concrete	Store 3 - ceiling	n/a	n/a	n/a	Spalled/missing concrete from ceiling

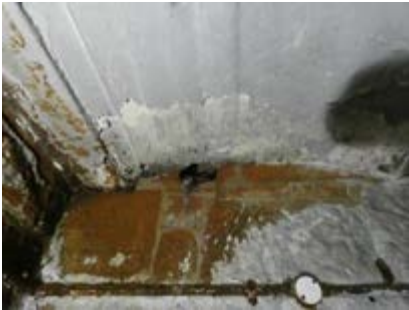
TBC
6.6	P1030151-152	Hole in wall	Store 3 - wall	n/a	n/a	n/a	Void/hole in wall at corner

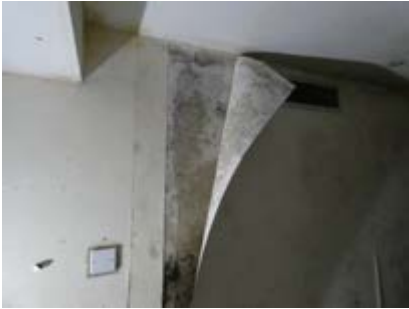
TBC
7.1	P1030245-250	Damp staining	Corridor 1 - walls	n/a	n/a	n/a	Damp staining to plasterboard walls

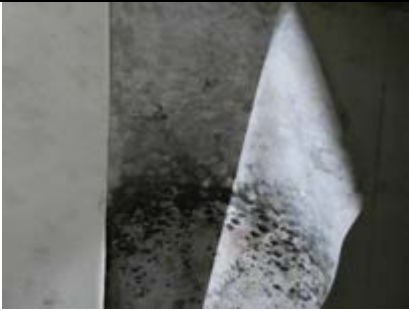
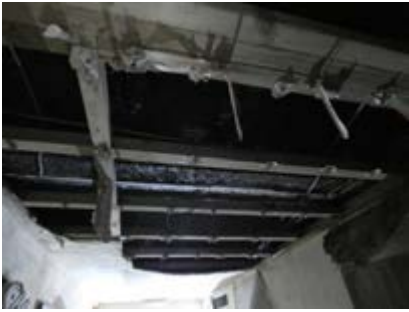
7.2	P1030251-254	Collapsed ceiling	Corridor 1 - ceiling	n/a	n/a	n/a	Plasterboard suspended ceiling collapsed. Approx. 2m x 10m.

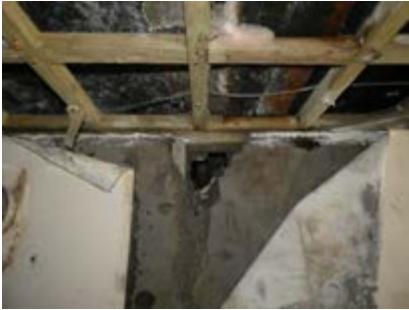
TBC
7.3	P1030255-256	Plasterboard damage	Corridor 1 - walls	n/a	n/a	n/a	Hole in plasterboard wall. Approx. 300mm x 300mm

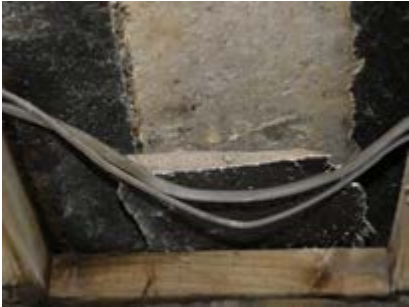
Defect ID	Photo Source	Defect Description	Defect Location	Crack Orientation	Crack Width (mm)	Crack Length (mm)	Comments	Photo	Severity Category
7.4	P1030257-259	Concrete damage	Corridor 1 - ceiling	n/a	n/a	n/a	Concrete/render collapse from ceiling

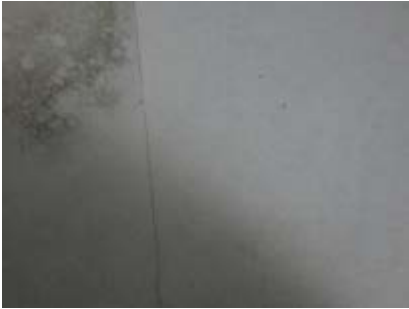
TBC
8.1	P1030216-219	Plaster crack	Hall 1 - ceiling	Horizontal	>1	3000	Crack to plaster ceiling

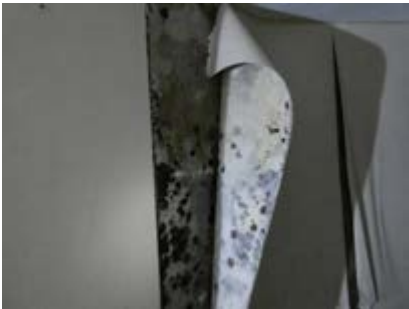
Defect ID	Photo Source	Defect Description	Defect Location	Crack Orientation	Crack Width (mm)	Crack Length (mm)	Comments	Photo	Severity Category
8.2	P1030220-227	Damp staining	Hall 1 - walls	n/a	n/a	n/a	Damp staining to walls. Wallpaper peeling. Indicative of water ingress

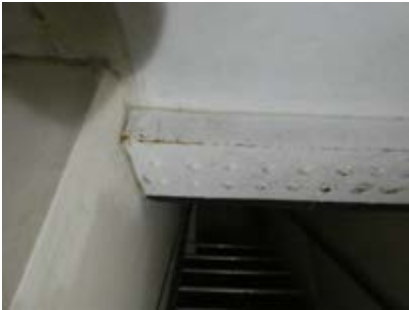
TBC
8.3	P1030228-230	Metal corrosion	Hall 1 - ceiling	n/a	n/a	n/a	Mild corrosion to metal support beam. Minimal section loss

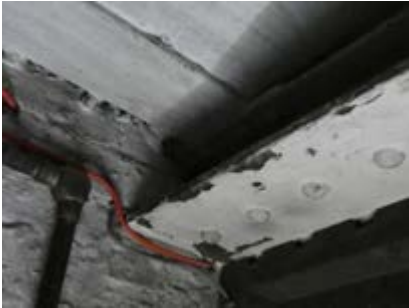
TBC
9.1	P1030189-190	Metal corrosion	Lift Motor Room - ceiling	n/a	n/a	n/a	Mild corrosion to metal support beam. Minimal section loss

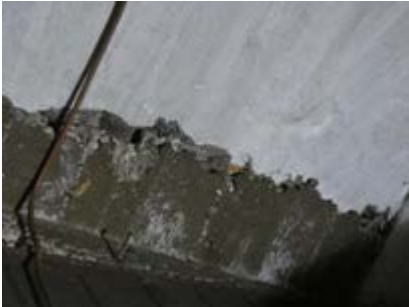
Defect ID	Photo Source	Defect Description	Defect Location	Crack Orientation	Crack Width (mm)	Crack Length (mm)	Comments	Photo	Severity Category
9.2	P1030191-196	Concrete/render failure	Lift Motor Room - ceiling	n/a	n/a	n/a	Concrete/render collapse from ceiling

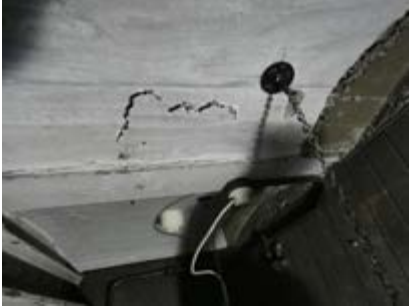
TBC
9.3	P1030197-200	Spalled concrete	Lift Motor Room - ceiling	n/a	n/a	n/a	Spalled/damaged concrete to ceiling

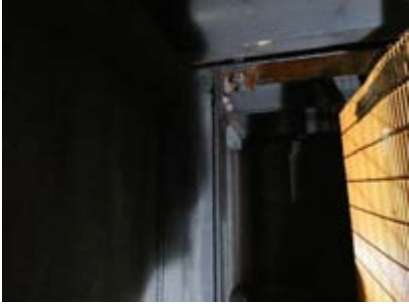
TBC
9.4	P1030201-205	Metal corrosion	Lift Motor Room - ceiling	n/a	n/a	n/a	Corrosion to lift support steelwork

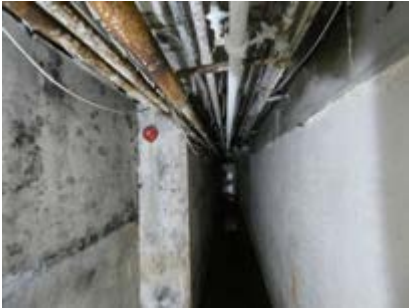
TBC
10.1	P1030322-332	Damp staining	Corridor 2 - walls	n/a	n/a	n/a	Damp staining to walls throughout corridor

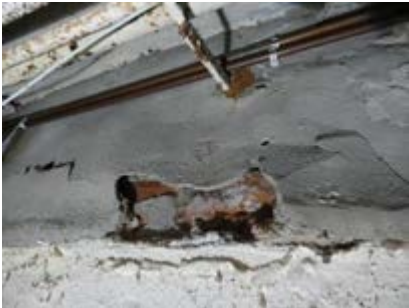
Defect ID	Photo Source	Defect Description	Defect Location	Crack Orientation	Crack Width (mm)	Crack Length (mm)	Comments	Photo	Severity Category
10.2	P1030333-338	Cracked render	Corridor 2 - walls	n/a	n/a	n/a	Cracking to render over stone walls

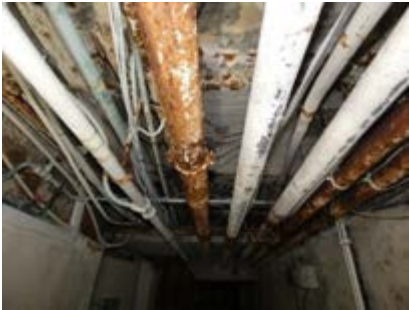
TBC
10.3	P1030339-344	Metal corrosion	Corridor 2 - ceiling	n/a	n/a	n/a	Mild corrosion to steelwork and pipework in corridor

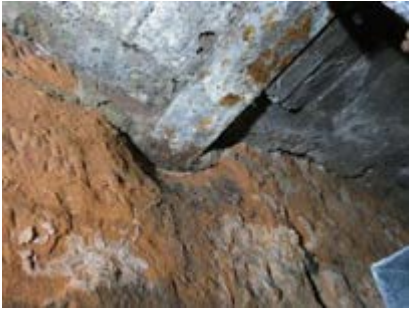
TBC
11.1	P1030265-266	Metal corrosion	Service Corridor - wall	n/a	n/a	n/a	Damp staining to stonework, mild corrosion to steelwork

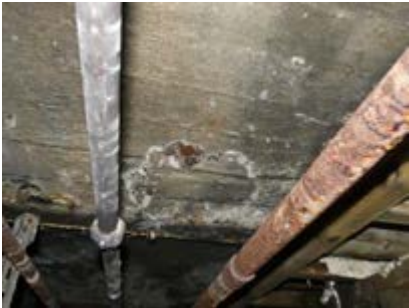
Defect ID	Photo Source	Defect Description	Defect Location	Crack Orientation	Crack Width (mm)	Crack Length (mm)	Comments	Photo	Severity Category
11.2	P1030267-268	Spalled concrete	Service Corridor - ceiling	n/a	n/a	n/a	Spalled/damaged concrete to ceiling

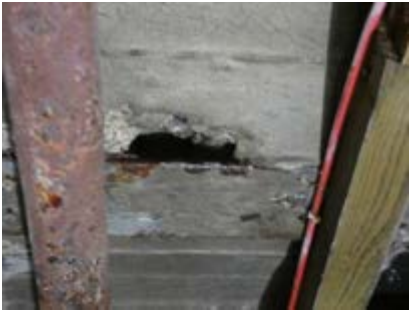
TBC
11.3	P1030269-270	Missing/detached concrete	Service Corridor - roof/beam	n/a	n/a	n/a	Missing/detached concrete from interface between concrete arch and metal beam

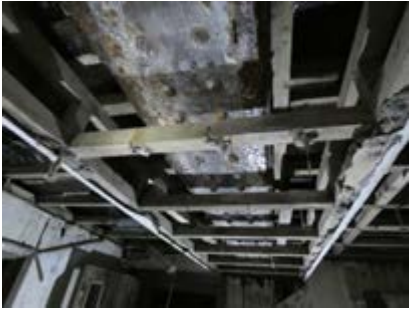
TBC
12.1	P1030281-286	Plaster failure	Gymnasium - ceiling	n/a	n/a	n/a	Missing plasterboard to suspended ceiling

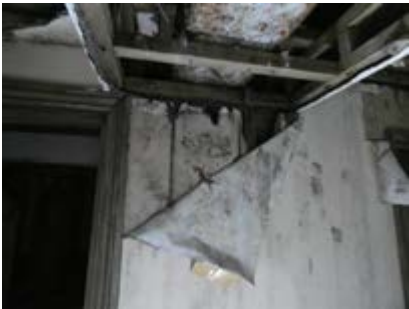
Defect ID	Photo Source	Defect Description	Defect Location	Crack Orientation	Crack Width (mm)	Crack Length (mm)	Comments	Photo	Severity Category
12.2	P1030287-293	Damp staining	Gymnasium - ceiling	n/a	n/a	n/a	Damp staining to walls, wallpaper peeling

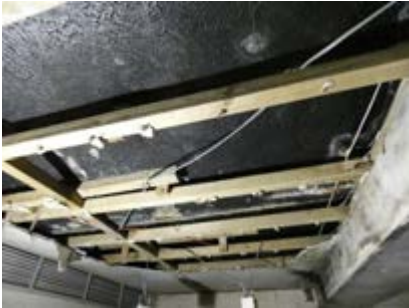
TBC
13.1	P1030369-373	Plaster failure	Reception - ceiling	n/a	n/a	n/a	Plasterboard ceiling collapse. Approx. 4m x 4m

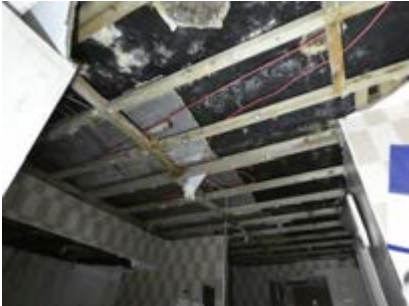
TBC
14.1	P1030443-450	Plaster failure	Changing room 1 - ceiling	n/a	n/a	n/a	Plasterboard ceiling collapsed. Approx. 3m x 6m

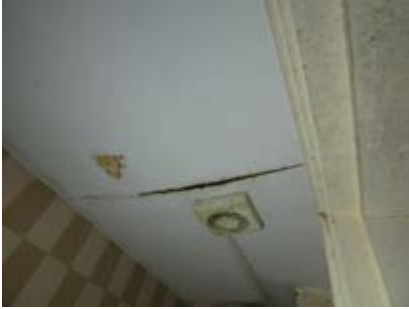
Defect ID	Photo Source	Defect Description	Defect Location	Crack Orientation	Crack Width (mm)	Crack Length (mm)	Comments	Photo	Severity Category
14.2	P1030451-452	Missing/detached concrete	Changing room 1 - ceiling	n/a	n/a	n/a	Missing/detached concrete from ceiling	 	TBC
14.3	P1030453-454	Missing/detached concrete	Changing room 1 - ceiling	n/a	n/a	n/a	Missing/detached concrete from ceiling	 	TBC
14.4	P1030455-456	Crack	Changing room 1 - ceiling	Horizontal	2-5	1000	Crack to ceiling.

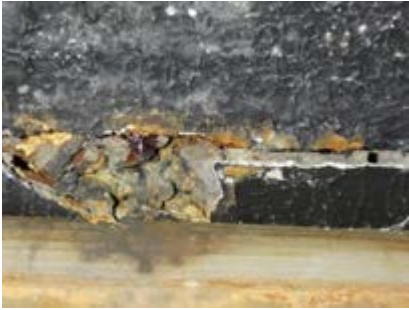
Defect ID	Photo Source	Defect Description	Defect Location	Crack Orientation	Crack Width (mm)	Crack Length (mm)	Comments	Photo	Severity Category
15.2	P1030483-486	Concrete failure	Changing room 2 - ceiling	n/a	n/a	n/a	Crumbling concrete at beam

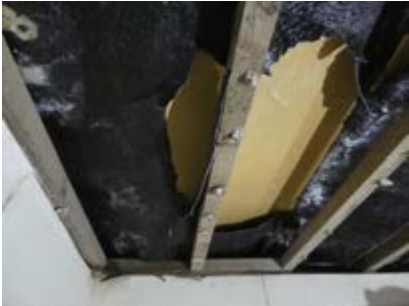
TBC
16.1	P1030393-399	Coating failure	Solarium - ceiling	n/a	n/a	n/a	Roof coating below concrete ceiling delaminating

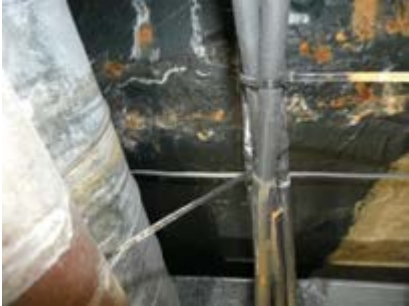
Defect ID	Photo Source	Defect Description	Defect Location	Crack Orientation	Crack Width (mm)	Crack Length (mm)	Comments	Photo	Severity Category
17.3	P1030426-428	Metal corrosion	Store 4 - ceiling	n/a	n/a	n/a	Mild corrosion to metal beam in ceiling. Beam obscured by ceiling finishes. Extent of corrosion not clear

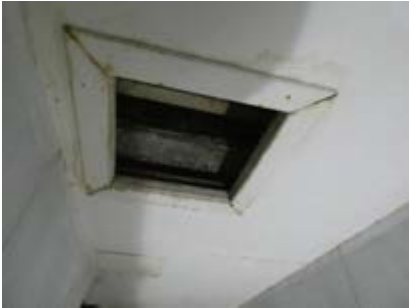
TBC
18.1	P1030500-506	Metal corrosion	Corridor 4 - ceiling	n/a	n/a	n/a	Mild corrosion to metal support beam. Minimal section loss

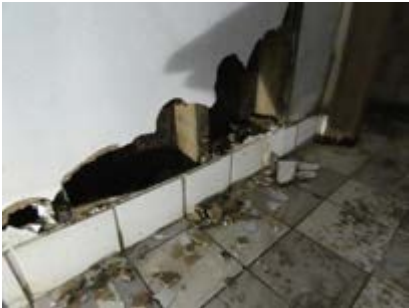
Defect ID	Photo Source	Defect Description	Defect Location	Crack Orientation	Crack Width (mm)	Crack Length (mm)	Comments	Photo	Severity Category
18.2	P1030507-510	Plaster failure	Corridor 4 - wall	n/a	n/a	n/a	Hole in plasterboard wall

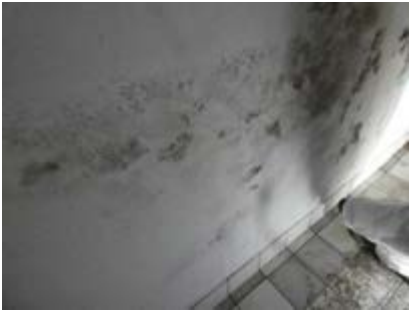
TBC
18.3	P1030511-516	Damp staining	Corridor 4 - wall	n/a	n/a	n/a	Damp staining to walls

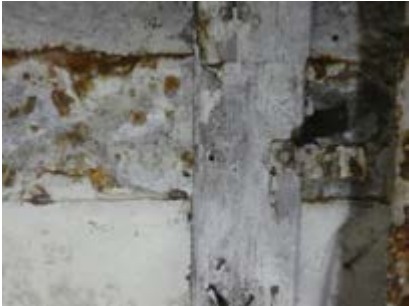
TBC
19.1	P1030544-553	Metal corrosion	Corridor 3 - ceiling	n/a	n/a	n/a	Mild corrosion to metal support beam. Minimal section loss

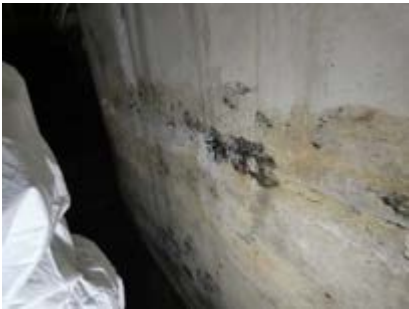
Defect ID	Photo Source	Defect Description	Defect Location	Crack Orientation	Crack Width (mm)	Crack Length (mm)	Comments	Photo	Severity Category
19.2	P1030554-560	Damp staining	Corridor 3 - wall	n/a	n/a	n/a	Damp staining to walls throughout corridor

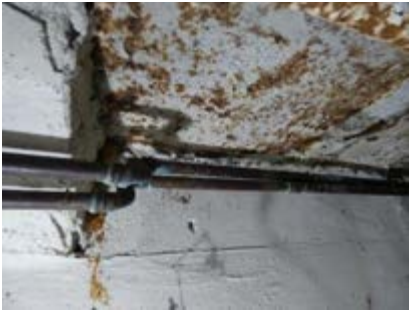
TBC
19.3	P1030561-564	Metal corrosion	Corridor 3 - ceiling	n/a	n/a	n/a	Mild corrosion to metal support beam. Minimal section loss

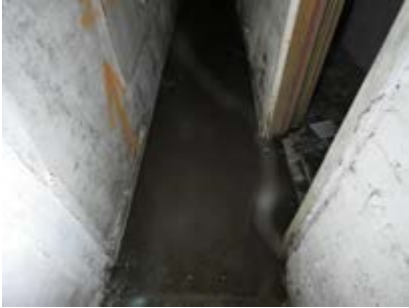
TBC
19.4	P1030565-568	Standing water	Corridor 3 - floor	n/a	n/a	n/a	Standing water on floor.

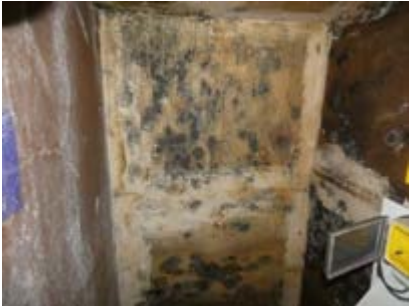
TBC
20.1	P1030577-580	Damp staining	Plant Room - wall	n/a	n/a	n/a	Damp staining to ceiling and walls

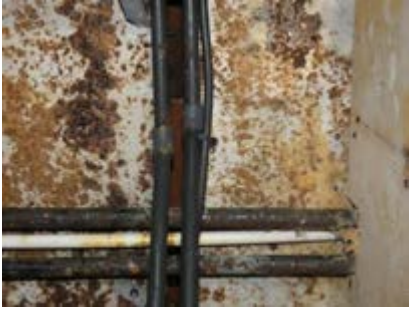
Defect ID	Photo Source	Defect Description	Defect Location	Crack Orientation	Crack Width (mm)	Crack Length (mm)	Comments	Photo	Severity Category
20.2	P1030587-591	Metal corrosion	Plant Room - ceiling	n/a	n/a	n/a	Mild corrosion to metal support beams. Minimal section loss

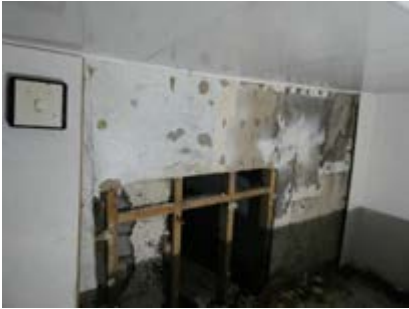
TBC
21.1	P1030605-608	Plaster failure	Jacuzzi - wall	n/a	n/a	n/a	Area of pvc missing and plaster missing behind

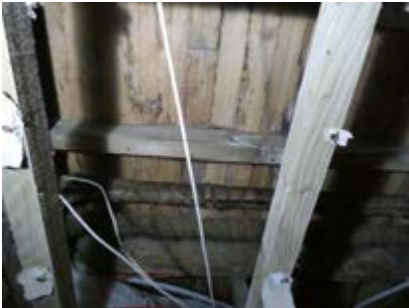
Defect ID	Photo Source	Defect Description	Defect Location	Crack Orientation	Crack Width (mm)	Crack Length (mm)	Comments	Photo	Severity Category
21.5	P1030619-625	Timber defect	Jacuzzi - ceiling	n/a	n/a	n/a	Evidence of warping to timber floor

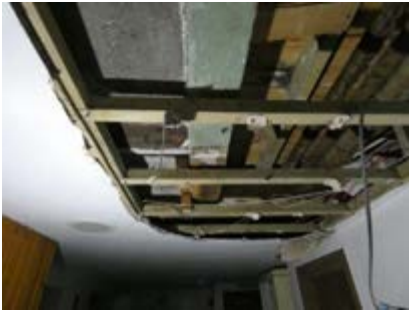
TBC
21.6	P1030626-628	Metal corrosion	Jacuzzi - ceiling	n/a	n/a	n/a	Mild corrosion to metal support beams. Minimal section loss

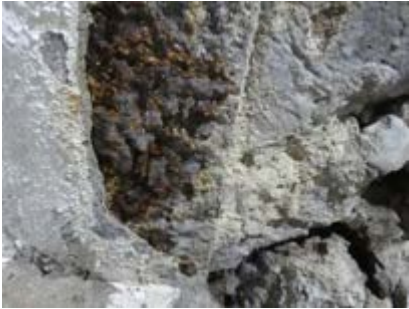
TBC
22.1	P1030644-648	Render failure	Store 5 - ceiling	n/a	n/a	n/a	Localised render collapse

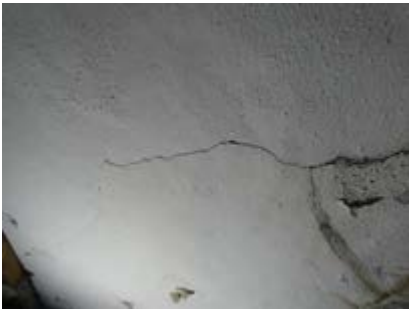
Defect ID	Photo Source	Defect Description	Defect Location	Crack Orientation	Crack Width (mm)	Crack Length (mm)	Comments	Photo	Severity Category
22.2	P1030649-653	Cracking to render	Store 5 - ceiling	n/a	n/a	n/a	Cracking to render on ceiling

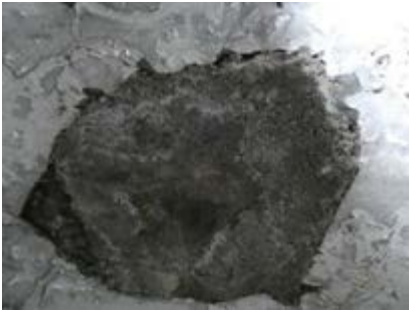
TBC
22.3	P1030654-655	Missing/detached concrete	Store 5 - ceiling	n/a	n/a	n/a	Missing/detached concrete from ceiling

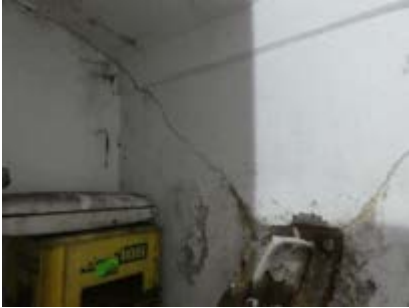
TBC
22.4	P1030656-661	Cracking to render	Store 5 - wall	n/a	n/a	n/a	Cracking to render on wall
